SUBJECT: Lowering of the Tail Pipe
MODEL AFFECTED: M20D, Serial Numbers 1, 101 through 160
TIME OF COMPLIANCE: Within the next 25 hours of operation

This Service Letter reidentified as
 Service Bulletin M 20-111
 per Service Instruction M20-15.

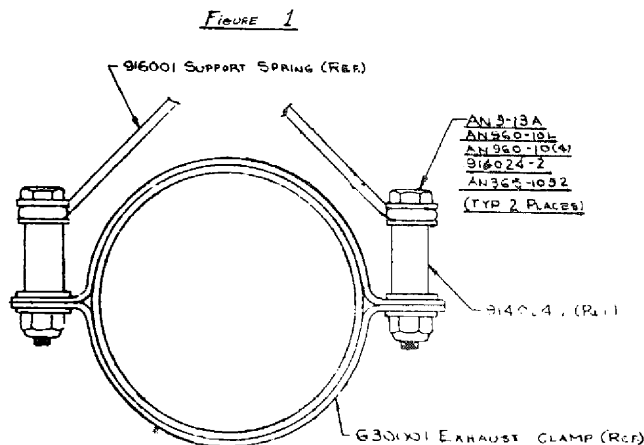
To insure a greater margin of safety from carbon monoxide entering the cabin, we recommend that the tail pipe pipe on M20D aircraft be lowered.

1. Remove the right side cowling.
2. Remove the two AN3-7A bolts which secure the 630001 exhaust pipe clamp to the 916001 support spring.
3. Install the 914024-2 bushings (2).
4. Install the AN3-13A bolts through the 914024-2 bushings and the 630001 clamp as per Figure 1.
5. Remove the right side cowl flap.
6. Modify the cowl flap as per Figure 2.
7. Install the modified cowl flap.
8. Install the right side cowling.
