This Service Letter reidentified as
Service Bulletin M 20-115
per Service Instruction M20-15.

SUBJECT: Inspection and Repair of Wheel Well Plate to
Wing Skin Attachment

MODELS AFFECTED: M20C, Serials 2506 thru 2622
M20E, Serials 101 thru 200

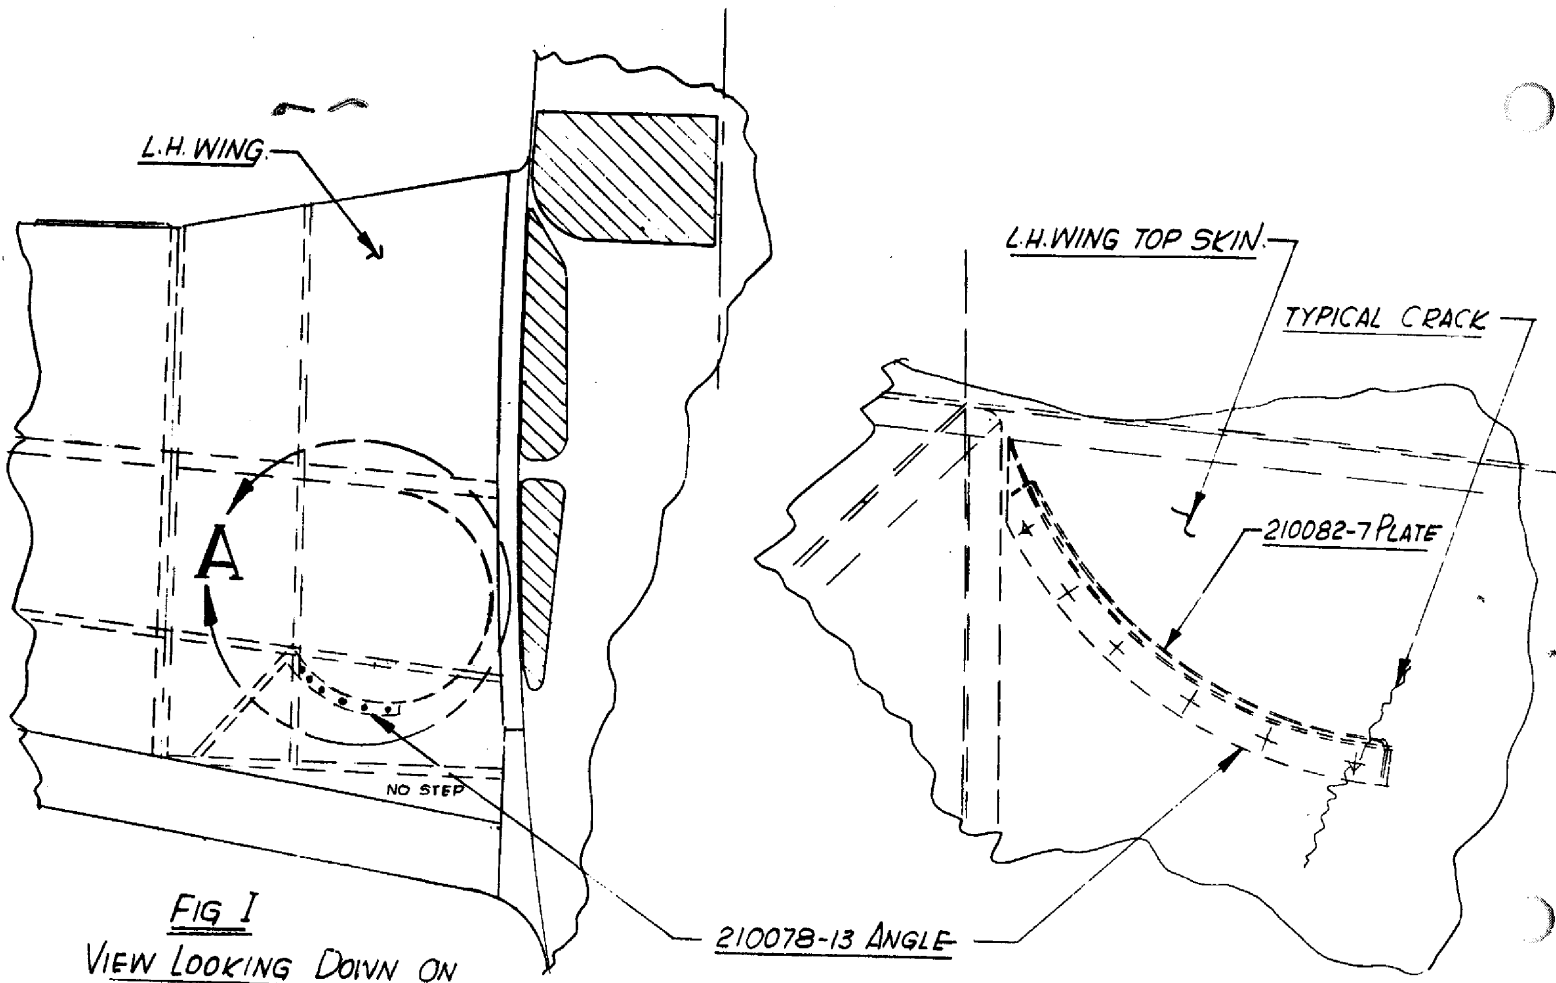
FIG 1
VIEW LOOKING DOWN ON AIRPLANE

There have been occurrences of fatigue cracks developing in the top left wing skin, above the main gear wheel well at the attach of Part No. 210078-13 angle. This service letter describes the inspection for and repair of such cracks if they develop.

1. At each 100 hour inspection, check the area described in Figure 1 for cracks from the last rivet attaching the wheel well plate to the top wing skin.
2. If cracks are found, remove 210082-7 plate and 210078-13 attach angle shown in Figure 1.
3. Cut out circular hole around crack, with edge of hole $\frac{1}{4}$ " minimum beyond the crack. Cut and locate a doubler per Figure 2 and rivet it and 210078-13 angle to the wing skin. Cut and install a filler plate to the attach angle and the doubler plate as shown.
4. Replace 210082-7 plate with $\frac{1}{8}$ " dia. rivets (may be blind rivets).
5. Repair may be smoothed over with any standard aerodynamic smoother (or body filler) before painting.
6. After repair has been accomplished, further inspection as described in Step 1 will not be necessary.
