## SERVICE LETTER 20-13

. Kit Turn & Bank Indicator Mounting Spacer.

MODELS AFFECTED: 1002 Thru 1043

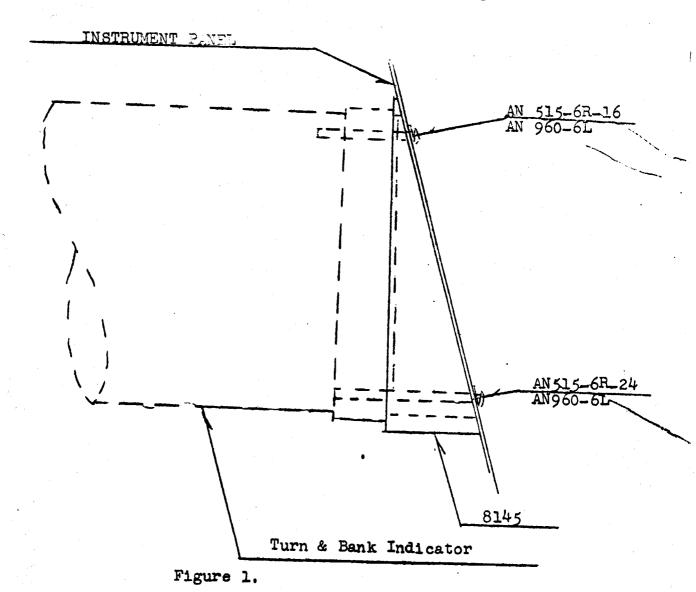
In several cases the turn and bank indicator on the M-20 has been replaced becaused it was not working properly. This is probably due to the fact that it is not mounted parallel to the line of thrust. In an attempt to correct this situation, a spacer is now being installed on production models. This kit is enclosed without charge for installation on units in the field as shown in figure one.
