LOUIS SCHREINER FIELD . KERRVILLE, TEXAS

Service Bulletin

NUMBER: M20-138

Replacement Tail Truss Part No. 480007

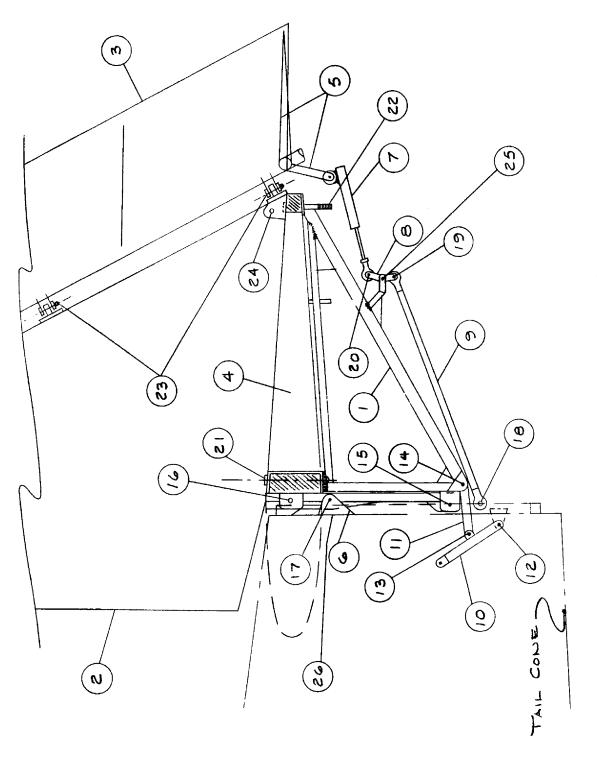
FIG 1 - EMPENNAGE INSTALLATION

This service bulletin is issued to advise of the approval and availability of a new designed truss, Part No. 480007. By installing this truss on the above referenced aircraft, this will eliminate the requirements shown on Airworthiness Directive 65-22-3 issued September 16, 1965, and amendment effective November 4, 1965. The new truss should be inspected on each 100-hour or annual inspection in the same manner as all other structure.

- 4. Remove the upper attach bolts (item 17, fig. 1) and the lower bolt (item 14, fig. 1). Also disconnect the tube at the tail cone bulkhead (item 18, fig. 1) and remove the empennage carefully.

- 5. Exchange trusses and carefully inspect the bolts and bushings for excessive wear. Replace if wear is evident.
- 6. Install the empennage as previously installed. With the two upper empennage attach bolts installed, check the alignment of the 7108 link (item 11, fig. 1) with the U-fitting on the 480007 tail truss (item 14, fig. 1) as described in items 5 and 6 of the instructions in Mooney Service Bulletin 20-60 (formerly service letter).
