SUBJECT: Replacement of Bolts – Main Gear Retract Truss Bracket

MODELS AFFECTED: M20C S/N 2807 thru 3466
M20E S/N 470 thru 1270

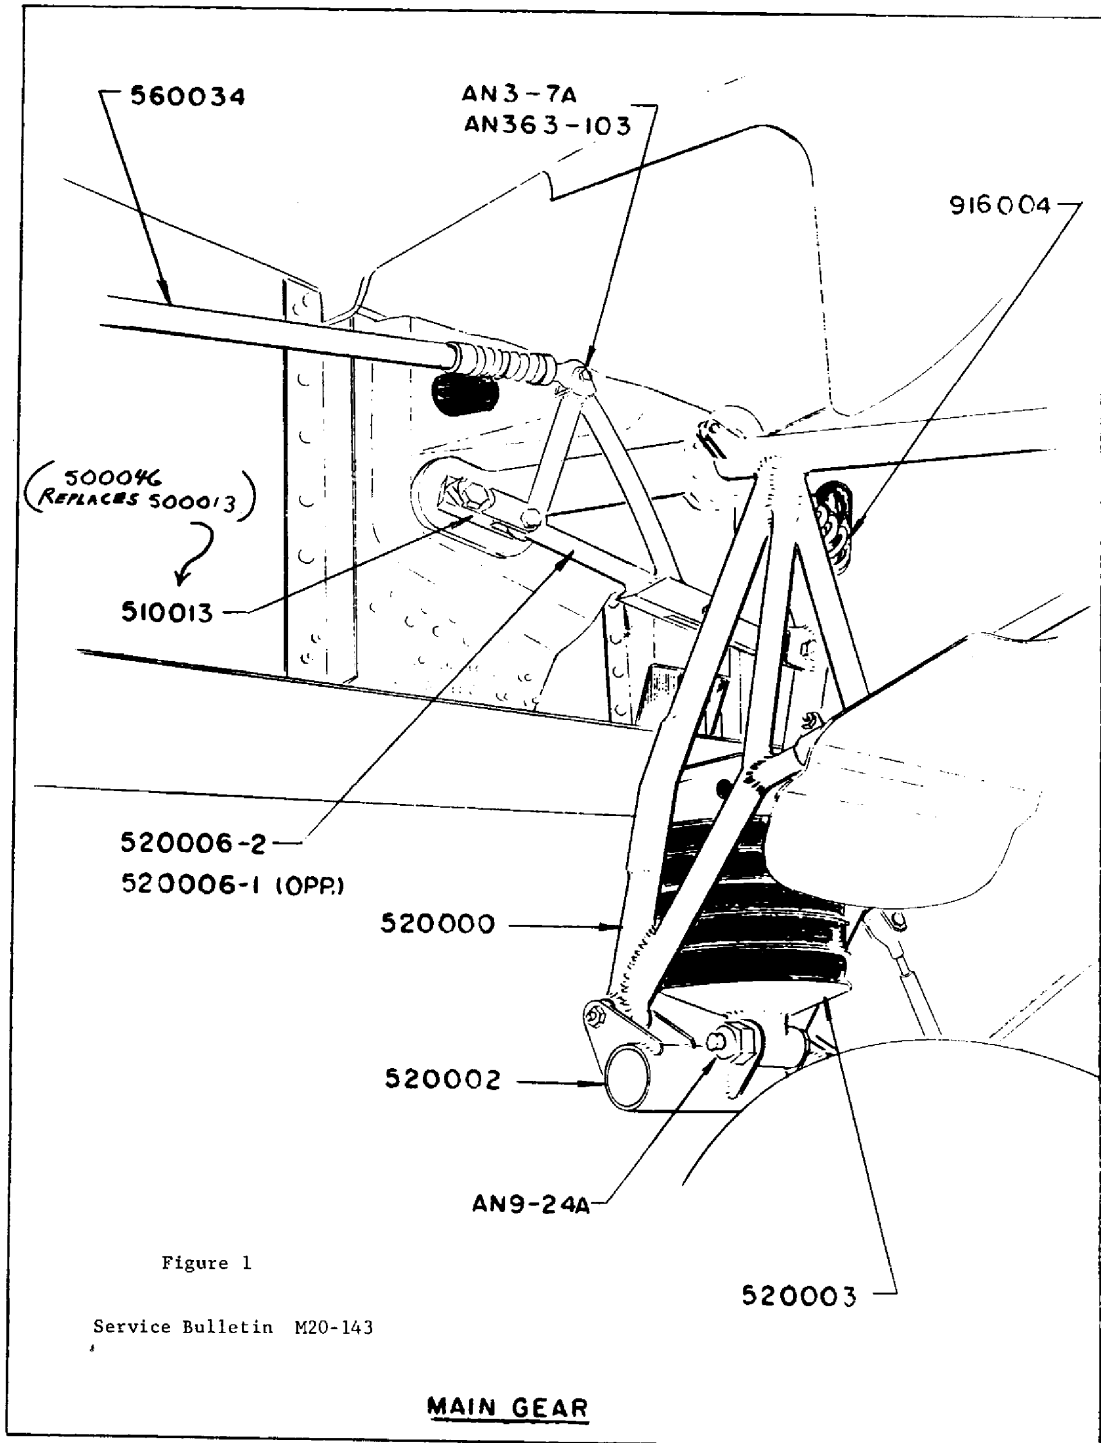
The bolts attaching the main gear retract truss bracket (P/N 510046 or 510013) have been found loose. To preclude the possibility of these bolts backing out and jamming the retracting mechanism, the change to drilled-head bolts and safety wire is required. The existing AN6-A or AN5-A bolts may be drilled or replaced with equivalent-length AN6H-A or AN5H-A bolts.

In some instances, a modified bolt with a milled head has been installed for clearance reasons. This milled head bolt must be drilled. Do not replace the modified bolts with AN6H-A bolts.

1. Place the aircraft on jacks and check the 2 bolts attaching the main gear retract truss in each wing. If any of the bolts are more than one thread loose, they must be replaced with new bolts. Check the preload in the retraction system per instructions in accordance with the Service and Maintenance Manual (1966).

2. Remove the bolts attaching the truss bracket on both sides.
3. Replace these bolts with drilled-head bolts.
 - a. If these bolts have modified heads, then they must be drilled

- b. If these are unmodified bolts then they may be drilled or replaced with drilled-head bolts. Use a #50 drill. Apply zinc chromate after drilling.
4. Safety the two bolts in each wing using AN995-C32 safety wire or equivalent.

5. Check the rigging of the retraction system in accordance with the Service and Maintenance Manual (1966).
6. Lower the aircraft, remove jacks, and return the aircraft to service.
