(This Service Bulletin is FAA D.O. Authorization SW-1 Approved)

SUBJECT: Rework of Top Vent System Drain Line

MODELS AFFECTED: M20F S/N 670001 thru 670296

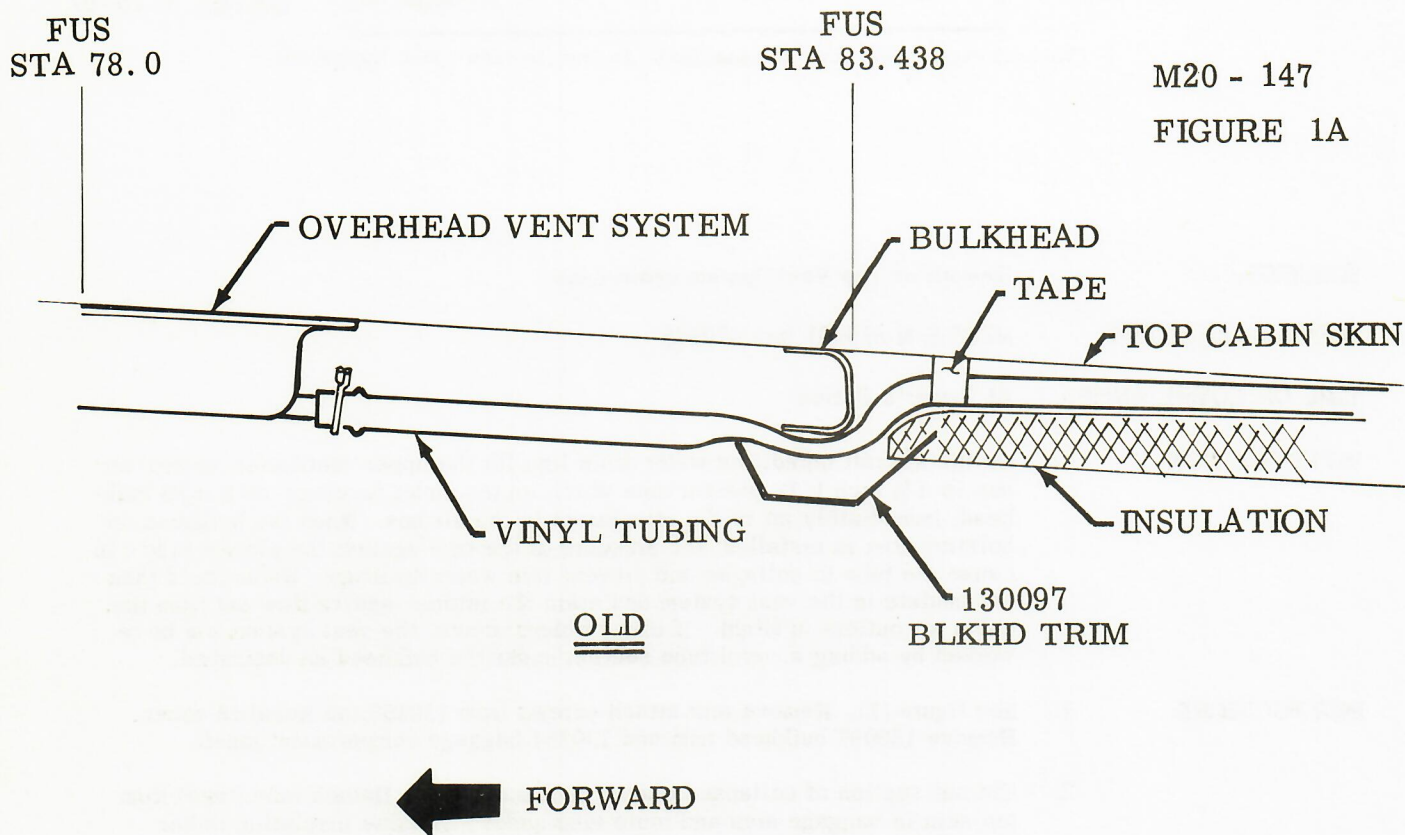
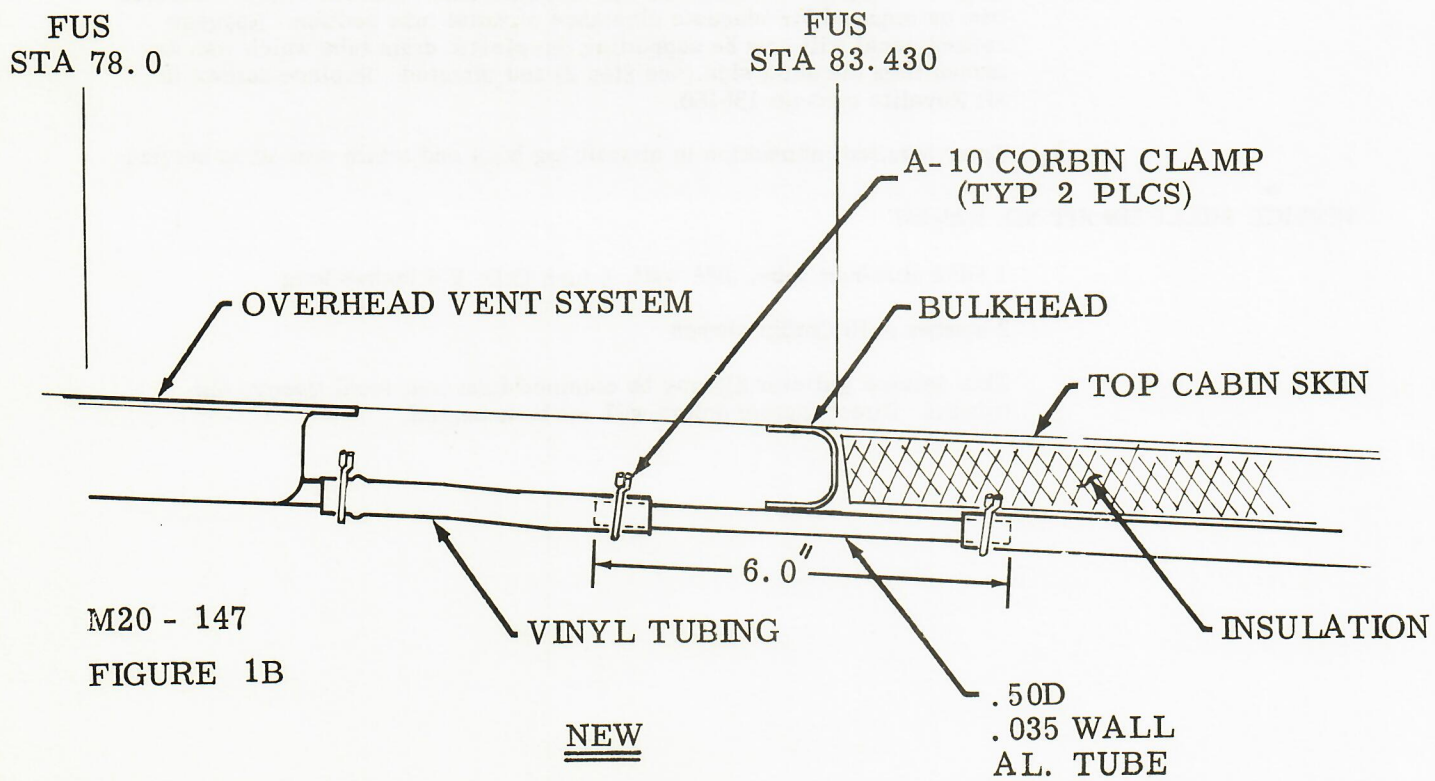
INTRODUCTION: On the aircraft noted, the water drain line for the upper ventilation system air box is a ½ inch I. D. plastic tube which routes under fuselage station 88 bulkhead, immediately aft of the attachment to the air box. When the bulkhead upholstery trim is installed, the pressure of the trim against the plastic tube can cause the tube to collapse and prevent rain water drainage. Water could then accumulate in the vent system and stain the interior and/or flow out from the cabin air outlets in flight. If this problem occurs, the vent system can be re-worked by adding a metal tube section under the bulkhead as described.

- INSTRUCTIONS:
1. See figure (1). Remove rear attach screws from 130160 top Royalite cover. Remove 130097 bulkhead trim and 130184 baggage compartment panel.

2. Cut out section of collapsed plastic tube as shown. Detach tube (tape) from top skin in baggage area and route tube under Fiberglass insulation rather than between insulation and outer aluminum skin.

3. Install metal tube section in area of drain line that passes under the fuselage bulkhead as shown in figure (1). Secure the two junctions with Corbin clamps.

4. Replace baggage ceiling panel and bulkhead trim. Cut out 130097 bulkhead trim as required for adequate clearance of metal tube section. Baggage ceiling panel will now be supporting the plastic drain tube which was detached from the outer skin (see Step 2) and rerouted. Replace screws in aft Royalite console 130160.
