(This Service Bulletin is FAA D.O. Authorization SW-1 Approved)

SUBJECT: Addition of Drain Holes in the M20F Rudder

MODELS AFFECTED: M20F S/N 660003, 660004, 670001 thru 670303 with the exception of the following serial numbers: 670139, 670201, 670246, 670255, 670257, 670258, 670268, 670271, 670273, 670276, 670277, 670279, 670284, 670285, 670286, 670289, 670290, 670293, 670295.

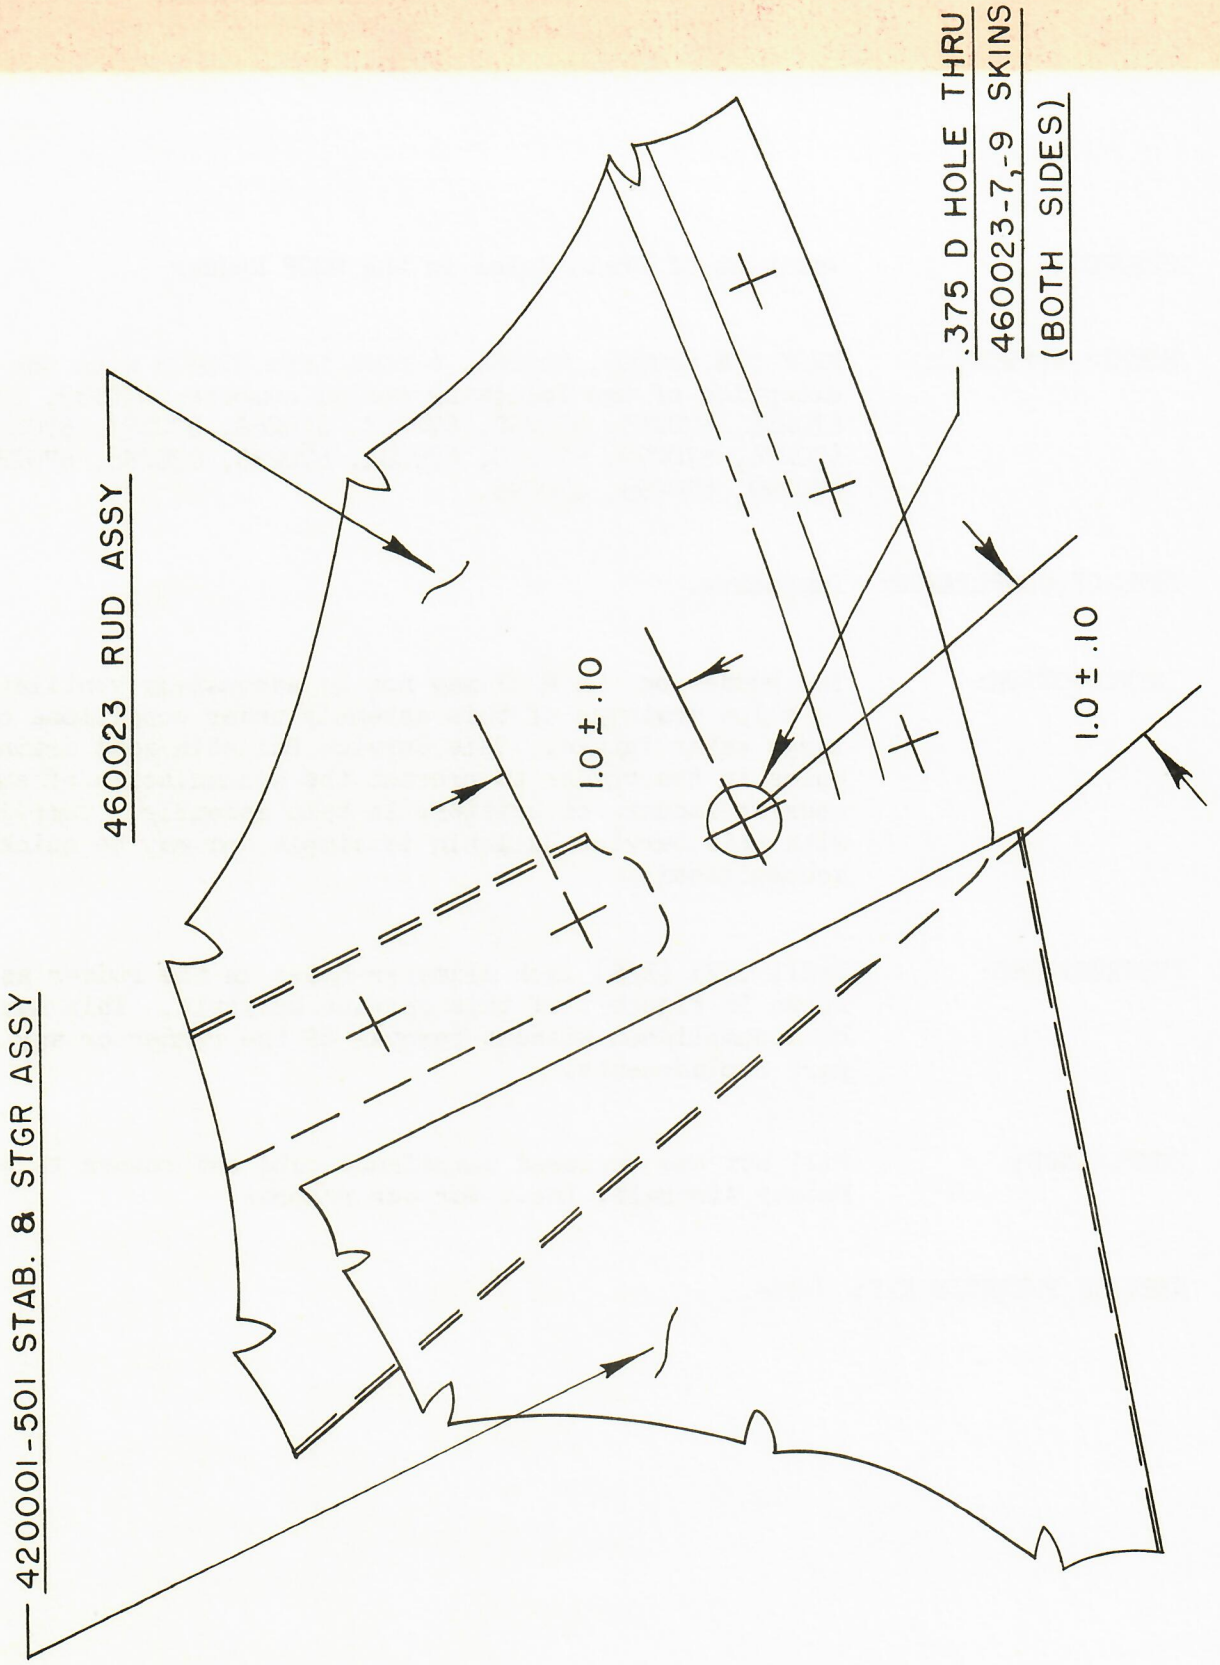
FIGURE 1.

INTRODUCTION: The rudder on the M20F may not be adequately ventilated to allow drainage of this assembly under conditions of large water intake. This Service Bulletin adds drain holes in the rudder to prevent the accumulation of excessive amounts of moisture in this assembly. Compliance with this Service Bulletin is simple and may be quickly accomplished.

INSTRUCTIONS: Drill .375 (3/8) inch diameter holes in the rudder as shown in Figure 1 of this Service Bulletin. This may be accomplished without removal of the rudder or any part replacements.
