(This bulletin obsoletes Service Bulletins M20-8, M20-134, and M20-150.)

**SUBJECT:** MAGNETIC COMPASS INTERFERENCE

**COMPLIANCE:** MANDATORY compliance at next scheduled annual inspection or within next 100 hours, whichever comes first.

**OBJECTIVE:** The magnetic compass must always compensate within  $\pm 10^0$  at any heading.

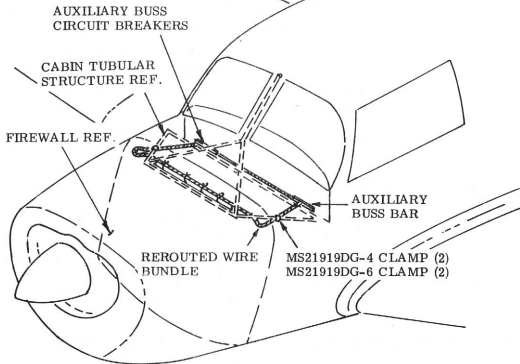
**FIGURE 1**

The aircraft noted in Instruction I have wiring configurations that may magnetize the cabin tubular structures and must, therefore, be rewired. Instruction II discusses the wire replacement procedure necessary if demagnetizing the cabin is not effective for the aircraft listed under Instruction II. Instruction III refers to the compass swinging and cabin demagnetizing procedures.

Refer to Figure 1 on page 8 and to magnetic attraction possibility number 1 in the Introduction.

- Step 1 Remove wires connecting "Aux Buss" circuit breaker and auxiliary buss bar. There are wire numbers: 800007-9 on M20B; 800007-169 on M20C, M20D, and M20E; and 800214-001 on M20F aircraft.
- Step 2 Select circuit breaker-to-buss bar wires having a 60-inch length of No. 6 MIL-W-5086, Type 2, wire with AMP 321298 terminals on each end. Mooney-manufactured wires conforming to these specifications carry wire number 800007-292 for M20B, M20C, M20D, and M20E; and 800214-147 for M20F aircraft (Refer to S.B. Kits Nos. M20-150A-1 & -2).
- Step 3 Route replacement wire forward from "Aux Buss" circuit breaker to firewall. Run wire across firewall with existing wire bundle and then straight aft to auxiliary buss bar.
- Step 4 Use cushioned clamps to attach wire to tubular structure, and string-tie wire to existing wire bundles across firewall.
- Step 5 Proceed with Step 1 of Instruction III.

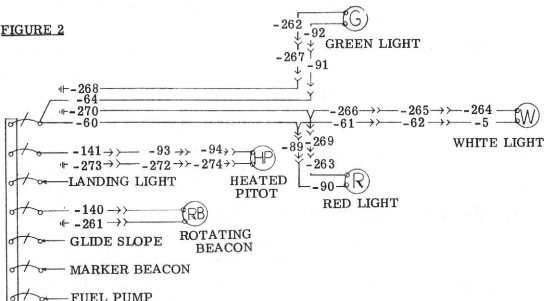
**FIGURE 2**

Refer to Figure 2 on page 8 and to magnetic attraction possibility number 2 listed in the Introduction.

Twisting a ground wire together with each navigation light, or rotating beacon, and/or heated pitot circuit supply wire can reduce compass error induced by using the airframe as a ground return path for such equipment.

Step 1 For an aircraft listed above that is equipped with navigation lights, or a rotating beacon, and/or a heated pitot, remove upholstery panels, inspection plates, access panels, and fairings necessary to gain access to wiring.

Step 2 Navigation Light Wiring:

A) Remove wire leading from navigation light to navigation light switch.

B) Install S.B. Kit M20-150A-4.

C) Connect wires number 800007-60 & -64 to navigation light switch, and ground wires number 800007-268 & -270 to nearest instrument panel mounting bolt below navigation light switch.

D) Solder wires number 800007-90, -92, and -5 to center contacts of their respective navigation lights. Solder wires number 800007-262, -263, and -264 to outside light shells.

Step 3 Rotating Beacon Wiring (if applicable):

A) Remove wire leading from rotating beacon to beacon light switch, and disconnect beacon ground wire.

B) Install S.B. Kit M20-150A-5.

C) Connect wire number 800007-140 to beacon switch and beacon light positive terminal.

D) Ground wire number 800007-261 to instrument panel mounting bolt nearest beacon switch, and connect other end to beacon light negative terminal.

Step 4 Heated Pitot Tube Wiring (if applicable):

A) Remove wire leading from pitot switch to pitot head.

B) Cut terminal from pitot ground wire, and install a knife disconnect on wire end.

C) Install S.B. Kit M20-150A-6.

D) Connect wire number 800007-141 to pitot tube switch, and ground wire number 800007-273 to nearest instrument panel mounting bolt.
