## THIS SERVICE BULLETIN OBSOLETES SB M20-160

**SUBJECT:** INSPECTION OF WIRE INSTALLATION AT STALL WARNING AND GEAR WARNING CIRCUIT BREAKERS.

**MODELS AFFECTED:** M20C, S/N 670001 thru 670123, S/N 670125 thru 670134, and S/N 670136 thru 670149.  
M20E, S/N 670001 thru 670062.

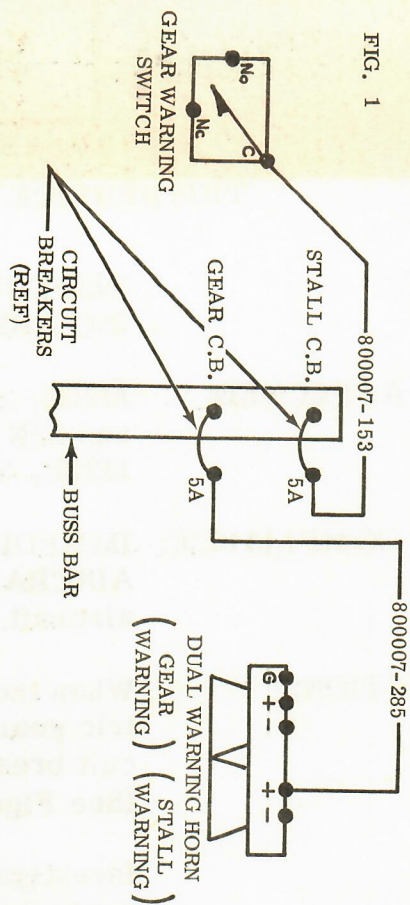
FIG. 1

Investigation reveals that the wire connections may be reversed (See Figure 1 & 3.) at the stall warning horn and gear warning horn circuit breakers. Reversed wires at this location will make the stall warning horn inoperative on electric-gear equipped aircraft.

## POSSIBLE REVERSED MANUAL GEAR WIRE CONNECTIONS

- 1) Inspect electric gear circuit breaker wire hookup. Reverse wire connections if hookup does not conform to the circuit illustrated in Figure 4.
- 2) Inspect manual gear circuit breaker wire hookup. Reverse wire connections if hookup does not conform to the circuit illustrated in Figure 2.

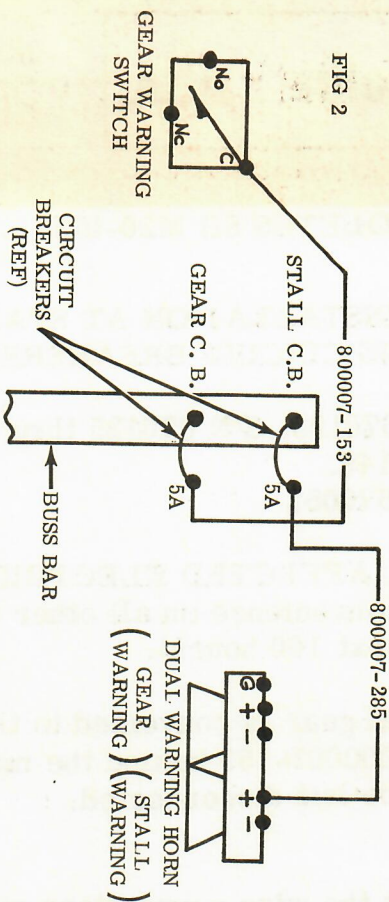
FIG 2

## CORRECT MANUAL GEAR WIRE CONNECTIONS

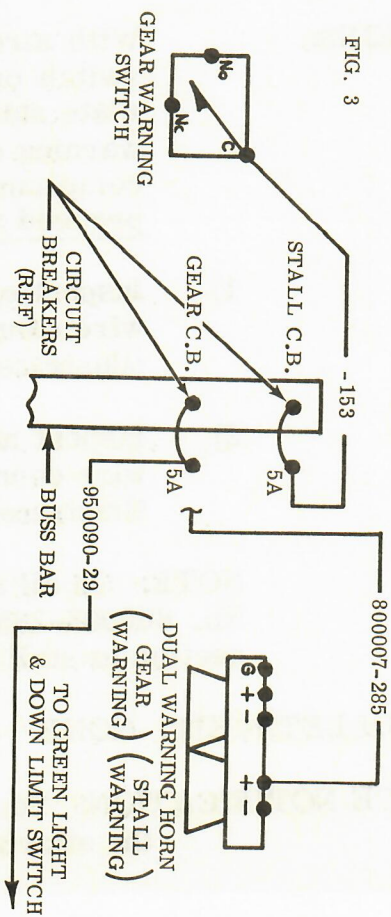
FIG. 3

## POSSIBLE REVERSED ELECTRIC GEAR WIRE CONNECTIONS MAKING THE STALL WARNING HORN INOPERATIVE

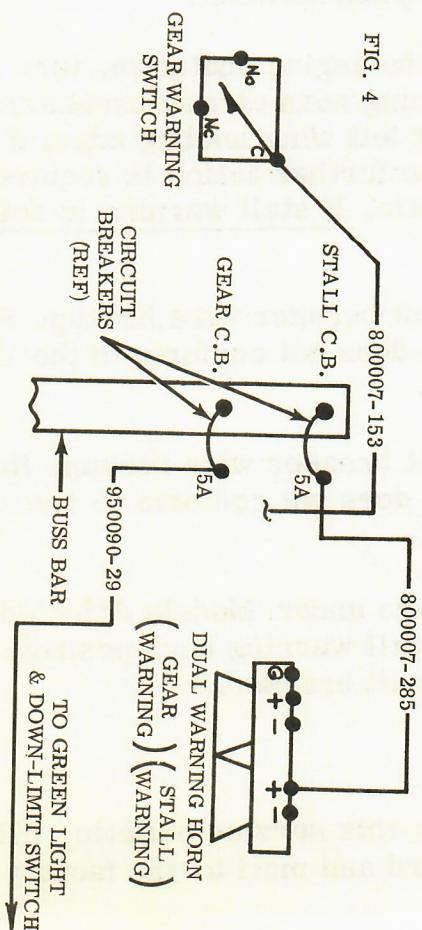
FIG. 4

**INTRODUCTION:** When the standard manual gear is converted to the electric gear, wire number 800007-153 behind the main circuit breaker panel is to be left disconnected.  
(See Figure 4.)

## CORRECT ELECTRIC GEAR WIRE CONNECTIONS
