SUBJECT: FUEL LINE ROUTING

MODELS AFFECTED: M20E S/N 101 thru 1308  
S/N 670001 thru 670062  
M20F S/N 660002 thru 660004  
S/N 670001 thru 670539  
S/N 680001 thru 680073

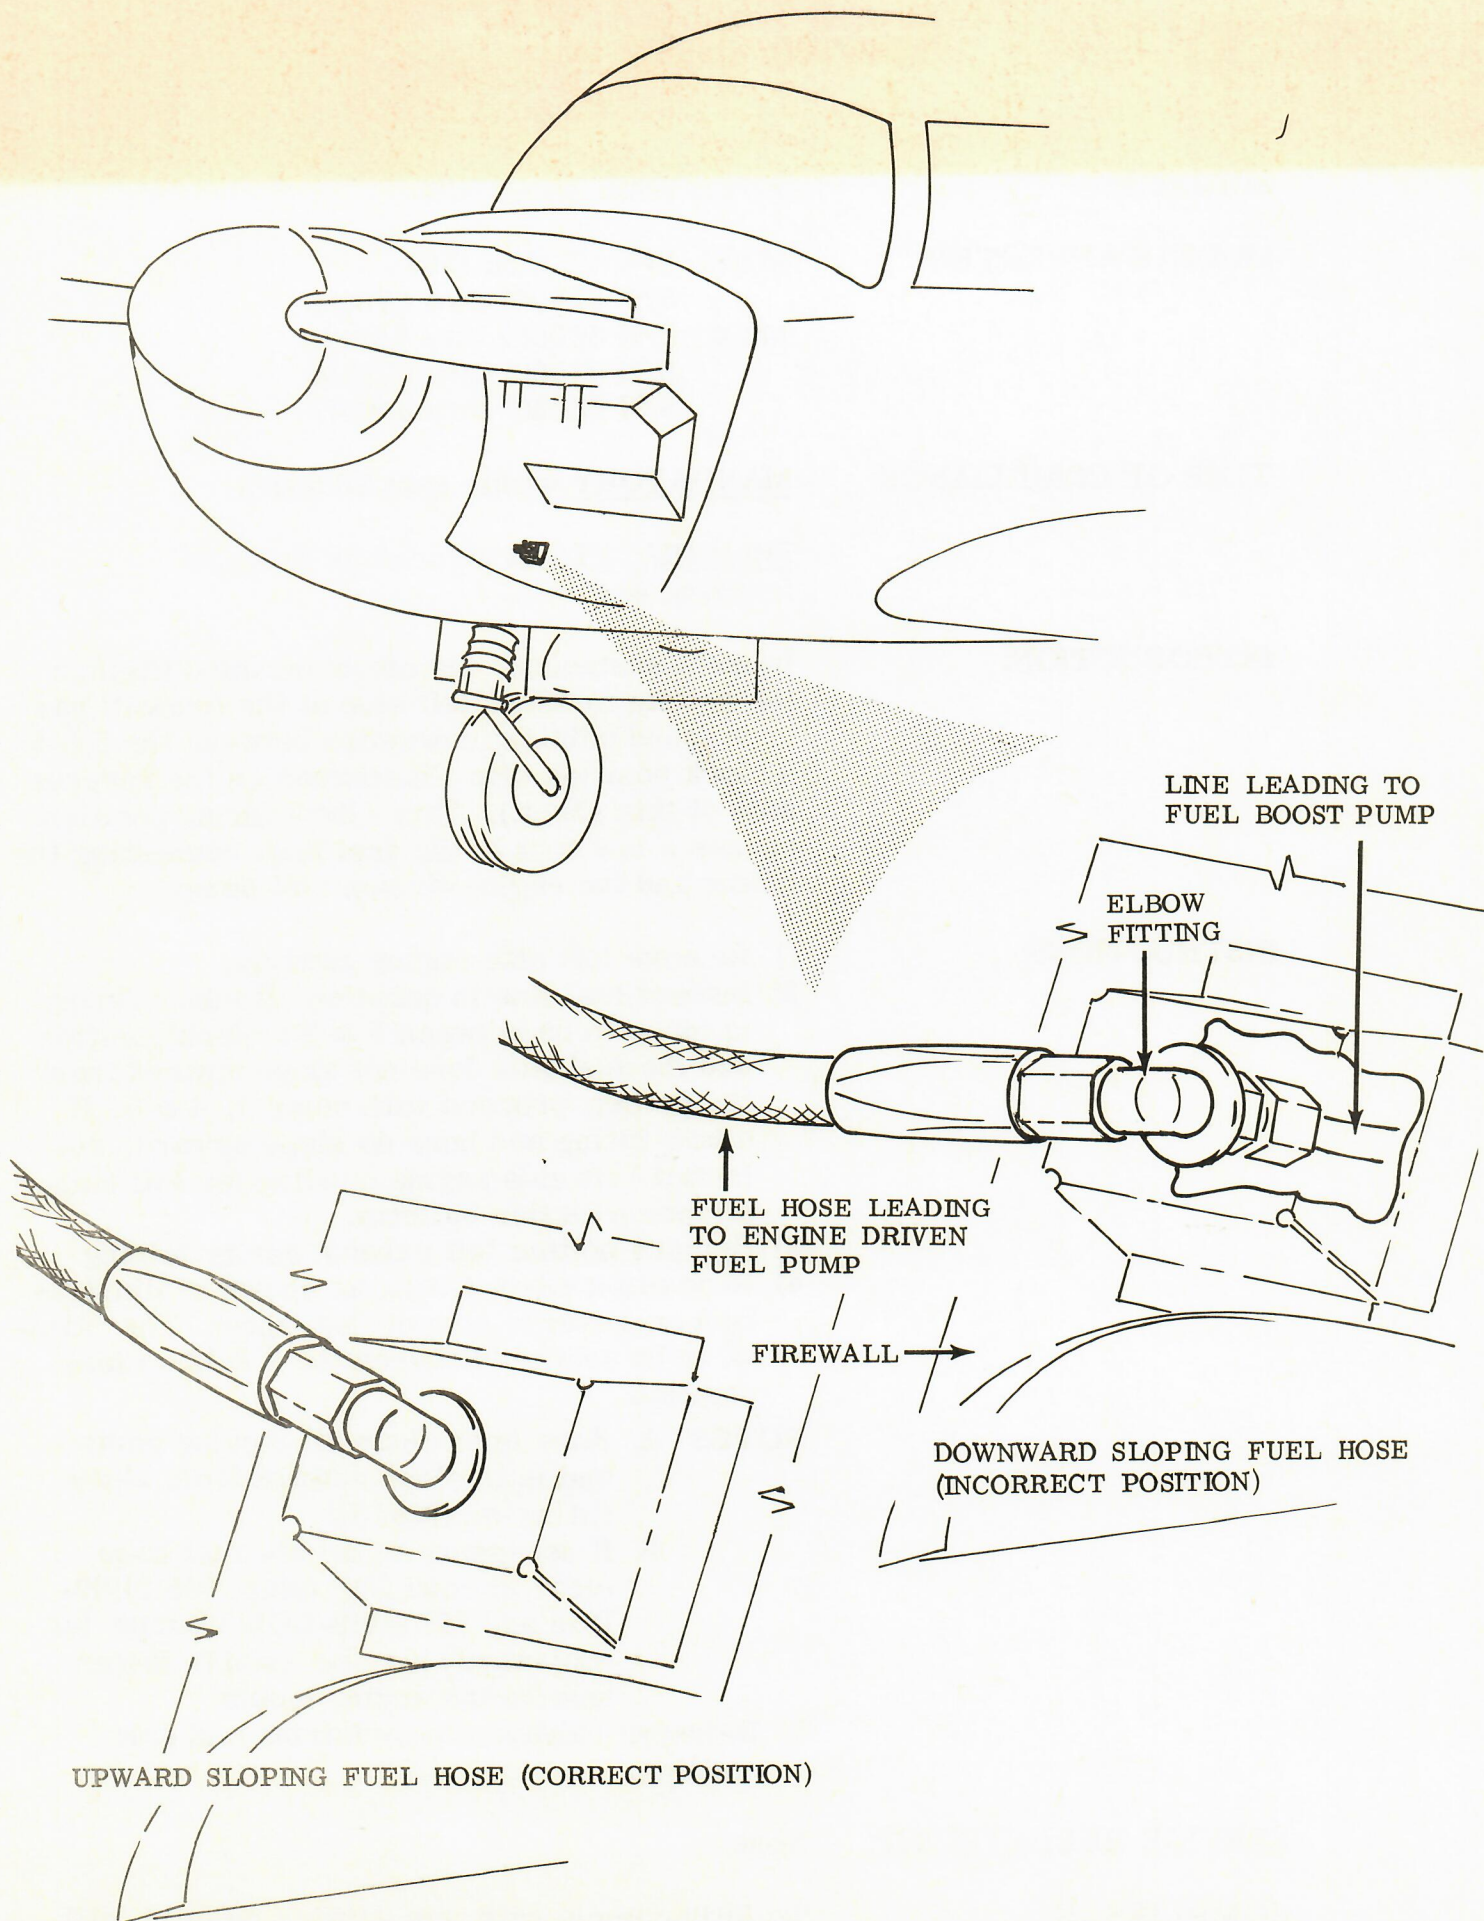
In some instances, the elbow mounted through the bottom forward left side of the firewall has been found pointing downward between the 5 & 9 o'clock position (See illustration on the reverse side of this sheet.). This elbow fitting position causes a low spot in the fuel hose connecting the fitting and the engine-driven fuel pump.

- 1) Remove left side engine cowling.
- 2) Inspect fuel line in question. If elbow fitting is found to be between 5 & 9 o'clock position and the fuel line does not slope upward from the fitting, proceed with steps 3, 4 & 5. If elbow fitting and hose do slope upward, re-install left side engine cowling for full compliance with this bulletin.
- 3) Remove bottom left exhaust cavity fairing.
- 4) Reposition elbow fitting as shown in illustration on reverse side of this sheet. The fitting is to be secured between the 9 & 12 o'clock position.

- NOTES
- A. Hose is to clear all moving parts and is to slope upward from elbow fitting on firewall.
  - B. If necessary to secure fuel hose clear of cowl flap idler, MS 21919-DG8 and MS 21919-DG14 clamps (or equivalent) may be used to fasten hose to the engine mount.
- 5) Reinstall exhaust cavity fairing and side cowling.
