SUBJECT: Replacement of Steering Shaft on Nose Gear Steering Horn Assy.

MODELS AFFECTED: M20C 690002 thru 690021 M20F 690002 thru 690032
M20E 690002 thru 690027 M20G 690004 thru 690008

MOONEY SERVICE BULLETIN 20-172

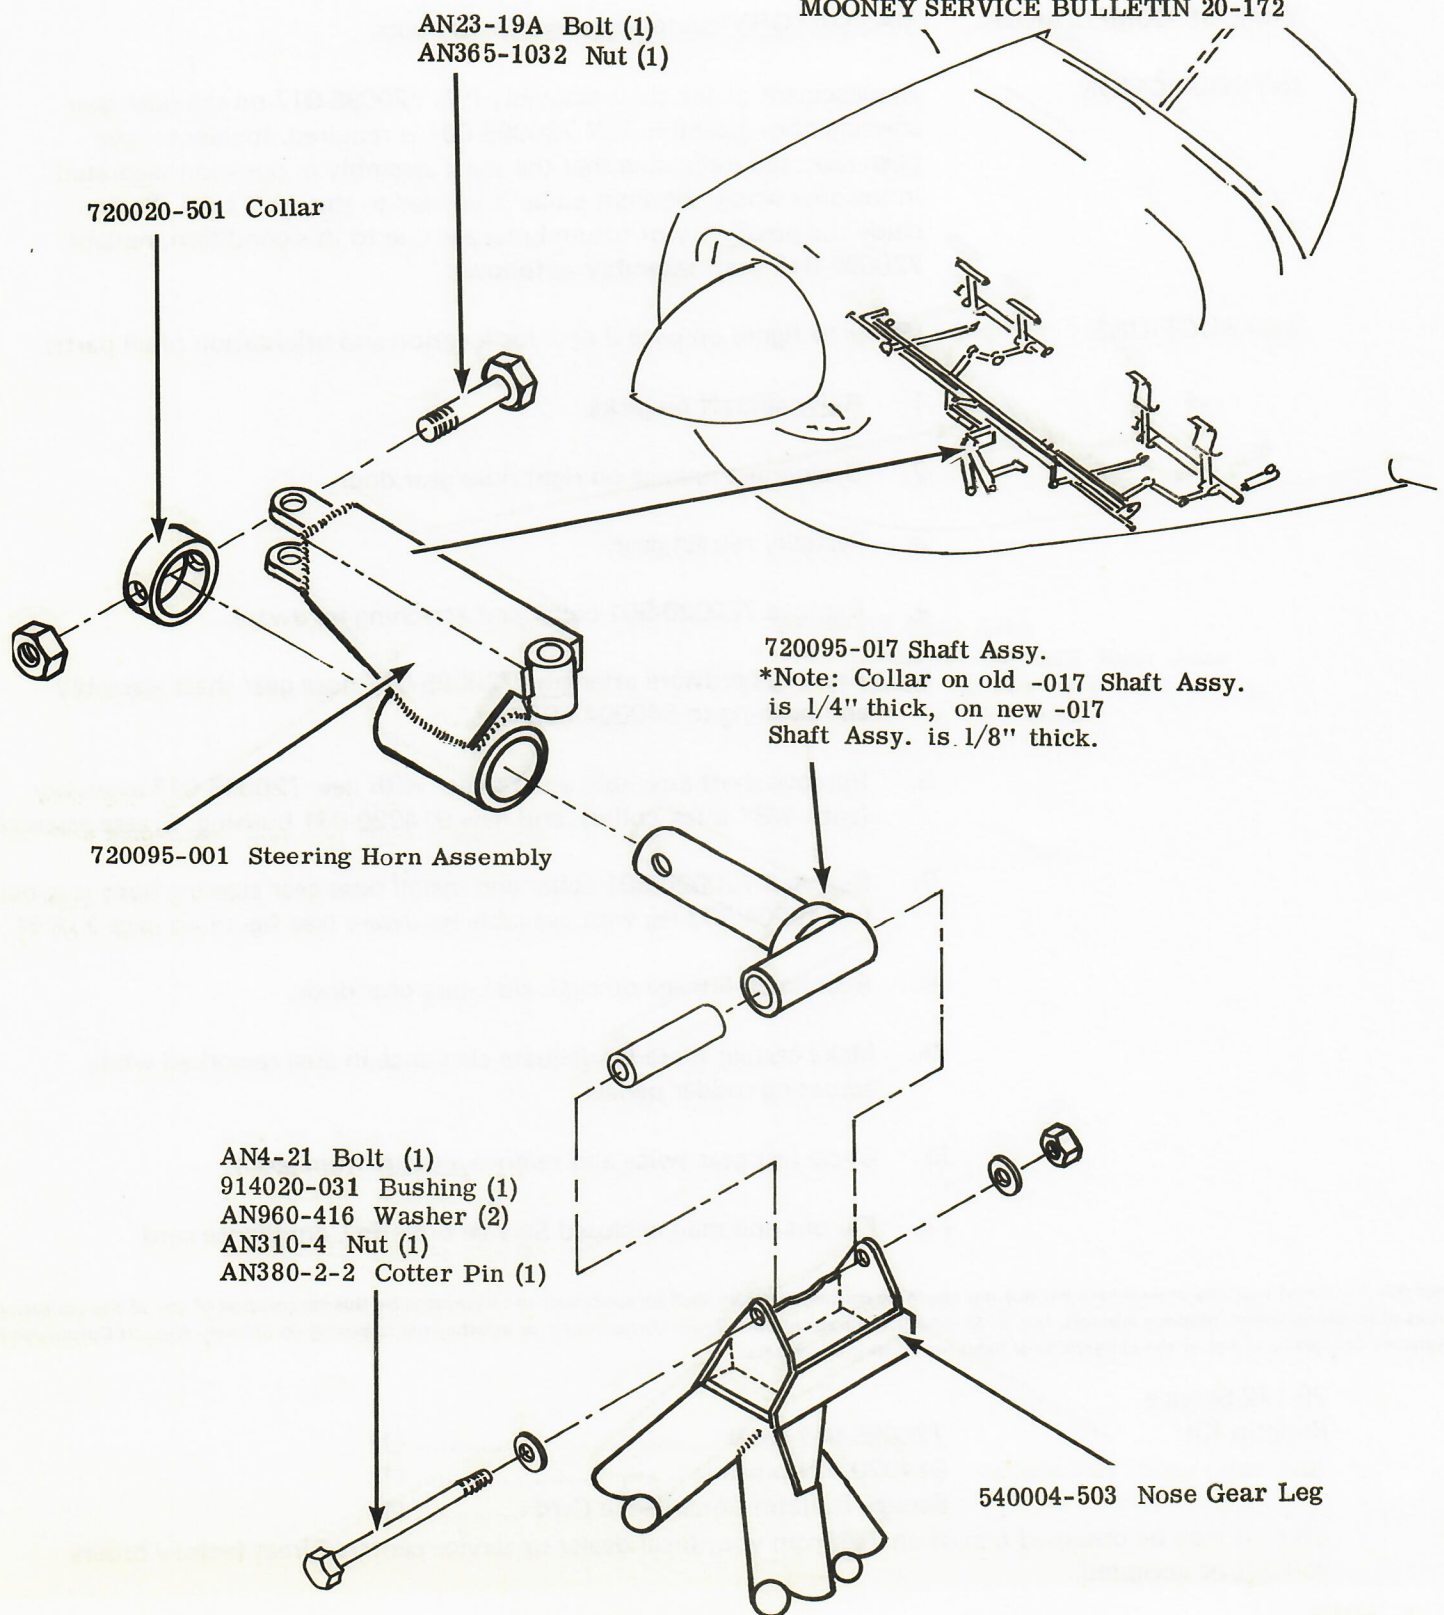
INTRODUCTION: Replacement of the shaft assembly P/N 720095-017 on the nose gear steering horn assembly P/N 720095-001 is required. Incidents have been reported indicating that the shaft assembly in question separated in the area where the shaft collar is welded to the shaft tube. To preclude the possibility of future breakage due to this condition, replace 720095-017 shaft assembly as follows:

INSTRUCTIONS: (Refer to figure on page 2 of 2 for location and orientation of all parts).

1. Raise aircraft on jacks.
2. Disconnect linkage on right nose gear door.
3. Partially retract gear.
4. Remove 720020-501 collar and attaching hardware.
5. Remove hardware attaching 720095-017 nose gear shaft assembly and bushing to 540004-503 leg.
6. Remove shaft assembly and replace with new 720095-017 assembly (with 1/8" thick collar), and new 914020-031 bushing. Grease assembly.
7. Reinstall 720020-501 collar and install nose gear steering horn assembly to 540004-503 leg with available hardware (see figure on page 2 of 2).
8. Reconnect linkage on right side nose gear door.
9. Make certain there is adequate clearance in area reworked while actuating rudder pedals.
10. Cycle test gear twice and remove aircraft from jacks.
11. Fill out and mail enclosed Service Bulletin Compliance card.
