SUBJECT: INSPECTION AND REWORK OF 0-360 & 10-360  
TUBULAR ENGINE MOUNTS.

MODELS AFFECTED: All Mooney M20C,D,E,F up to M20C S/N 680001,  
M20D S/N 261, M20E S/N 690001 & M20F S/N 680210.

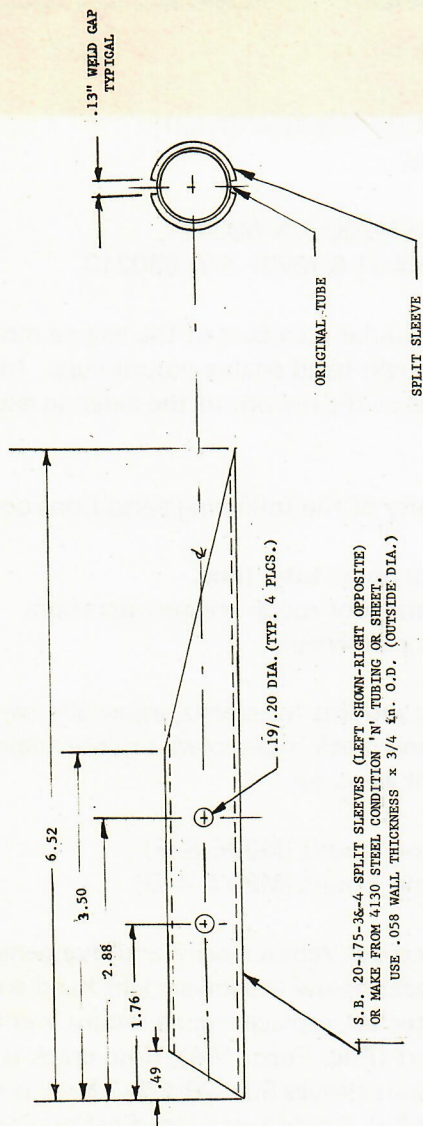
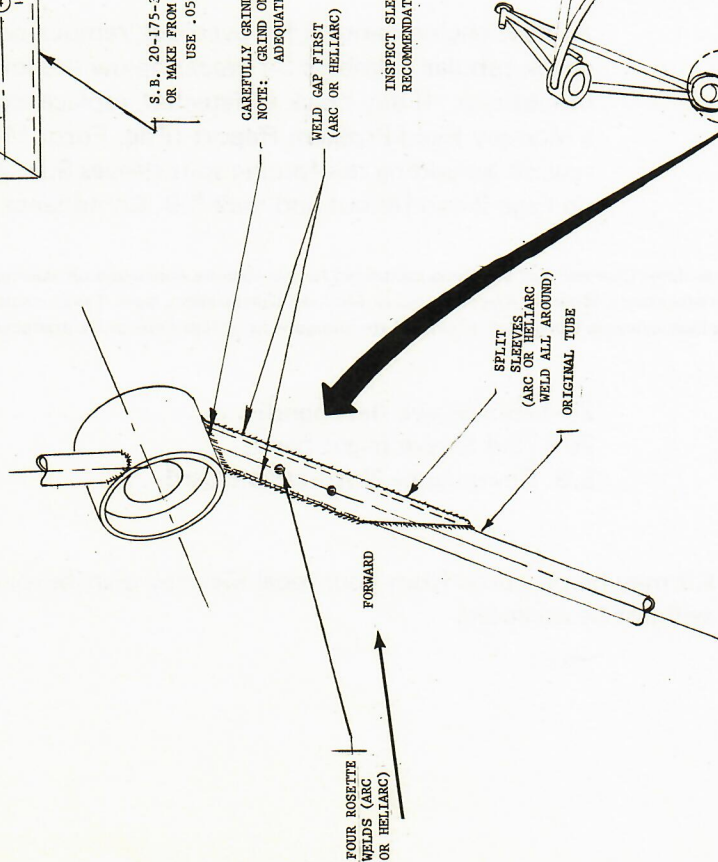
ENGINE MOUNT - TYPICAL ALL MODELS  
SCALE: NONE  
ALL TOLERANCES  $\pm .03$

INTRODUCTION: There have been reports that tubular members of the engine mounts  
have cracked below the lower right hand engine mount cups. Installing  
a new reinforced engine mount or the rework of the existing engine  
mount is recommended.

At next engine removal for overhaul, remove paint and dye penetrant  
check tubular members for cracks below the lower right hand engine  
mount cup. If any crack is detected, replace engine mount and fill out  
a Mooney Field Problem Report (Eng. Form 114); if no crack is found,  
rework by adding reinforcing split sleeves S.B. 20-175-3 & -4 as shown  
on Page 2 and fill out and mail S.B. Compliance Notification Card.

INSPECT SLEEVE AND MOUNT, AND WELD IN ACCORDANCE WITH  
RECOMMENDATIONS SET FORTH IN AC-43.13-1 CHAPTER 2, SECTION 2
