SUBJECT: INSPECTION OF FUEL PRESSURE LINE

MODELS AFFECTED: M-20E S/N's: 101 thru 1308
670001 thru 670062
690001 thru 690073
700001 thru 700053

M-20F S/N's: 660003, 660004
670001 thru 670539
680001 thru 680206
690001 thru 690092
700001 thru 700057

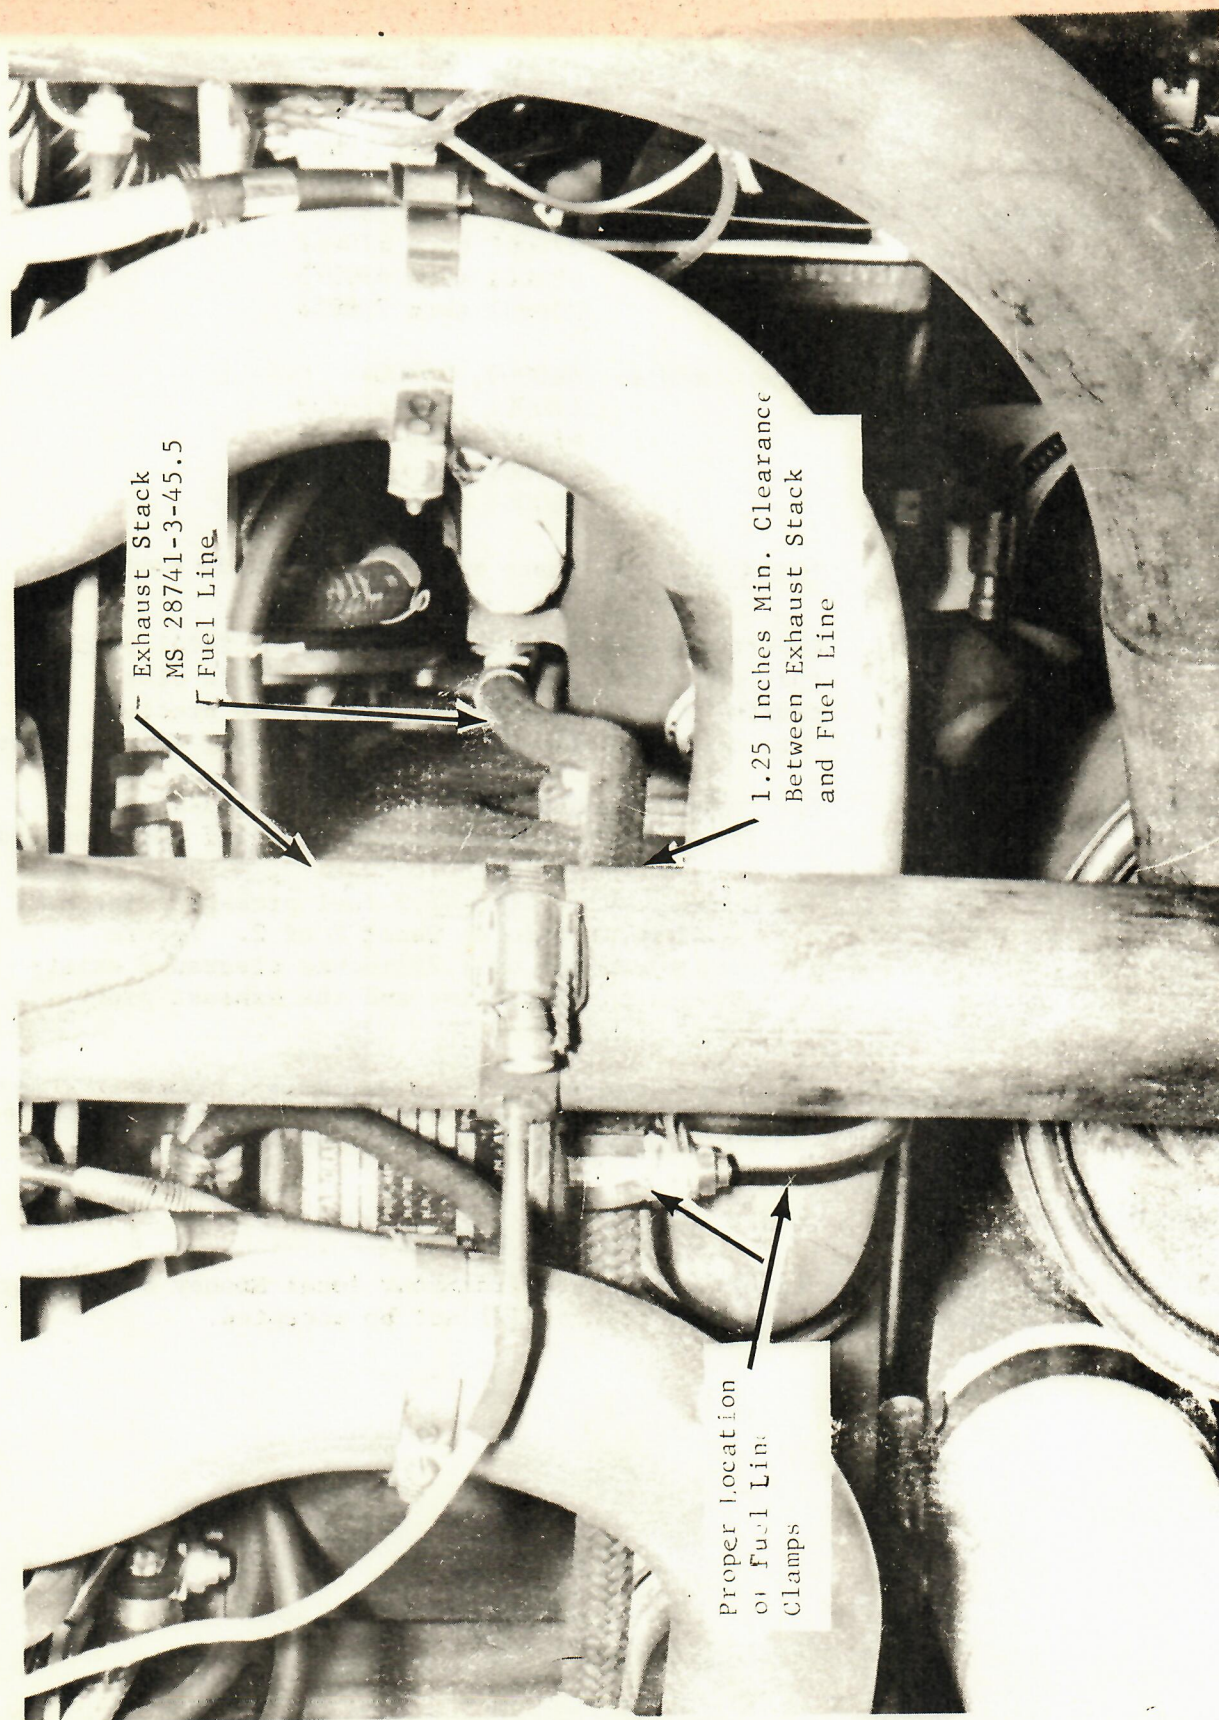
View Looking Inbd.
on R.H. Engine Compartment

INTRODUCTION: Reports have been received of the MS 28741-3-45.5 fuel pressure line deteriorating due to close proximity with the exhaust stack. To preclude this condition accomplish the following instructions.

- INSTRUCTIONS:
1. Inspect condition of the MS 28741-3-45.5 fuel pressure line. Replace the line if deteriorated.
 2. Reroute MS 28741-3-45.5 fuel pressure line as shown in picture on Sheet 2 of 2. Insure that a minimum of 1.25 inches clearance exists between the fuel line and the exhaust pipe.
