MOONEY AIRCRAFT CORPORATION

SERVICE BULLETIN

NUMBER: M20-180

INSPECTION OF ENGINE GROUND WIRE

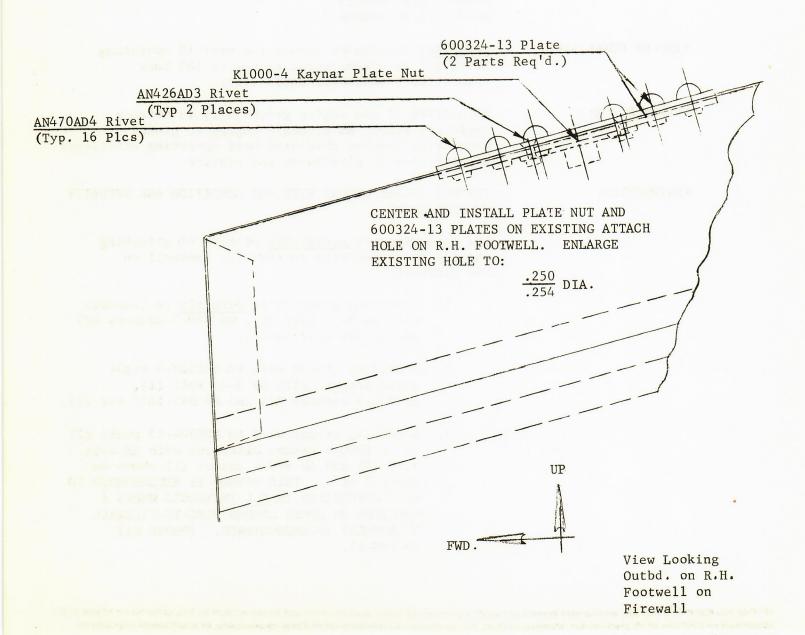
Inspection of the engine ground wire is often a neglected item. An adequate engine to ground connection assures obtaining best operating efficiency of generator or alternator and starter.

INSPECT ENGINE GROUND WIRE FOR CONDITION AND SECURITY OF ATTACHMENT.

The following are <u>acceptable</u> methods of attaching the engine ground wire to the R.H. footwell on the firewall:

- 1. Attaching ground wire directly to footwell with AN 3-4A bolt (1), AN 970-3 washers (2) and AN 365-1032 nut (1).
- 2. Attaching ground wire to 600324-9 right angle bracket with AN 3-4A bolt (1), AN 970-3 washers (2) and AN 365-1032 nut (1).
- 3. Attaching ground wire to 600324-13 plate (2) and K 1000-4 Kaynar plate nut with AN 4-5A bolt (1) and AN 970-4 washer (1) shown on Sheet 2 of 2. THIS METHOD IS RECOMMENDED TO BE INCORPORATED IN ALL INSTANCES WHERE A DOUBTFUL OR LOOSE GROUND WIRE-TO-FIREWALL ATTACHMENT IS ENCOUNTERED. (ORDER KIT 20-180-1).
