SUBJECT: INSPECTION & MODIFICATION OF ELEVATOR

MODELS AFFECTED: See Figure I for Zones 1, 2, 3.

Service Bulletin M20-185

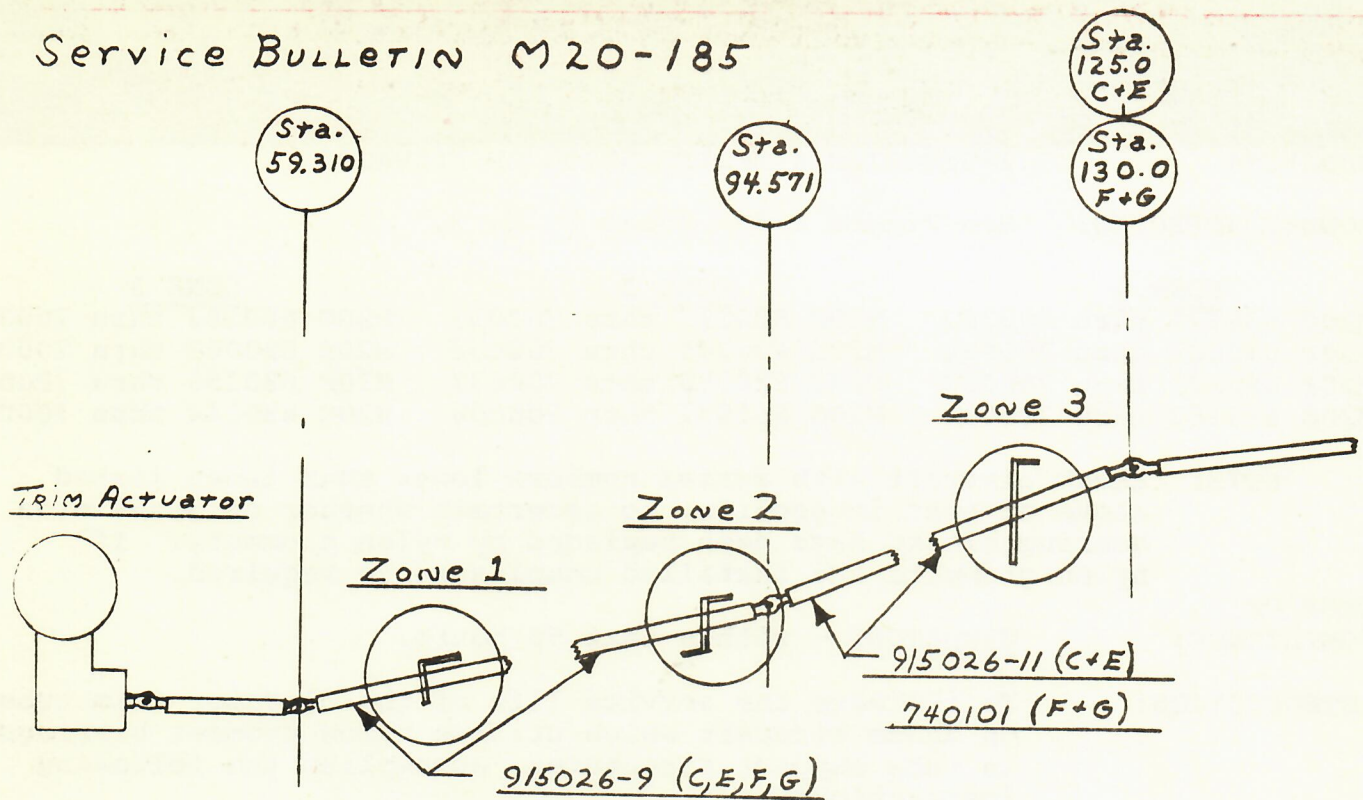
Figure I

- (c) Left side fuselage panel
 2. Remove those trim tubes which pass through nylon grommet bearing supports (Figure I).
 3. Check wear of the two tubes in Zones 1, 2, 3 as indicated in Figure I.

4. If tube wear exceeds .007 per wall or .014 reduction in diameter, tube replacement is mandatory and replacement tubes must be modified as indicated in steps 6 & 7.

Typical bulkhead Zones 1, 2, 3
