MOONEY AIRCRAFT INC.  
KERRVILLE, TEXAS  
SERVICE LETTER 20-19

DATE: 12-18-56  
SUBJECT: Kit-Cabin Door Latch

MODELS AFFECTED: ~~M 20 Serial Numbers 1062 Thru 1116~~

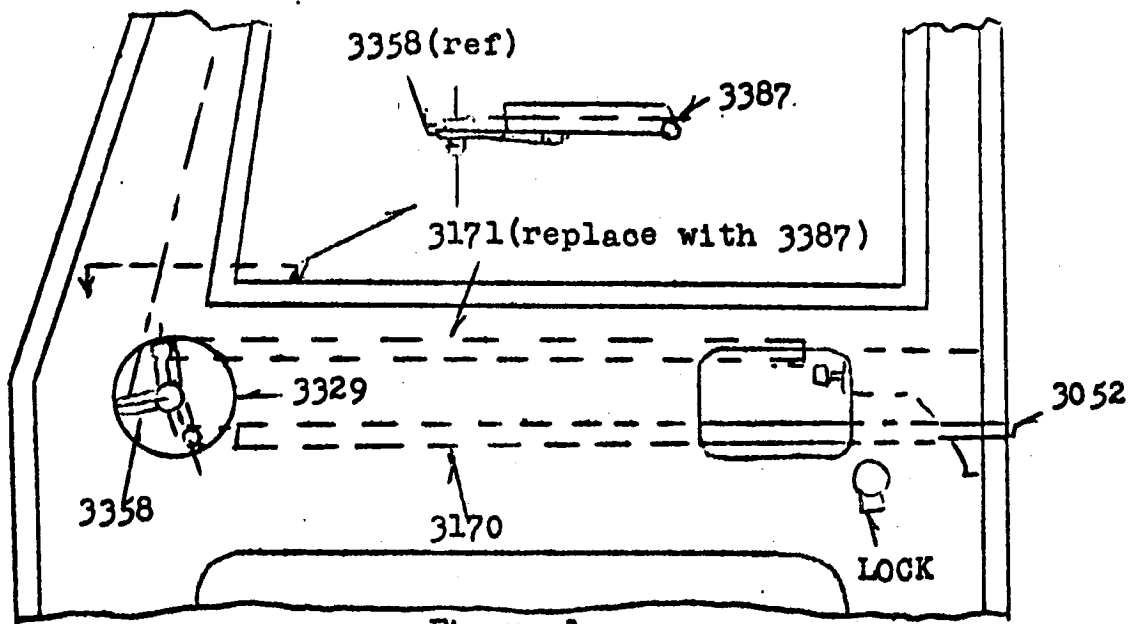
Figure 1.

Difficulty has been experienced in the operation of the cabin door latch mechanism due to the following causes.

1. With the cabin door locked, enough force can be applied to the outside handle to force P/N 3170 past the lock, when the door is closed, if P/N 3170 hangs on the lock going back, P/N 3171 will be bent.
2. P/N 3171 Can also be bent if P/N 3052 is not in line with its hole in the striker plate when the door is closed. If P/N 3171 is bent, the latch mechanism will not function properly. To eliminate these problems, compliance to the following instructions is recommended.

1. Remove window frame and inside handle from door. Hold lower upholstery panel out of the way.
2. Remove P/N 3329 being careful to retain washer spacers which are between this plate and P/N 3358.
3. Remove P/N 3171 and replace with new part P/N 3387 as shown.
4. Remove lock and weld on small tab as shown on drawing #3386.  
CAUTION: Wrap body of lock in a wet rag and keep rag wet during welding operation.
