**SUBJECT: ENGINE MOUNT INSPECTION AND REPAIR OR REPLACEMENT**

MODELS AFFECTED: All Mooney M20C, M20D, M20E, M20F and M20G aircraft with 400 or more hours time in service as listed below:

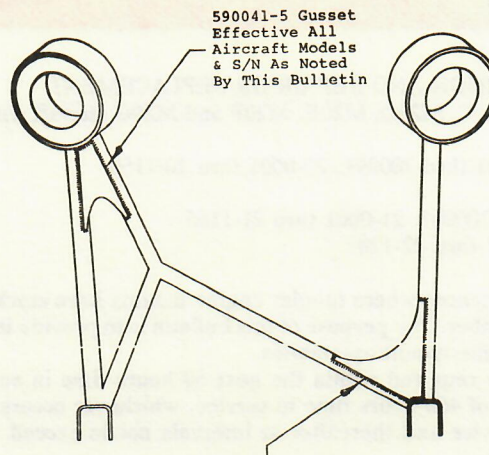
FIGURE 1.
(View Looking Forward)

INTRODUCTION: There have been instances where tubular engine mounts have cracked at the upper left and lower right ends of the lower diagonal cross-member. The purpose of this bulletin is to provide instructions for inspection and repair or replacement of these tubular engine mount assemblies.

INSTRUCTIONS: Remove cowl and visually inspect entire engine mount for cracks. Particularly note the juncture of the diagonal cross-member at both the lower right firewall attachment saddle and the upper left attachment to the engine mount ring. (Left and right as viewed facing forward, Ref. Fig. 1) Proceed as follows:

ENGINE MOUNT REPAIR: The engine mount repair consists of the addition, by welding, of two flat gussets at each end of the lower diagonal cross-member. These gussets may be ordered from your local Mooney Service Center (Service Kit #M20-192-1) or fabricated locally per attached actual size drawing (see Fig. 2).

1. Remove engine and engine mount from the aircraft. (Ref. Mooney M20 Series Service and Maintenance Manual - paragraphs 3-7 through 3-10).
2. Refer to Fig. 1 and remove paint from mount in two areas to be welded. Close cracks by welding.
3. Fit gussets into place per Fig. 1 and arc or heliarc weld in accordance with recommendations set forth in AC-43.13-1A Chapter 2, Section 2. NOTE: Mount and gussets are 4130N steel)
4. Clean, re-prime, and re-paint bare areas of mount assembly.
5. Re-install mount, engine and cowling per Service and Maintenance Manual.
