MOONEY AIRCRAFT INC.

~~Service Letter No.~~ 20-2 Rev. A

Subject: Inspection of weld joint attaching aileron counterweight Balance arm to Aileron Frame.

Revision Models Affected: M-20 Ser. No. 1003 thru 1051

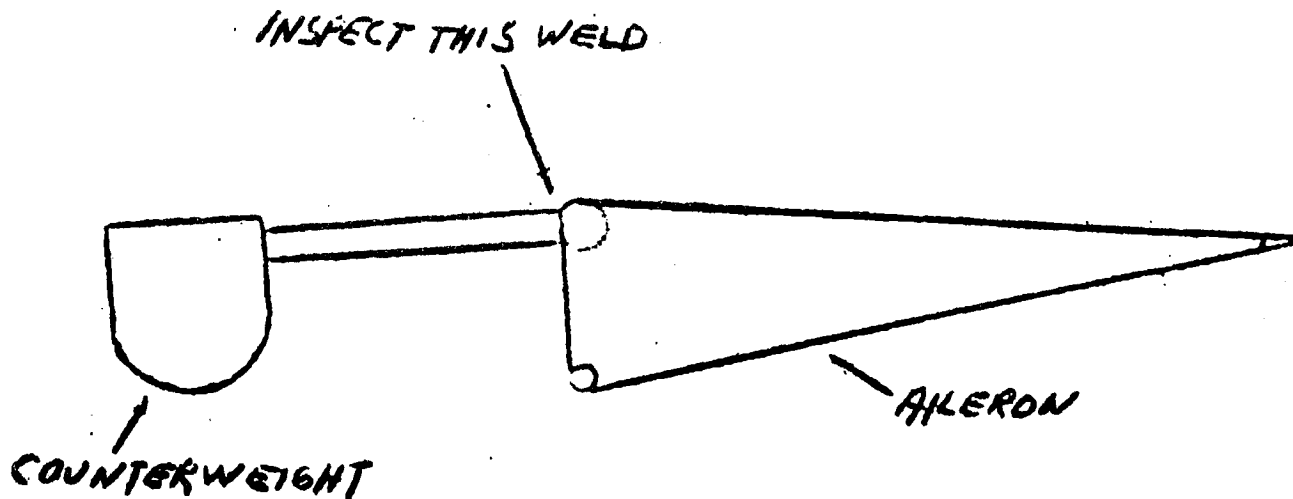
FIGURE 1

Due to the possibility of fatigue cracks at the weld attaching the aileron counterweight balance arm to the aileron frame it is requested that the following inspection be accomplished. Remove the aileron counterweight fairings. Remove the paint from the welded joint in question (see Figure 1) and inspect for cracks. If cracks are in evidence please inform the factory of the details. Suitable repair instructions will be furnished. If a repair is necessary the airplane should be grounded until it is accomplished.

Revision A: *Parts and instructions necessary to make this repair will be sent without charge upon request.
