SUBJECT: LOWER EMPENNAGE HINGE ASSEMBLY MODIFICATION

M20K S/N 25-0001 thru 25-0086,
25-0091 and 25-0094

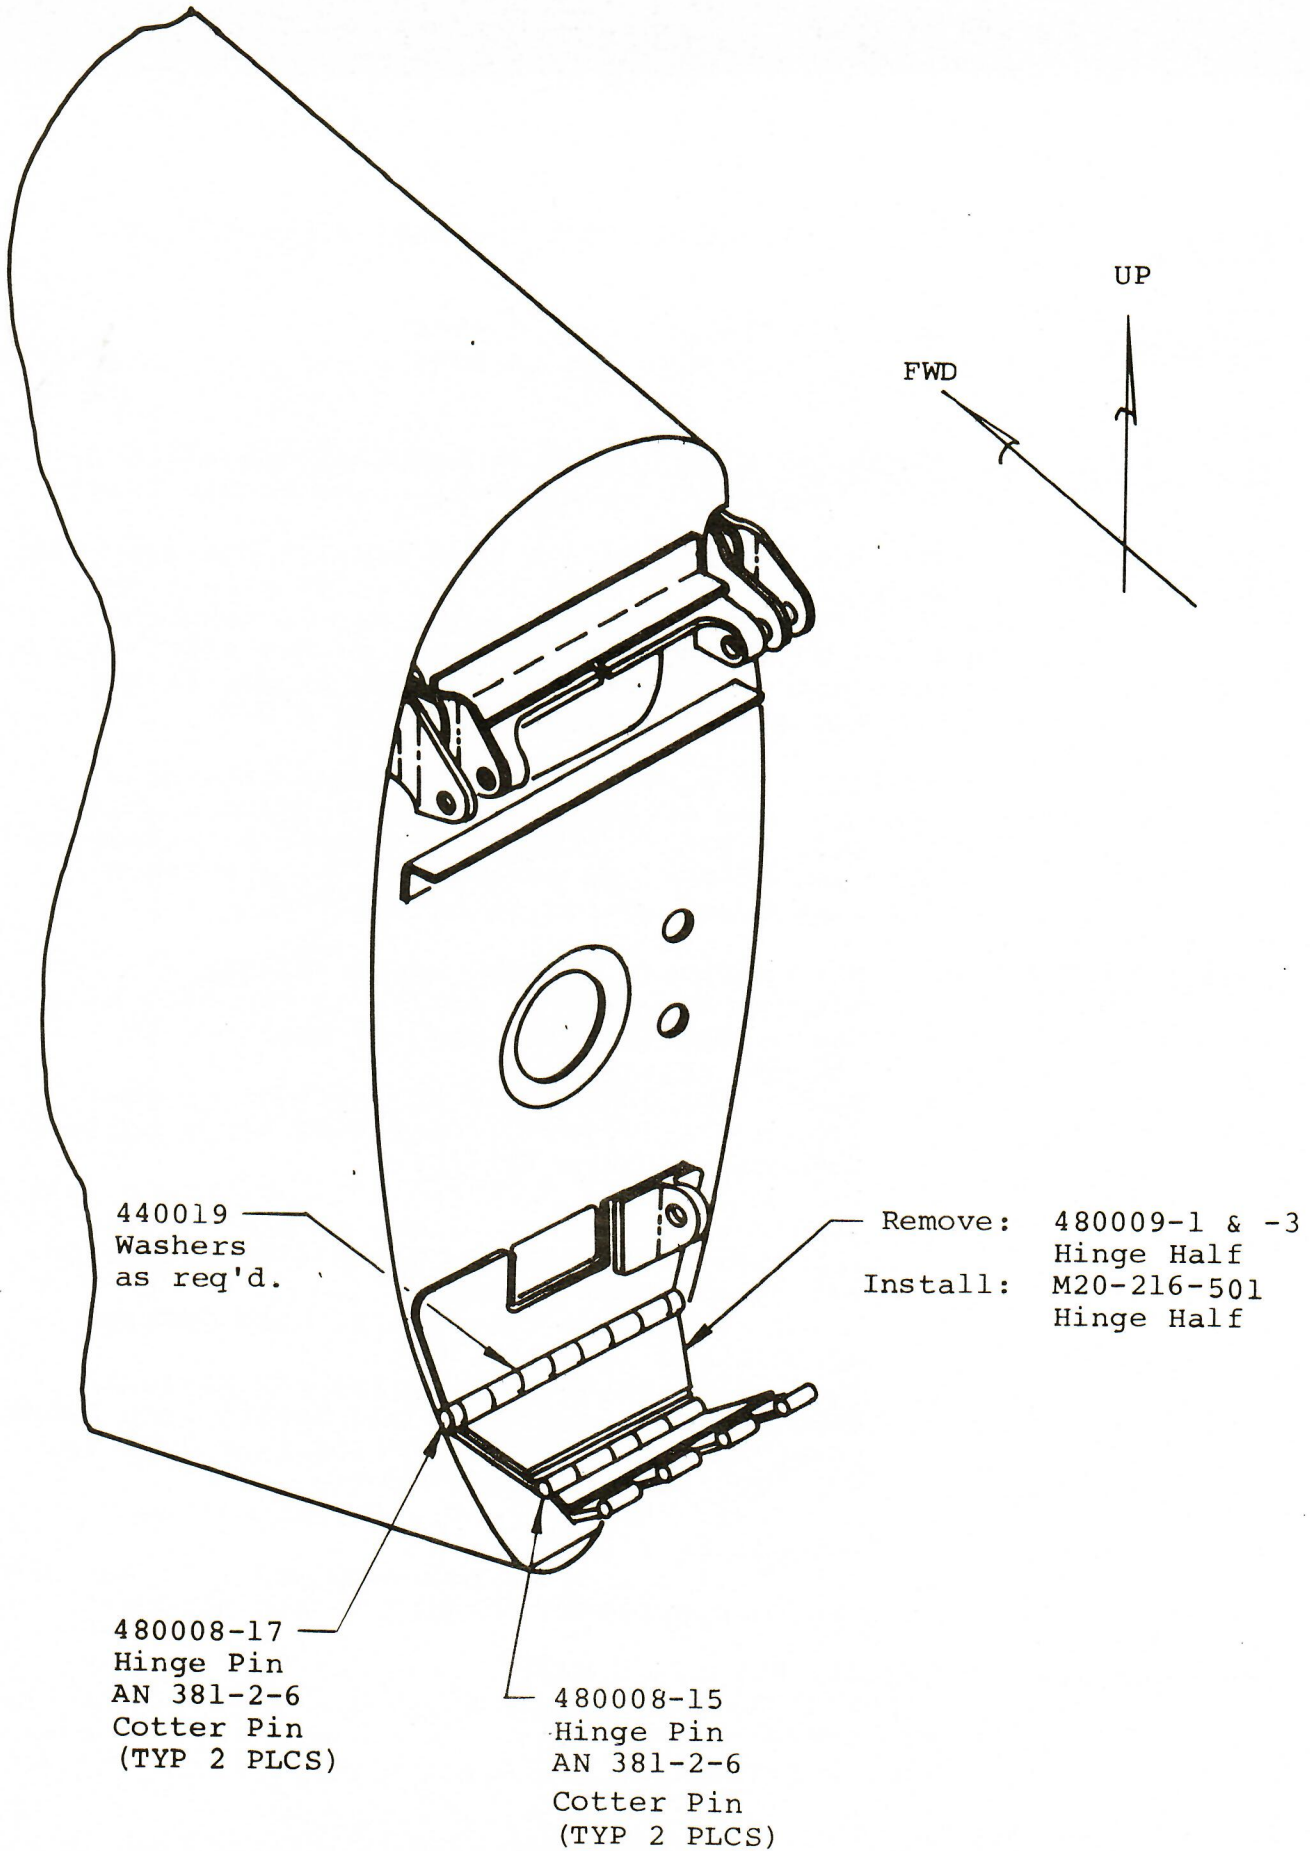
The possibility exists that some of the aircraft serial numbers listed above cannot attain the full 7° nose-up trim rigging due to tolerance build up during manufacturing of the 480009 hinge assembly. Some aircraft may be rigged to the minimum of the specifications of 6 1/2°.

In order to provide the full capability of 7° nose up trim as defined in the rigging specifications, a longer hinge half should be assembled into the 480009-501 assembly. The procedure for this modification is as follows:

1. Set empennage trim to approximately 4° nose-up for ease of access to the trim hinge.
2. Remove the 470002-9 and -10 tailcone to stinger fairings.
3. Remove the 480008-017 and -015 hinge pins. Remove the 480009-001 and -003 hinge halves. Reference Figure M20-216-1.
4. Install Service Bulletin kit part hinge half (480009-3 and -7) in place of the 480009-001 and -003 hinge halves, using 480008-015 and -017 hinge pins removed.
NOTE: 440019 washers are to hold lateral movement to .010 max.
5. Check rigging of trim system and variable down spring per Service and Maintenance Manual, paragraphs 6.3 and 6.4, stabilizer 3.8° to 4.2° up, -6.5° to -7.0° down.
6. Reinstall 470002-9 and -10 tailcone to stinger fairings.
7. Enter compliance in Log Book and fill out and return Compliance Card to Mooney Aircraft.
