# SERVICE BULLETIN

SUBJECT: REAR SPAR CENTER SPLICE INSPECTION,  
P/N 2212 or 210057

SERVICE  
BULLETIN KIT  
No. M20-217

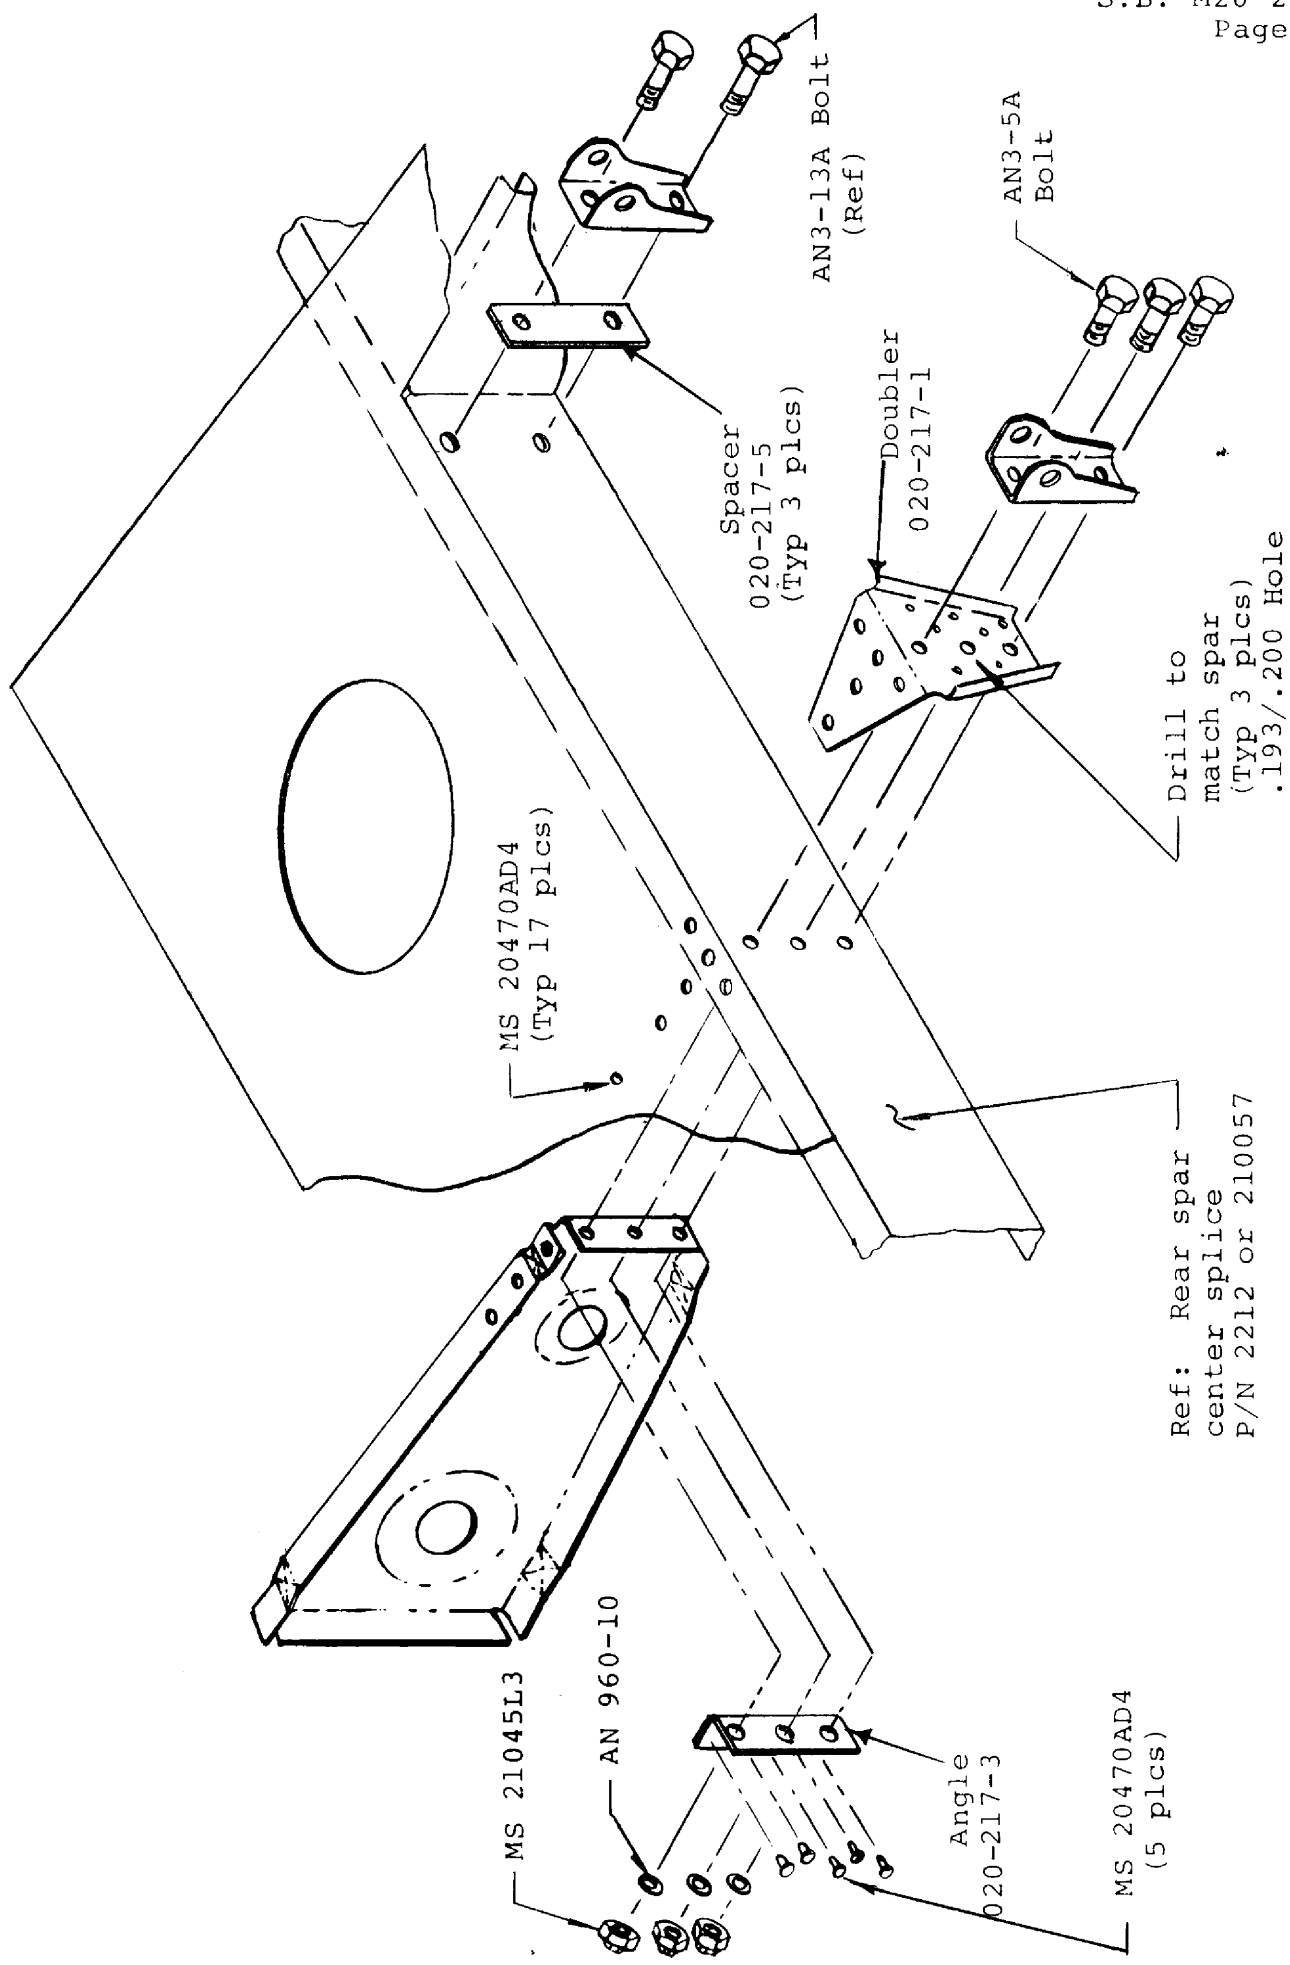
FIGURE 217-2

To prevent the possible failure of the rear spar  
center splice web due to cracking with associated  
crack growth, accomplish the following inspection:

- a) Remove the aft belly fairing assembly to gain  
access to the flap actuator jack shaft assembly.
- b) Inspect the rear spar center splice (see  
Figure 217-2) for cracks, paying particular  
attention to the web area above the flap actuator  
attachment brackets. It may be necessary to  
remove the flap torque tube and brackets to  
inspect behind this area. Use visual or dye  
penetrant inspection methods aided by magnification  
devices as required.
- c) Inspect the rib area forward of the rear spar  
for cracks in the same manner as above.
- d) Repair or modify the rear spar center splice as  
defined in the following repair paragraph.  
Repair or modification of the spar will permit  
discontinuance of the inspection.
- e) Reinstall belly fairing and return to service  
by proper log book entry.

3. Stop drill all cracks in spar.
4. If rib is not damaged, install the 020-217-1 doubler as follows (see Figure 217-2): Locate doubler and bracket over spar web, and drill three .193/.200 holes through rib flange, spar web, doubler, and bracket to match existing spar web holes. Install doubler on spar web and upper rib flange with 17 MS 20470AD4 rivets. Attach bracket with three AN3-5A bolts, MS 21045L3 nuts, and AN 960-10 washers. (Apply zinc chromate primer on all mating surfaces.)

5. If rib is damaged, stop drill cracks or remove damaged portion and install 020-217-3 angle forward of the spar at the rib as shown in Figure 217-2. The angle is attached to the rib web with five MS 20470AD4 rivets. Drill three .193/.200 holes in the angle to match the existing holes in the spar web. Install the 020-217-1 doubler as described in 4 above.

6. Install 020-217-5 shims under all flap jackshaft support brackets using new bolts with existing washers and nuts. The shims are required to align the brackets with the new doubler. Depending on the configuration, the 020-217-7 shim may need to be installed under the rudder bellcrank for alignment.
