SUBJECT: SEAT BELT LATCHING MECHANISMS,
INSPECTION AND MODIFICATION

SERVICE BULLETIN

SUBJECT: Possible Improper Latching of Seat Belt Assemblies
FDC-5900-160-4 and FDC-5900-160-6

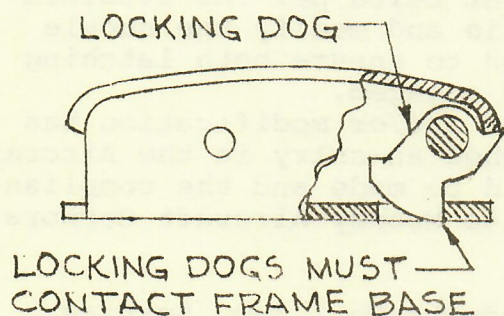
Sketch A

We have found that the release fitting may latch improperly when inserted into the buckle. Improper latching exists if both locking dogs are not engaged with the release fitting. (Note: FAA strength requirements are met even if only one locking dog is engaged.)

To inspect for improper latching, insert the release fitting into the buckle and observe the locking dogs through the rectangular slots in the base of the buckle. If properly engaged, the locking dogs will make contact with the buckle frame base. (Sketch A)
