SUBJECT: FUEL FLOW TRANSDUCER, AEROSONIC PART NO. 32622-6

Mooney Model M20K, S/N 25-0282, -0285, -0293 thru -0295, -0297 thru -0300, -0304, -0305, -0307 thru -0310, -0314, -0317, -0333, -0335 thru -0352, -0354, -0359, -0362, -0364 thru -0371, -0374 thru -0377, -0379 thru -0400, -0403, -0405 thru -0407, -0413, -0415 thru -0417, -0419 and ALL M20K's and applicable M20J's that have had the fuel flow transducer replaced between 1-1-80 and 8-14-80.

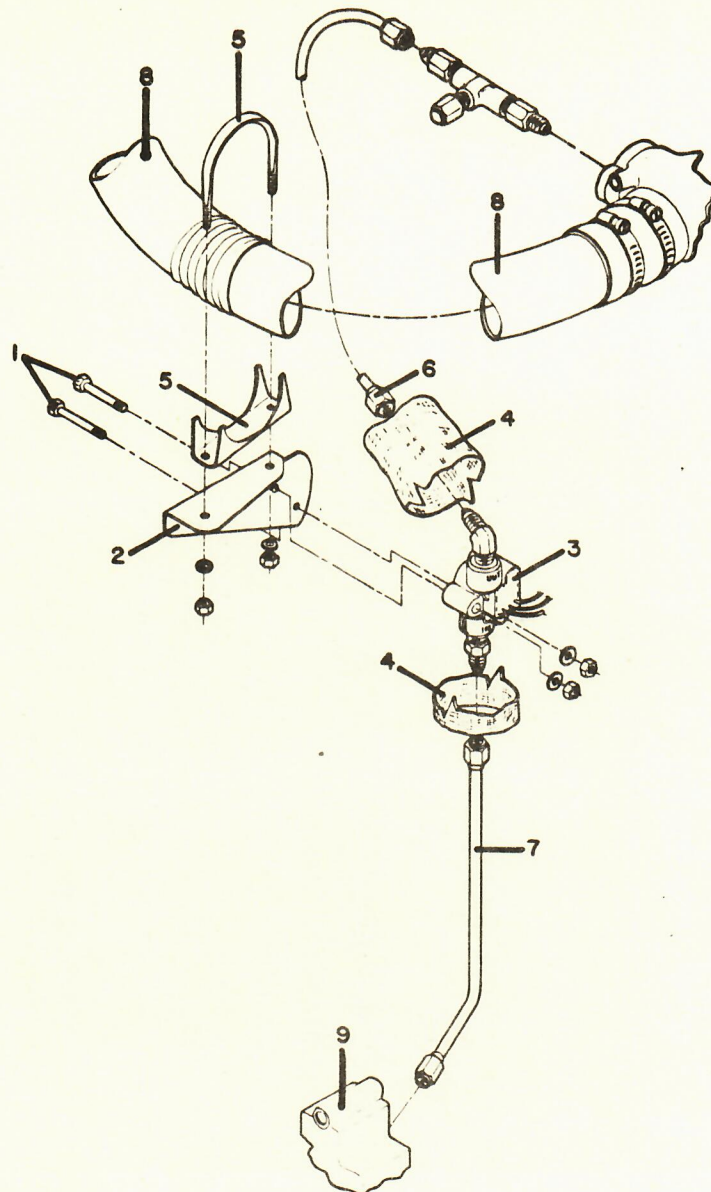
FIGURE 1

It has been determined that certain transducers manufactured by Aerosonic were improperly assembled and on some installations may leak or come apart during engine operation. This Bulletin requires inspection and replacement of suspect transducers on above aircraft serial numbers.

- 4) Loosen the nuts on the C10Y-34-6S clamp assy and rotate bracket and clamp so the back side of the transducer is exposed. Inspect for the name "FLOSCAN" embossed on the backing plate of the transducer housing. If the name "FLOSCAN" is found on unit it does not need replacing.

- 5) If no name is found on the backing plate, the transducer must be removed and replaced with a "FLOSCAN" unit.
  - a. Disconnect the fuel lines from the transducer ports.

- b. Remove sleeving from knife blade type connections and disconnect.
- 6) Install and secure the new transducer and leak check all fuel fittings prior to covering with the firesleeve. Install 45° elbow and union to transducer to a minimum torque of 40 inch/lbs., rotate to index to position. If leak persists, tighten one full turn, do not overrun or back off. Torque fuel line flare nut fittings to 50-90 inch/lbs.
