SERVICE BULLETIN M20-240
DATE: 1 - 13 - 89

SUBJECT: MOONEY AIRCRAFT CORPORATION, M20L MASTER SWITCH CIRCUIT MODIFICATION.

MODEL/S/N AFFECTED: MOONEY M20L, S/N 26-0001 THRU 26-0045

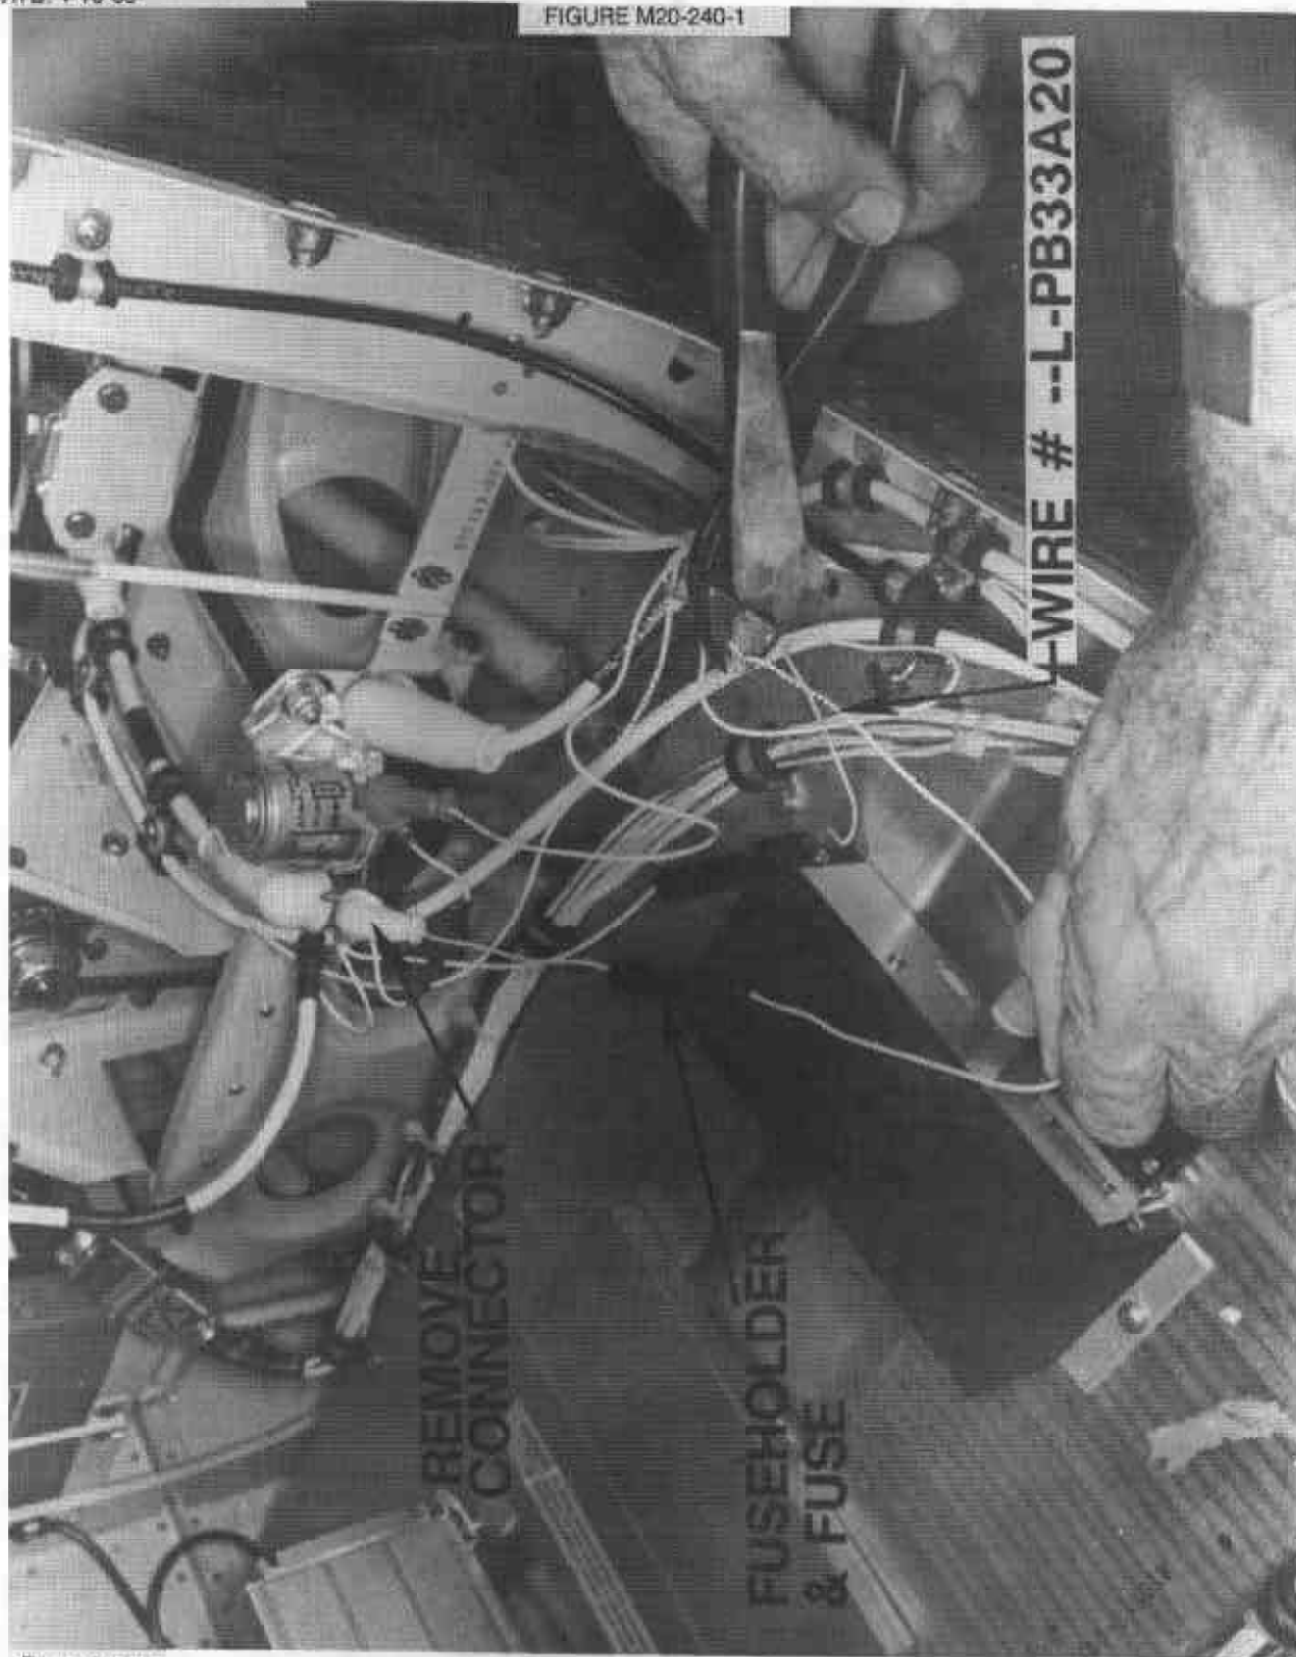
FIGURE M20-240-1

The Master Switch circuit, in an extremely rare circumstance, is configured on M20L Models (Mooney PFM), S/N 26-0001 thru 26-0045, in a way that all circuits except engine and A/H may become inoperative due to a blown fuse. In order to alleviate the situation, the following modification procedures need to be accomplished within the time frame shown above.

1. Remove left rear tailcone access door and perform the following actions:
(SEE FIGURE NO. 1 BELOW)
 - a. Remove wire (—L-PB33A20) from tailcone connector (JKL-PL20A), pin 1, by clipping wire approximately 1.5 inches from connector and install a wire cap on the portion still connected to the connector.

- b. Remove wire (—L-PB32A20) ring terminal from left battery relay, pin X.
 - c. Remove this separated wire, which includes the Left Master Fuseholder (L-PB180A) and fuse, from the tailcone and discard.
