SUBJECT: M20J INDUCTION AIR/ALTERNATE AIR DOOR RETROFIT

MODEL/S/N
AFFECTED: M20J - S/N 24-0001 THRU 24-3243

SERVICE BULLETIN M20-250 B
 DATE: 12 - 95
 Page 2 of 2

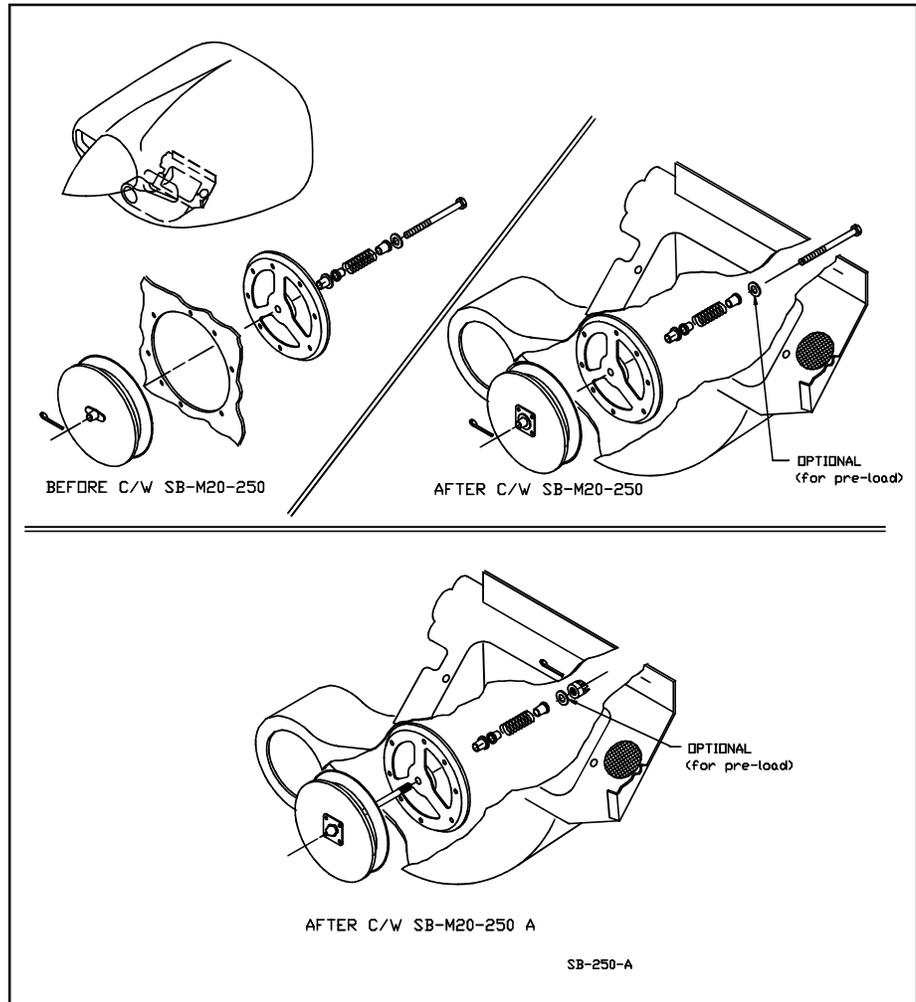
FIGURE SB M20-250 B-1

There have been reports of the alternate air door lodging in the induction air duct and restricting induction air flow to the engine. This retrofit kit is prepared to reduce the possibility of this occurring.

FIGURES/
 TABLES:
 SEE BEFORE AND AFTER CON-
 FIGURATIONS BELOW,
 SB M20-250 B-1.

5. Retain sleeve, washer(s) (if installed), nylon bearings and spring. Inspect sleeve and nylon bearings for evidence of wear. It is recommended that components showing any wear be replaced.
6. Remove the alternate air door assembly, 600118-015, from induction area.
7. Remove the nut plate assembly, 600355-505 (or AN362F428 nutplate/original configuration), from alternate air door by carefully drilling out the MS20426AD3 rivets.
8. Install new 600355-507 plate assembly (included in kit) to alternate air door, 600118-015, using 4 MS20426AD3 rivets (included in kit). Use next oversize rivets, if necessary. Insert bolt of 600355-507 plate assembly into hole in 600118-015 alternate air door (from opposite side of rubber seal). Align bolt in center of hole as components are being riveted together. Use existing rivet holes in 600118-015 alternate air door.

Note: If modifying original configuration with AN362F428 nutplate installed, two existing rivet holes for AN362F428 nut plate should be aligned with two holes of 600355-507 plate assembly and two more holes drilled to match the other two holes in the 600355-507 plate assembly.
