SUBJECT: M20M LANDING GEAR RIGGING INSPECTION AND MODIFICATION.

S/N AFFECTED: **M20M - S/N 27-0107 THRU 27-0147** - (S/N's 27-0115, 27-0123, 27-0127, 27-0131, 27-0137, 27-0142, 27-0144, 27-0150 HAVE HAD INSTRUCTIONS OF SB ACCOMPLISHED).

COMPLIANCE: WITHIN NEXT 25 FLIGHT HOURS OR AT NEXT SCHEDULED MAINTENANCE.

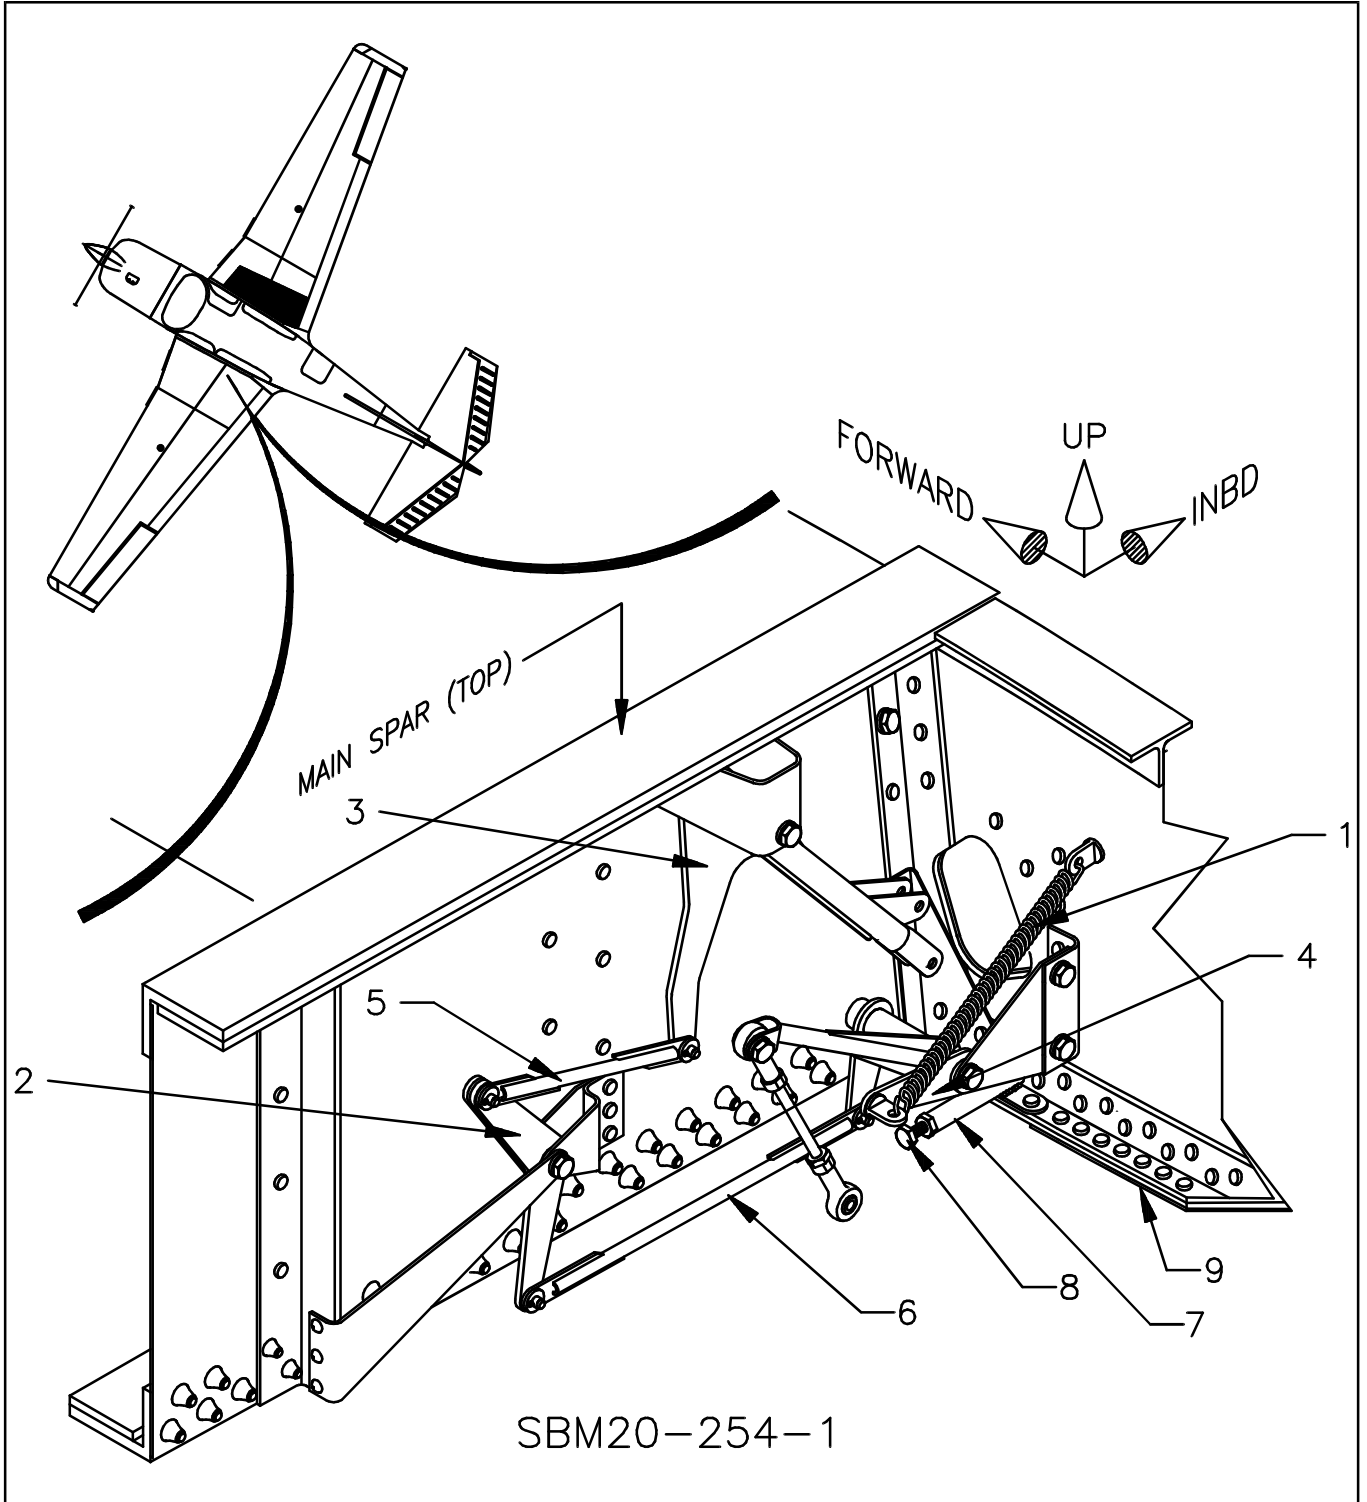
6. Aircraft still on jacks. Landing gear down and locked.
7. Locate the two rivets on LH & RH wheelwells that are just forward of the inboard gear door hinge (9) attaching rivets (Ref. Fig M20-254-1). This is the location for the 550075-501 stops (7) to be installed.
8. Disconnect Inboard Gear doors. Carefully drill off the two rivet heads on LH & RH sides; punch rivets out.

**550075-501 stop (7) has two #40 pilot holes in flange. In some instances, due to manufacturing tolerances, the pilot holes may not align exactly with both drilled holes in wing rib. If this is the case, determine which of the two holes in stop flange will create the better alignment of the stop bolt head (8) with the bellcrank (4) arm. Use this hole as the "primary" attachment hole.**

9. Drill "primary" attachment hole to size (#20 drill) in each stop. Cleco stops (7) in place, at "primary" attach hole only, so head of bolt (8) in stop aligns with arm of inboard gear door bellcrank (4) that spring (1) is attached to.

10. When stop (7) is clecoed in proper position, drill second attach hole in stop flange to size (#20 drill), by back drilling through existing "non-primary" rivet hole. Deburr hole in flange and cleco in position. Make sure head of bolt (8) in stop aligns (directly centered) with arm of bellcrank (4).

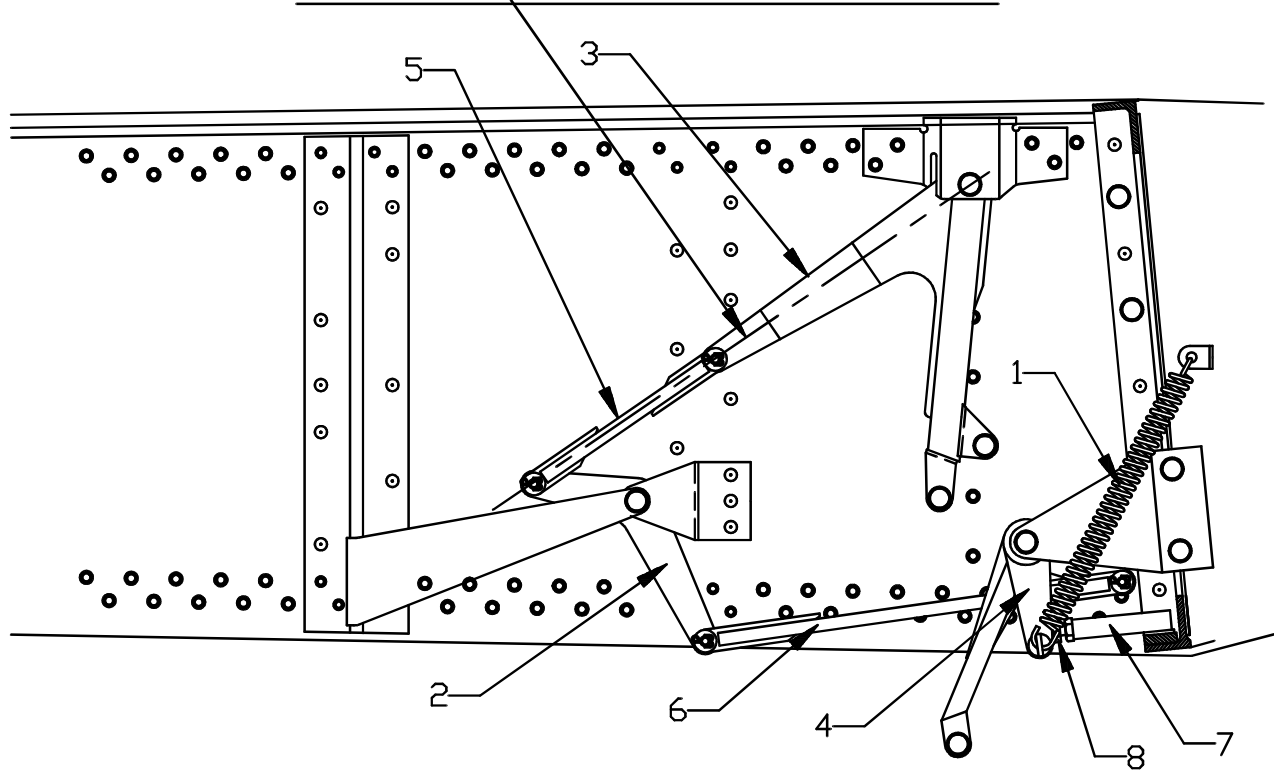
SBM20-254-2

13. Retract landing gear using safety by-pass switch (See S & M, Section 32-30-01, steps 5, 6, 7) until inboard gear door has traveled as far as it will go during its retraction cycle. In this position, the pivot points of bellcrank (3) & center line of rod (5) will be in a straight line (Reference Figure M20-254-2). Components (2), (5) & (6) should now be in a loaded condition and feel very tight.

NOTICE  
THESE PIVOT POINTS ARE IN ALMOST A STRAIGHT LINE.  
THIS REPRESENTS THE MOST EXTREME TRAVEL THAT THESE  
COMPONENTS SHOULD BE.

14. Adjust stop bolt head (8) OUT until it rests on bellcrank (4) arm. Continue to adjust bolt head OUT until rods (5) & (6) become loose (no load felt on either rod). Bellcrank (2) will also become loose when bolt head (8) is in correct position. Tighten jam nut on bolt (8) against tube on stop (7).
