SERVICE BULLETIN M20-258
ISSUE DATE: 1 JULY, 1995

SUBJECT: MOONEY M20R FUEL SYSTEM, SUPPLY AND RETURN LINE, RETROFIT

MODELS/S/N AFFECTED: M20R, S/N 29-0001 THRU 29-0068

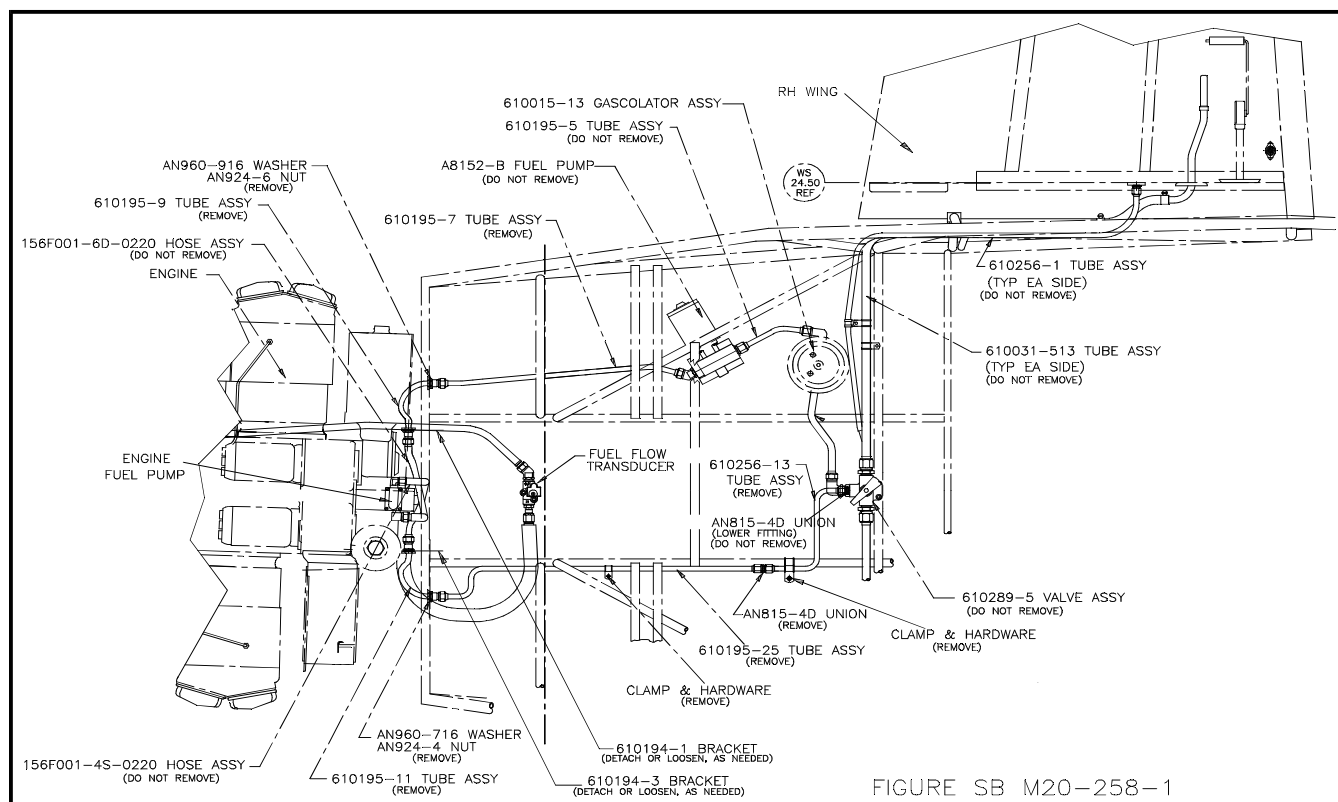
CURRENT PRODUCTION CONFIGURATION OF THE FUEL SUPPLY TUBE ASSEMBLY AND THE FUEL/VAPOR RETURN TUBE ASSEMBLY ARE MULTIPLE TUBE CONFIGURATIONS AND CONTAIN A JOINT WHERE EACH LINE PASSES THROUGH THE FIREWALL. TO AVOID THE POSSIBILITY OF A LEAK DEVELOPING, EACH OF THESE LINES HAVE BEEN CHANGED TO A SINGLE TUBE ASSEMBLY, WITH NO JOINT, BETWEEN THE FLEX LINES IN THE ENGINE COMPARTMENT AND THE COMPONENT EACH LINE CONNECTS TO UNDER THE FLOORBOARD. SOME EXISTING CONFIGURATION COMPONENTS WILL BE REMOVED AND DISCARDED AND SOME COMPONENTS WILL BE REUSED FOR THE NEW CONFIGURATION.

— **Removal of Fuel Supply Lines (RH side)** (see Fig. SB 258-1) —

— **Removal of Fuel/Fuel Vapor Return Lines (LH side)** — (see Fig. SB 258-1)

6. Disconnect flex hose, P/N 156F001-6D-0220 from fuel supply tube assembly, 610195-9, at bracket, 610194-1.
7. Disconnect fuel supply tube assembly, 610195-7 from firewall bulkhead fitting end of tube assembly, 610195-9 (aft of firewall).
8. Disconnect nut and washer, AN924-6 and AN960-916, at tube assembly bulkhead fitting, from bracket, 610194-1. Temporary removal of bracket will prevent distortion of new line assembly during installation.
9. Disconnect nut, AN924-6, and washer, AN960-916, from bulkhead end of 610195-9 tube assembly (fwd side of firewall).
10. Tube assembly, 610195-9, can now be removed from aircraft.
11. Disconnect nut of tube assembly 610195-7, from elbow, MS51528B6, on auxiliary fuel pump.
12. Remove tube assembly, 610195-7, from aircraft.

13. Disconnect flex hose, P/N 156F001-4S-0220, from fuel/fuel vapor return tube assembly, 610195-11, at bracket, 610194-3.
14. Disconnect fuel/fuel vapor return tube assembly, 610195-25 from the firewall bulkhead fitting end of tube assembly, 610195-11 (aft of firewall).
