SUBJECT: Mooney Aircraft Corporation, M20R Models with Air Conditioning System Installed, to provide retrofit instructions to reduce the Carbon Monoxide (CO) within the cabin area of the aircraft during operation of the Air Conditioning System.

MODELS/S/N AFFECTED: M20R, S/N's: 29-0033, 29-0062, 29-0088, 29-0090, 29-0092, 29-0096, 29-0098, 29-0109, 29-0117, 29-0119, 29-0130, 29-0132, 29-0133, 29-0134, 29-0139, 29-0142, 29-0143, 29-0144, 29-0149, 29-0154, 29-0155, 29-0156, 29-0159, 29-0161, 29-0162, 29-0164, 29-0171, 29-0180 & any other S/N's which have MAC Air Conditioning System installed but not specified above.

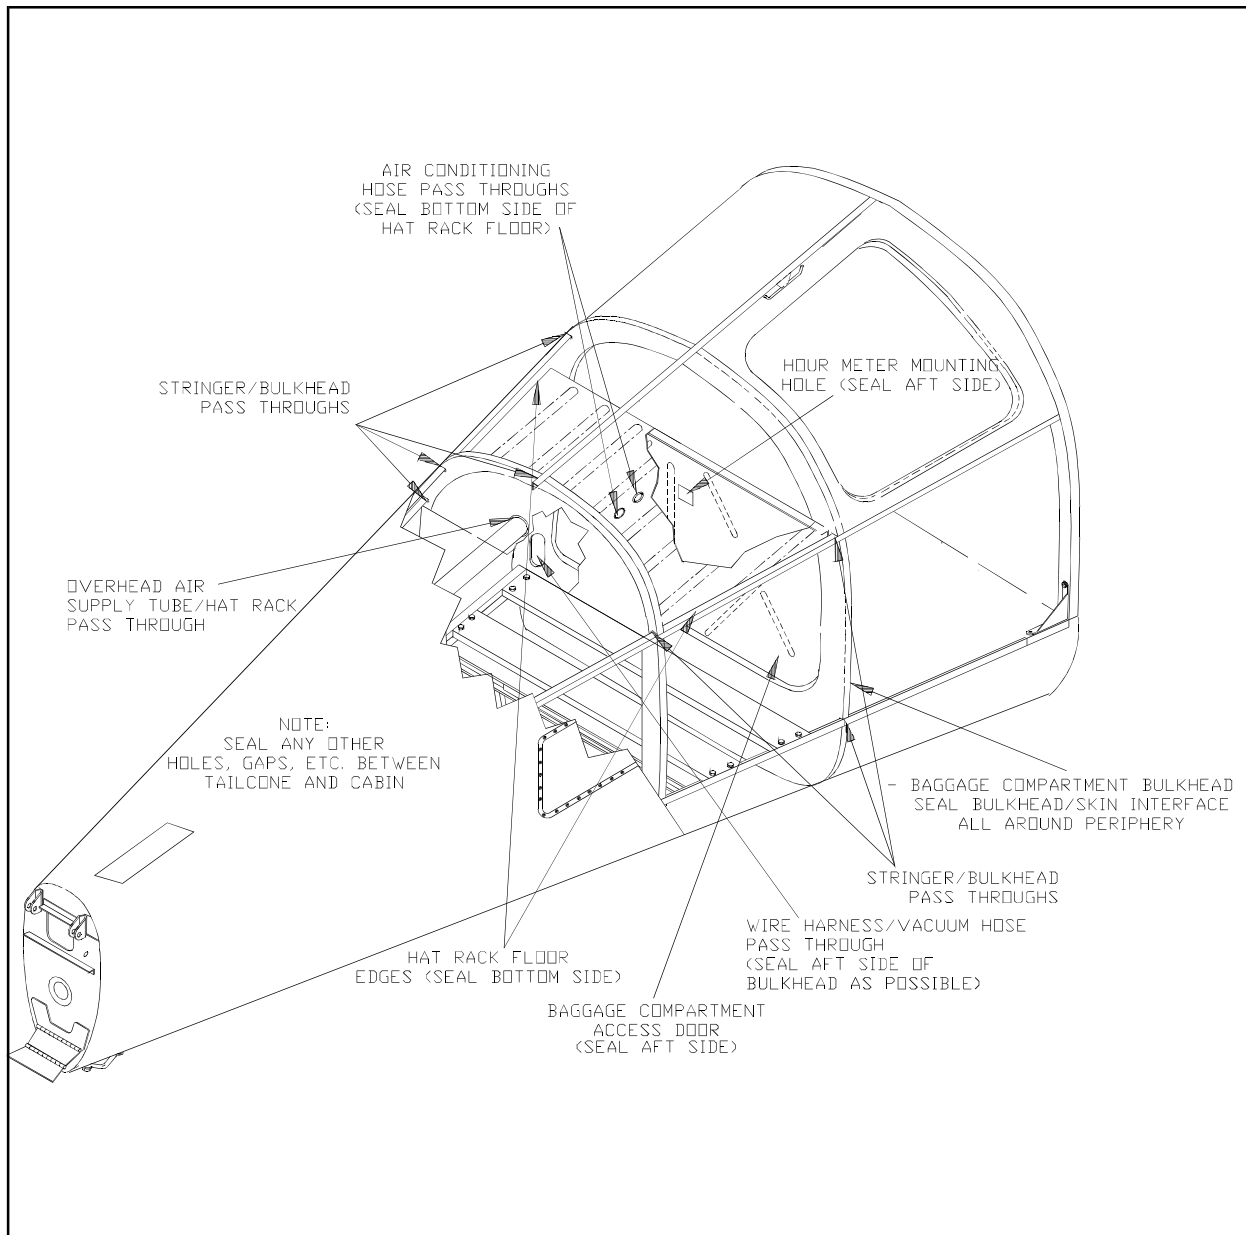
FIGURE SB M20-269 -1 - RECOMMENDED ALUMINUM TAPE SEALING LOCATIONS

INTRODUCTION: It was found that the M20R model aircraft with the factory Air Conditioning System installed and operating during ground, takeoff and climb operations may produce Carbon Monoxide (CO) levels that were in excess of F. A. R. allowables. Special Letter 98-3 & 3A were issued to advise the field of the situation and provide a placard to restrict operation. Special Letter 98-3B provided retrofit instructions and kit that would allow full use of the Air Conditioning System during all aircraft operations. This Service Bulletin is prepared (basically a duplicate of SL 98-3B) at FAA request to support a proposed Airworthiness Directive (AD). If retrofit has been accomplished in accordance with SL98-3B the intent of the AD has been accomplished.

**2.0 BAGGAGE COMPARTMENT BULKHEAD/SKIN SEALING BETWEEN TAILCONE AND CABIN
(REFERENCE FIGURE SB M20-269-1 FOR SEALING RECOMMENDATIONS)**

- 2.1. Gain access through the left hand tailcone access door for baggage compartment bulkhead sealing. Use 3M, #425, Aluminum tape (4" wide) to seal all holes, corners, edges and wiring and hose pass through areas on baggage compartment bulkhead. Seal the left, outside corner of the hat rack bottom shelf while at this left hand access door.
- 2.2. Gain access through the right hand tailcone access door for hat rack bulkhead and the right, outside corner of the hat rack bottom shelf. Apply #425 Aluminum tape over all holes, corners, edges, of rear hat rack bulkhead and over wiring and hose/tube pass through areas on bottom of hat rack.
