SERVICE BULLETIN

SERVICE BULLETIN M20-275 ISSUE DATE January 4, 2001

ELECTRICAL SYSTEM MODIFICATION, ADDITION TO FUSES TO CHARGING SYSTEM

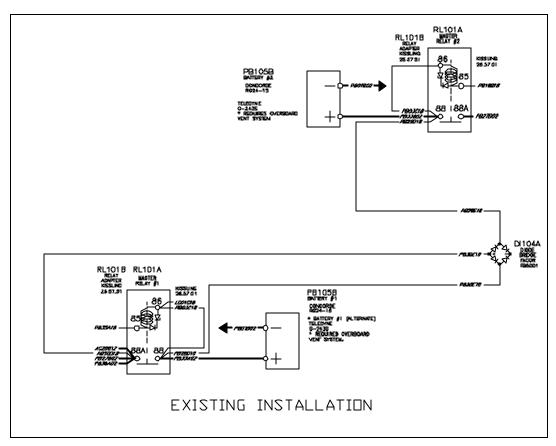
FIGURE SB M20-275- 1

2. Reference Figure SB M20-275-1 for existing wiring configuration without fuses included.
