SERVICE BULLETIN M20-278

- SUBJECT:** Wing Flap Actuator Bracket Repair
- MODELS/ S/N** M20M, Serial Numbers 27-0306 thru 27-0311
AFFECTED: M20R, Serial Numbers 29-0247 thru 29-0261, 29-0263, 29-0266, 29-0268 thru 29-0271,
29-0275
M20S, Serial Numbers 30-0056 thru 30-0058

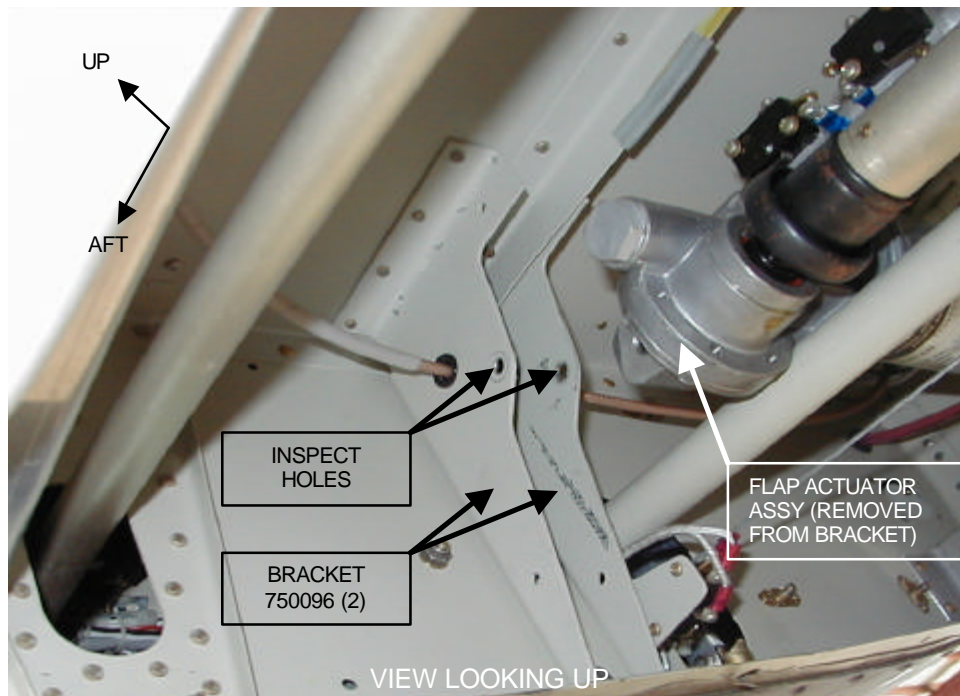
Figure M20-278- 1

2. Remove actuator mounting bolt and support actuator.
 3. Inspect flap actuator mounting holes (2) in the 750096 bracket (figure M20-278-1).
 - A. If hole size is .250 / .254 no further action or inspection is required; go to step 9.

- B. If hole size exceeds .3125 inch diametrical dimension, replace oversize or damaged 750096 bracket.
 - C. If hole size is not between the 0.250 / 0.254 inch diameter limit, and does not exceed .3125 inch diametrical dimension, proceed with the following steps.
