# MOONEY INTERNATIONAL CORPORATION, INC.

COVER LETTER - SB M20-323

SUBJECT: To verify installation of correct propeller governor gasket on M20TN model aircraft

MODELS/ SN  
AFFECTED: Mooney Aircraft M20TN Acclaim SNs 31-0128, 31-0133, 31-0134, 31-0135, and 31-0137

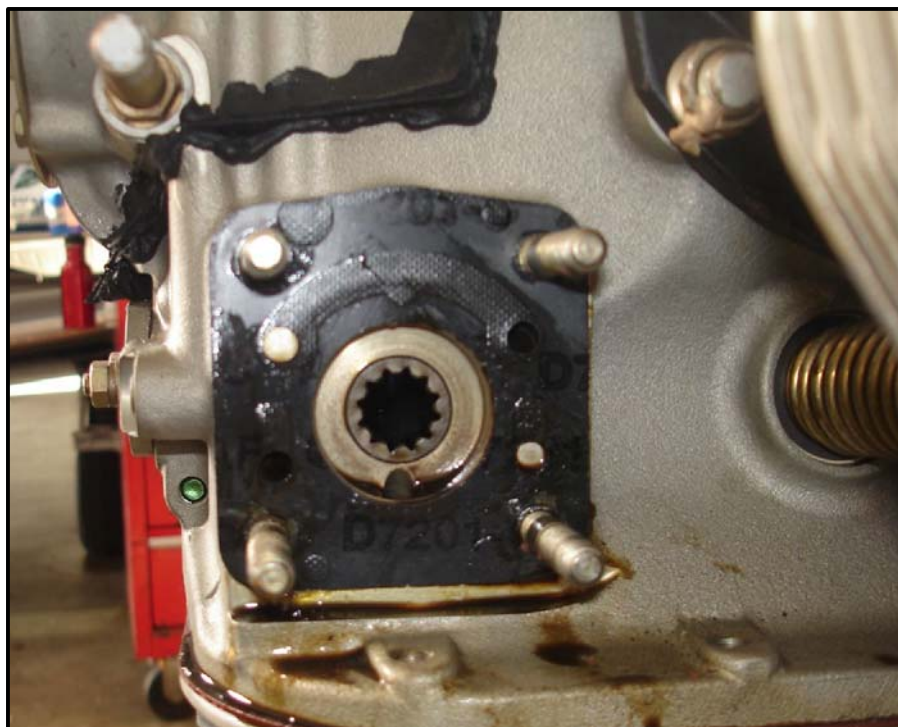
INTRODUCTION: It was discovered in the field during routine maintenance that an M20TN Acclaim had an improper propeller governor gasket installed between the propeller governor and the mounting pad. (See Figure SB M20-323-1) This Service Bulletin is to provide instructions for inspecting the aircraft to determine whether the correct gasket is installed and to provide instructions on replacing the gasket if it is found to be incorrect. **The attached compliance card needs to be filled out and returned to Mooney International Corporation upon completion of this Service Bulletin M20-323.**

**Figure SB M20-323-1 - INCORRECT GASKET INSTALLED**

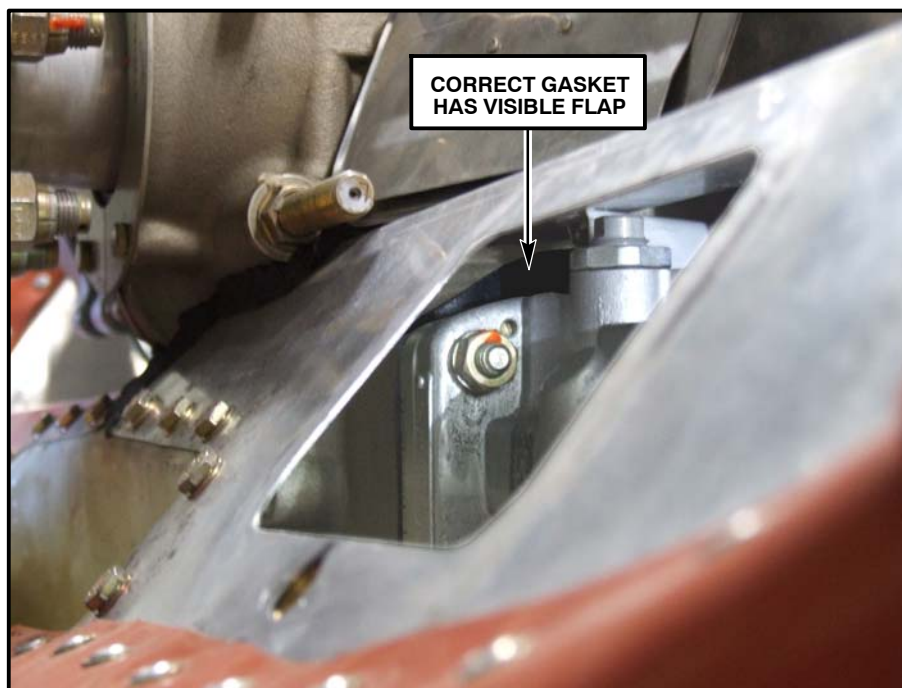
- 1.1. Remove top cowling.
- 1.2. Remove inspection cover above propeller governor.
- 1.3. Using an inspection mirror, perform a visual inspection of the propeller governor gasket located between the propeller governor and the mounting pad on the engine. (See Figures SB M20-323-2 and Figure SB M20-323-3) The correct gasket has a flap that extends above the propeller governor. If the top flap of the gasket is not visible, install gasket P/N MS9144- 01 using the following procedure.

**Figure SB M20-323-2 - VERIFY CORRECT GASKET IS INSTALLED THROUGH INSPECTION HOLE**

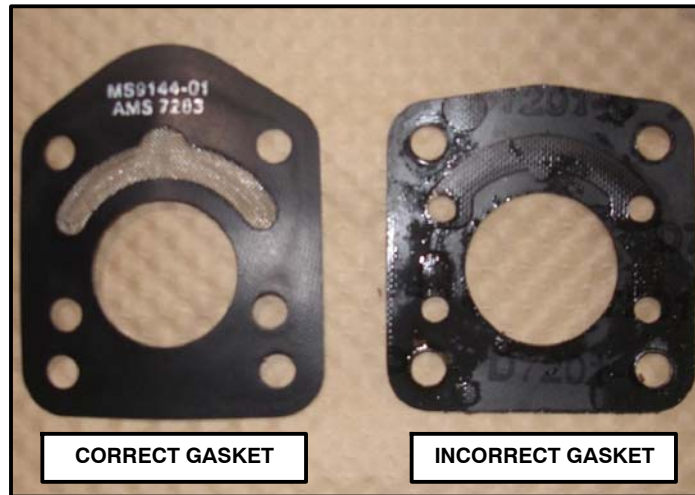
Figure SB M20-323-3 - VERIFY CORRECT GASKET IS INSTALLED
