MOONEY AIRCRAFT, INC.

SERVICE LETTER 20-40, Rev. A
(This Service Letter & Rev. A are FAA Approved)

SERVICE BULLETIN NA 20-40

DATE: 9-5-58
SUBJECT: Kit - Rudder Horn Reinforcing Strap
MODELS AFFECTED: M20, Serials 1002-1126
TIME OF COMPLIANCE: As soon as possible
PARTS LIST: P/N 4057 (1) Reinforcing Strap
ENCLOSURE: Compliance Card

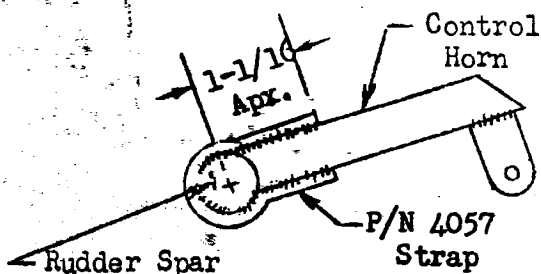
View looking up
at rudder

Several cases have been reported in which the rudder control horn broke at the point where it is attached to the rudder spar. It is therefore necessary that the following modification be accomplished.

1. Remove tail stinger assembly as follows:
 - (a) Set trim aft.
 - (b) Remove fairing strips between tail cone and stinger.
 - (c) Disconnect tail light wire.
 - (d) Detach stinger from tail truss at 3 points fwd and 1 point aft.
2. Remove paint from subject joint and inspect for cracks.
3. Protect fabric and structure near rudder horn with wet asbestos sheet.
4. Reweld joint if cracks are present and weld P/N 4057 in place as shown in sketch.

Tack P/N 4057 aft side and apply heat to form strap in place at center line of control horn. Attach strap to rudder spar and control horn with weld along full length of strap top and bottom. Do not weld end of strap.
