Service Bulletin

NUMBER: M20-52

Subject: Modification of Brake Pedals

Models Affected: M-20A Ser. Nos. 1305 thru 1475

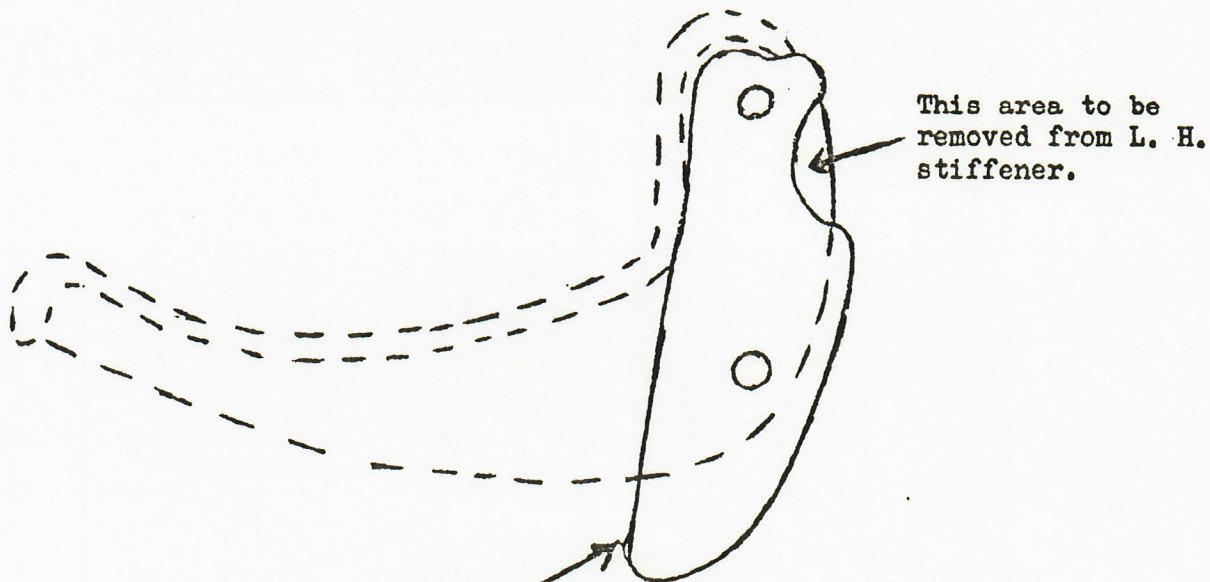
It has been determined that insufficient clearance between the stiffeners² on the Brake Pedal casting (P/N 7018) causes the brakes to be actuated at the points of full travel of the steering system, thus hindering ground handling. It is therefore, recommended that the following rework be accomplished.

- (1) Remove right and left brake pedal castings from the rudder pedals and brake rods.
- (2) Scribe an arc on the left stiffener of each casting with a metal scribe or a lead pencil, using the sketch enclosed as a template.
- (3) Remove the metal within the arcs with a round file or a grinding wheel.
- (4) Replace the pedals in the same manner as removed.

Cut out this part for template and locate on L. H. pedal stiffener as shown.
