## SERVICE LETTER 20-60

NOVEMBER 17, 1959

KIT - EMPENHAGE TO FUSELAGE ATTACHMENTS

M-20 AND M-20A SERIAL NOS. 1002 through 1540 manufacture of the state of the

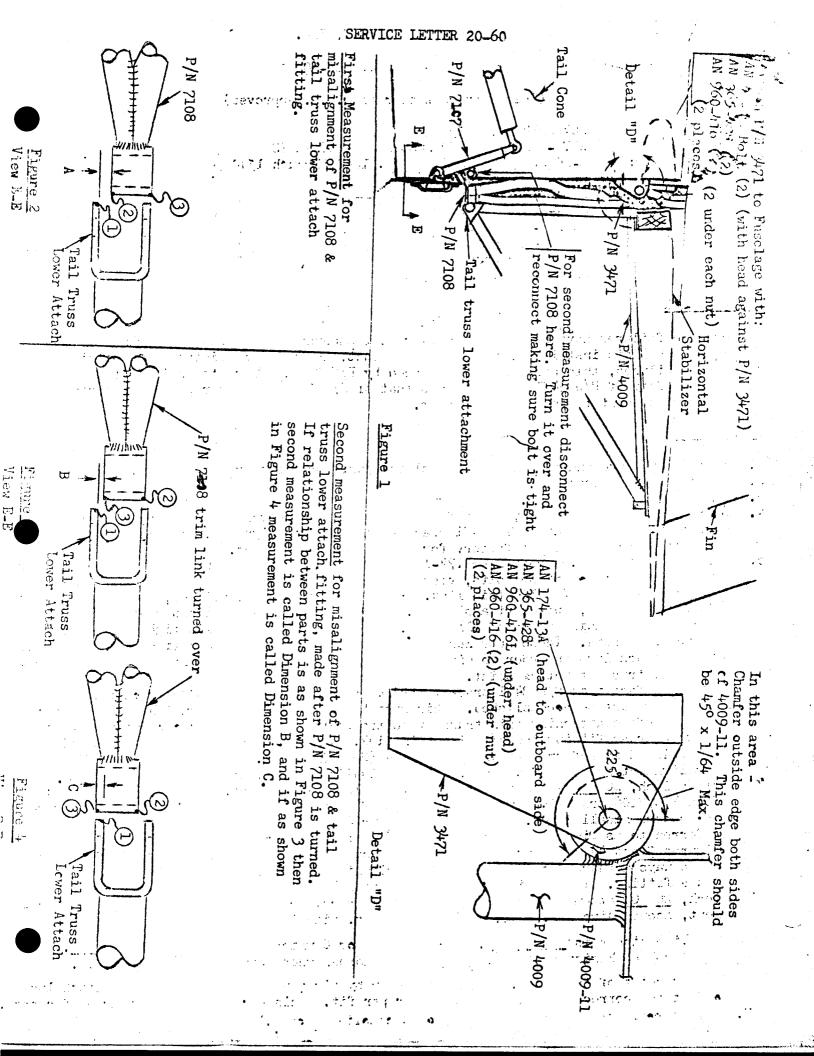
Although no failures have occurred on the present empennage to fuselage attachment (P/N 30 with P/N 3449 Plate installed), tests indicate that, in order to eliminate the possibility of future failures, this part must be replaced by P/N 3471. These tests indicate that the margin of safety of P/N 3471 is many times that of P/N 3009. These replacement parts are furnished at no cost to the aircraft owner.

Install 1/N 3471 brackets. (See Figure 1)
Before replacing empennage, use a file to remove sharp edges of tail truss attach lugs where they bear against P/N 3471 brackets as shown in Figure 1, detail D. This item

5. Reanctall empennage. Install AN 174-13A upper attach bolts as shown in Figure 1. Before tightening nuts on these bolts, visually check alignment between the lower tail trus attach point and P/A 7108 trim link. If these parts are misaligned, do not attempt t mily align them, but exert a slight pressure at the lower tail truss attach point in a direction tending to cause alignment. Hold this pressure while tightening upper attach bolt nuts. These nuts must be tight so that brackets bear tightly against tag iruss attach lugs in order to minimize empenhage free play. See Item 6 before attach ing tail truss at bottom point.

6. Due to the fact that P/N 3471 brackets are much stiffer than P/N 3009 brackets, the following must be accomplished. This must be done only after Item 5 has been complied with. Before attaching tail truss at bottom point, measure and record misalignment , between truss fitting and P/N 7108 trim link. This first measurement between Point 1 and Point 2 is referred to as Dimension A (See Figure 2). The maximum allowable misalignment is 1/32 of an inch. If the misalignment (Dimension A) is more than 1/32 of an inch, DO HOT attempt to mate parts at lower attachment, but do the following: Turn P/N 7108 trim link over at its point of attachment to P/N 7107 and again measure and record misalignment. This second measurement between Point 1 and Point 3 is referred to as Dimension B or C depending on the relationship between parts (See Figures 3 and 4). Be sure to make both measurements on the same side of the airplane and always measure from the outside of trim link to the inner edge (Point 1) of tail truss fitting. If the misalignment (Dimension B or C) is still more than 1/32 of an inch, DO NOT attempt to mate parts, but send a collect telegram to Spare Parts Depart ment, Mooney Aircraft, Inc., Kerrville, Texas, with the following information:
