This Service Letter reidentified as Service Pulletin M 20 - 64 per Service Instruction M20-15.

Carburetor Air Box - Inspection and Rework

Service Letter 20-64 Page 2

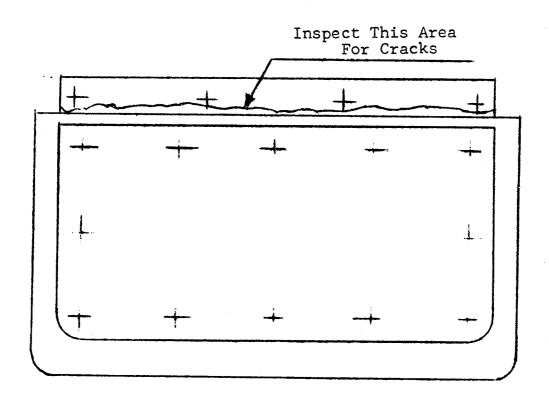
INSPECTION OF P/N 6175
FIGURE I

A few cases have been reported in which the carburetor air box valve assembly P/N 6175 has failed in the group of airplanes listed above. This failure can cause a power loss if the valve is drawn over the carburetor inlet. Airplanes, after Serial No. 1151, were equipped with an improved valve, P/N 6175 made of heavier gauge material, which has given good service. It is necessary that an inspection be made and that the following rework be accomplished if the valve is defective. If the valve is not defective, it is recommended that the rework be accomplished when convenient to eliminate the possibility of a future failure. Parts are available at no charge. Order kit S. L. 20-64-1 from:

(1) Remove Carburetor Air Filter P/N 6382 and inspect Valve P/N 6175 for cracks as shown in Figure 1.

(1) Replace old valve with new P/N 6175 valve.

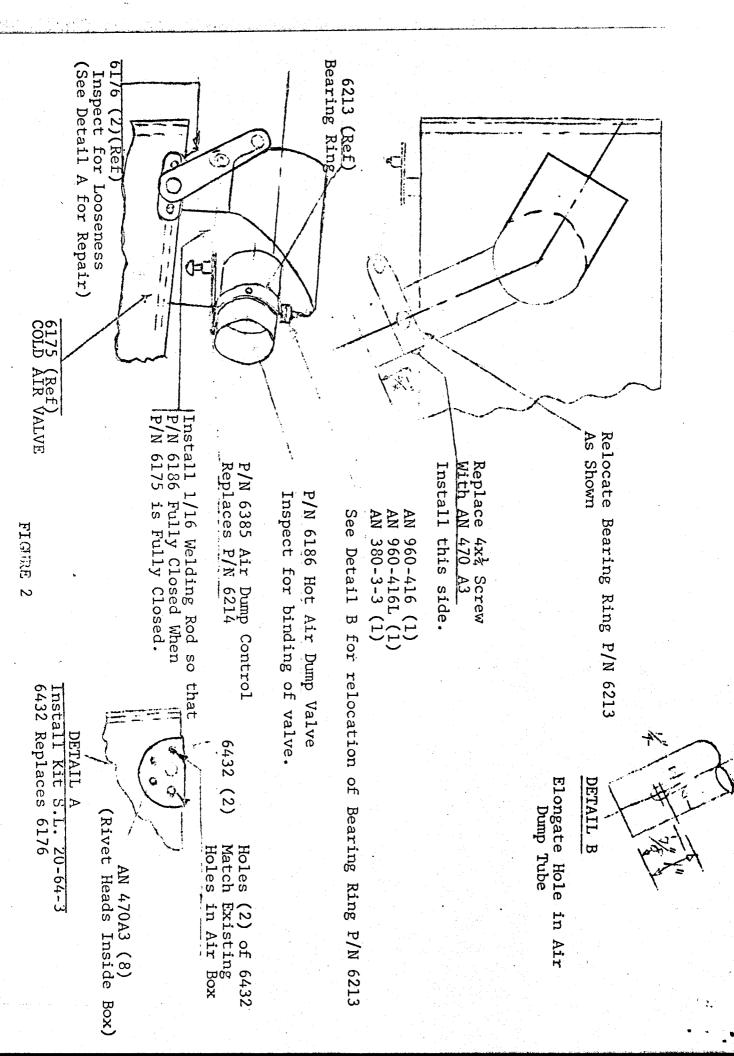
Several cases have been reported in which the shaft of P/N 6214, Air Dump Control, became worn and caused the dump valve to bind. If this condition is allowed to continue, the shaft may break and the valve be carried into the carburetor, It is necessary that an inspection be made and that the following rework be accomplished if the shaft is defective. If P/N 6214 is not defective, it is recommended that this rework be accomplished when convenient to eliminate the possibility of a future failure. Parts are available at no charge.

(1) Remove left hand side cowl and inspect dump control P/N 6214 for wear and P/N 6186 for binding as shown in Figure 2.

Several cases have been reported in which the rivets which fasten bearing plates P/N 6176 to the air box failed and allowed the carburetor cold air valve shaft to wear on the air box sides. This action may cause the carburetor control to operate improperly. It is necessary that an inspection be made and that the following rework be accomplished if the rivets have failed. If the rivets are secure, it is recommended that this rework be accomplished when convenient to eliminate the possibility of a future failure. Parts are available at no charge,

(1) Inspect P/N 6176 for looseness as shown in Figure 2.

- (1) Remove old Carburetor Dump Valve P/N 6214.
- (2) Install Kit S. L. 20-64-2 as shown in Figure 2.

- (1) Remove P/N 6176 (2 places).
- (2) Install Kit S. L. 20-64-3 as shown in Figure 2.
