MOONEY AIRCRAFT INC.
KERRVILLE, TEXAS

SERVICE LETTER 20-9
SERVICE BULLETIN M 20-9

Date: 5-30-56
Subject: Kit-Seat Roller Brackets Reinforcement
Models Affected: M-20 Serial No. 1002 thru 1031
Time Of Compliance: at owners convenience
Parts List: reinforcing Plate (8)
Enclosure: ~~EO 20-9~~

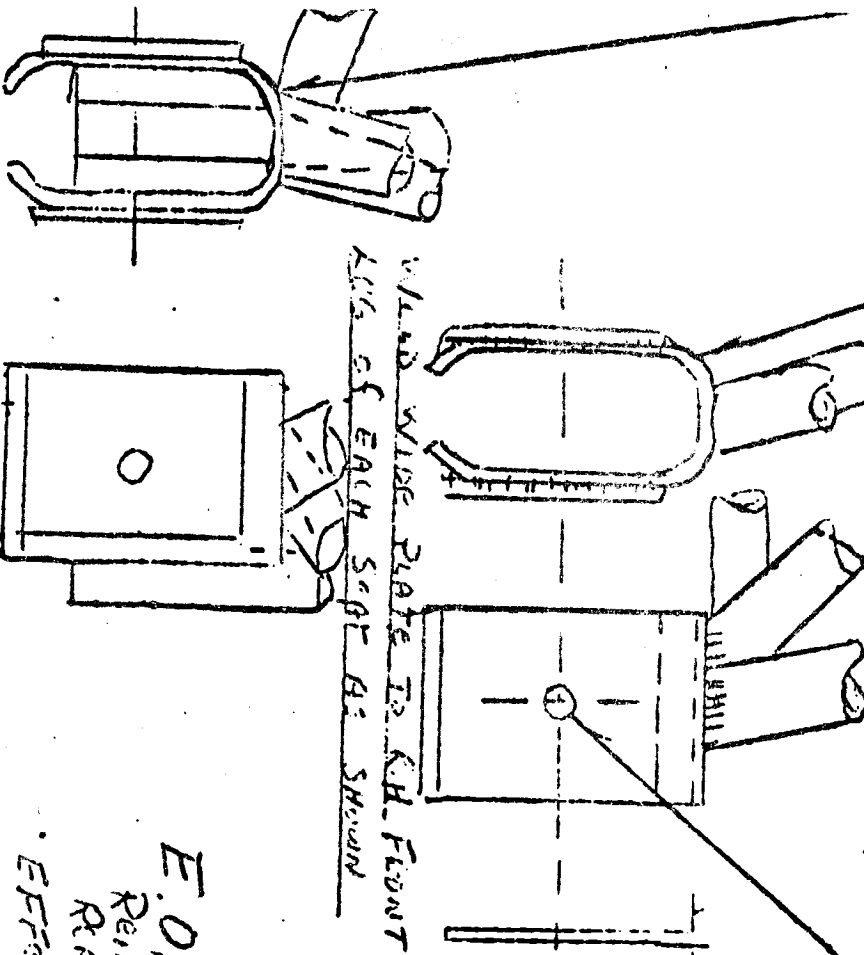
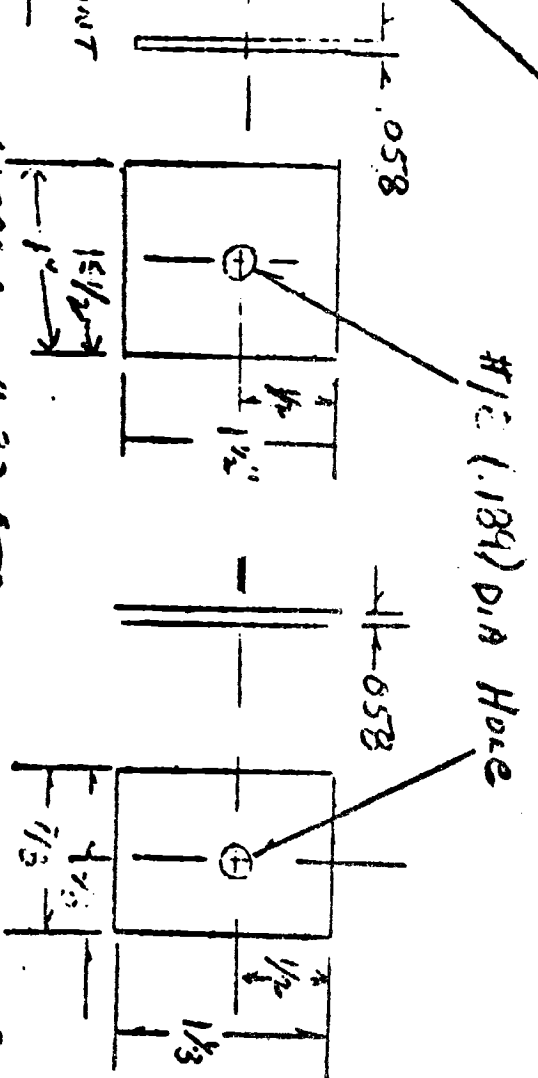
E.O. 20-9. DRAWING # 3045
REINFORCEMENT OF SEAT ROLLER BRACKETS
REASON FRONT BRACKETS SPREADING AT BOTTOM
EFFECTIVE PT. IN PRODUCTION SER. NO. 1052 FOW

There have been cases in which the pilot's seat toppled back when considerable pressure was applied to the back of the seat. This occurrence is possible when an up load spreads the forward seat roller brackets allowing them to slip off the seat rails.

BOLT PLATES IN POSITION FOR WELDING

WELD SEAT
WIDER SET (REF)
THRU EXISTING HOLE IN 3046

WELD WIDER SET PLATE TO R.H. FRONT
LEG OF EACH SEAT AS SHOWN

WELD NARROW PLATE TO L.H. FRONT
LEGS OF EACH SEAT AS SHOWN.

- 1) WELD REINFORCING PLATES TO FRONT TWO BRACKETS ONLY ON EACH SEAT.
- 2) OMIT WASHERS WHEN REPLACING ROLLERS.
