This Service Letter reidentified as
Service Bulletin M 20-99
per Service Instruction M20-15.

SUBJECT: Inspection of Oil Radiator Flanges and
Modification of Oil Radiator Installation

MODELS AFFECTED: M20C, Serial Numbers 1940 through 2219

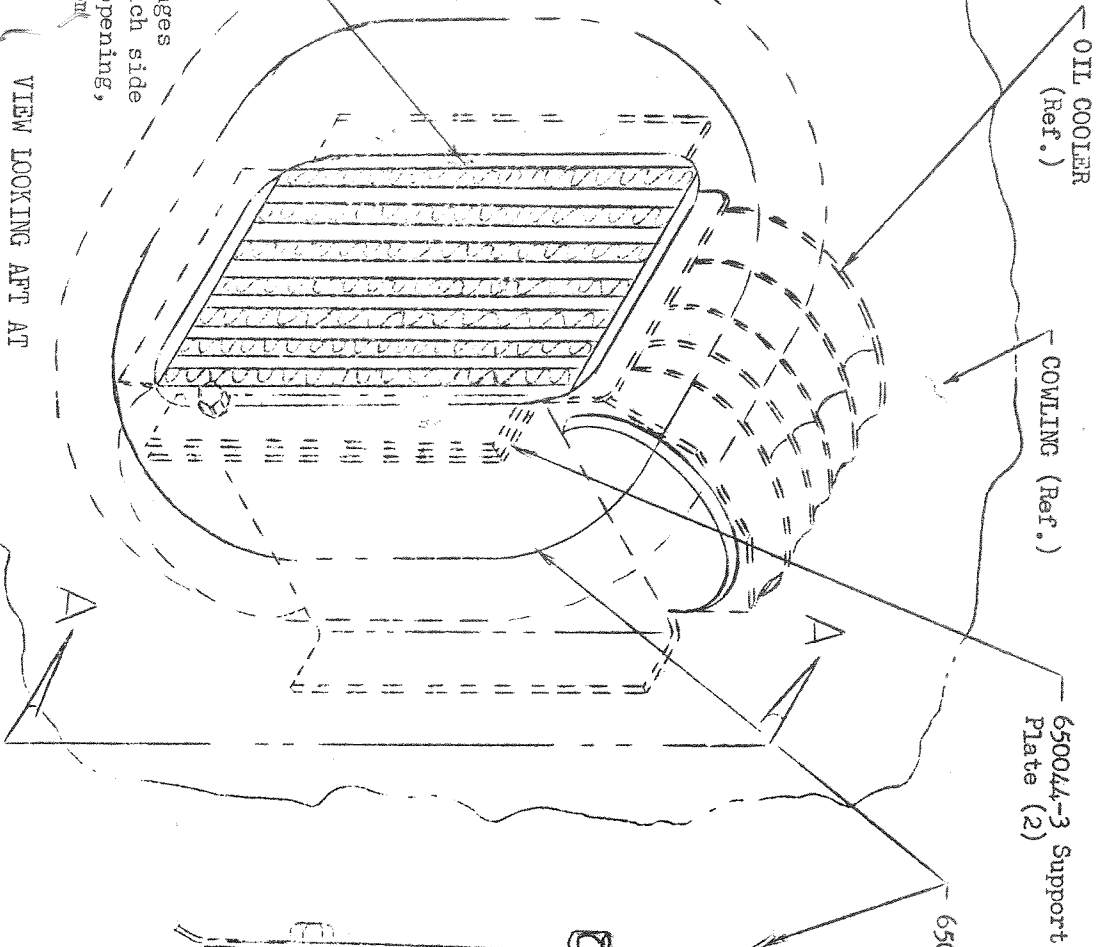
FIGURE 1

1. Inspect the oil cooler attachment flanges every twenty-five hours. The cracks are most likely to appear in the immediate area of the four mounting bolts and are clearly visible in the outside of the flange bend radii as shown in Figure 1.

Inspect flanges
for crack each side
of bracket opening,
top to bottom

1. Remove the oil cooler from the mounting bracket.
2. Remove the air deflector from the back of the oil cooler.
3. Position the oil cooler on the mounting bracket and insert the bolts. If any of the bolts must be forced into place, this indicates the holes are misaligned and the holes should be reamed with a #12 drill. Forcing the bolts can cause the flanges to crack.
4. Install 650044-3 support plate as shown in Figure 2. Install the nuts and tighten.
5. Cut the two inboard air deflector bushings as shown in Figure 2. In some instances, the deflector may be installed with two bushings on each bolt. In this case, discard the shorter bushing and re-install the air deflector using only the 7/8" long bushings on the inboard side.
