S.I. Number: M20-35

SERVICE INSTRUCTION

Inspection of Empennage Attach Brackets

MODELS AFFECTED: All M20 Series aircraft equipped with metal tails

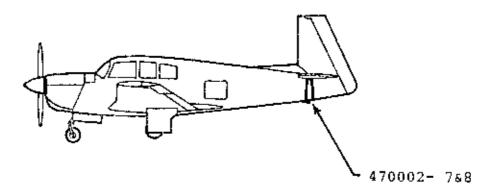
FIGURE 1

Evidence has been found that an accumulation of assembly tolerances may result in decreased rigidity of the empennage at the attachment to the tailcone. Since this condition is likely to exist in all M20 Series airplanes equipped with all metal tails it is necessary that the following inspection and corrective action be performed.

- 1) Remove 470002-7 and -8 fairings (Figure 1).
- Check torque on the AN 174-20A bolt (Figure 2) 2) 60-70 IN-LBS. dry threads. (Due to the inaccessibility of the nut the torque must be checked on the bolt and consideration must be given to friction in accordance with AC 43-13 Chapter 5, Section 227.)

- Install 470002-7 and -8 fairings (Figure 1). 7)

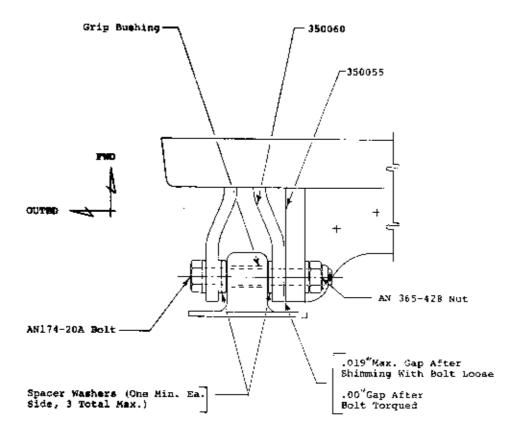
FIGURE 2 (View Looking Up)

- 3) Using a .005 feeler gage check between the 350060 bracket and the 350055 fitting (Figure 2). feeler gage touches shank of bolt continue with If gap does not exist no rework is Step 4. required.

- 4) Support the empennage and remove the bolt carefully noting the arrangement of washers used as spacers. These must be replaced in the reverse order of removal.

- Shim as required to eliminate gap between the 5) 350060 bracket and the 350055 fitting with aluminum shim stock in the shape of an AN 960-416 washer. "Do not use brass shim stock". (Maximum allowable gap with bolts loose and shims installed is .019").

- Carefully inspect the condition of the AN 174-20A bolt. Replace if any signs of wear are evident. Reinstall the AN 174-20A bolt, washers, and AN 365-428 nut in the reverse order of disassem-Torque to 60-70 IN-LBS. (dry thread) and again check gap between the 350055 fitting and the 350060 bracket.
