S.I. No. M20-44A

SUBJECT: RUDDER AND ELEVATOR AFT BELLCRANK MODIFICATION

M20D,E,F,G, All Serial Numbers;
M20C, All Serial Numbers prior to 20-1259;
M20J, All Serial Numbers prior to 24-0901;
M20K, All Serial Numbers prior to 25-0247.

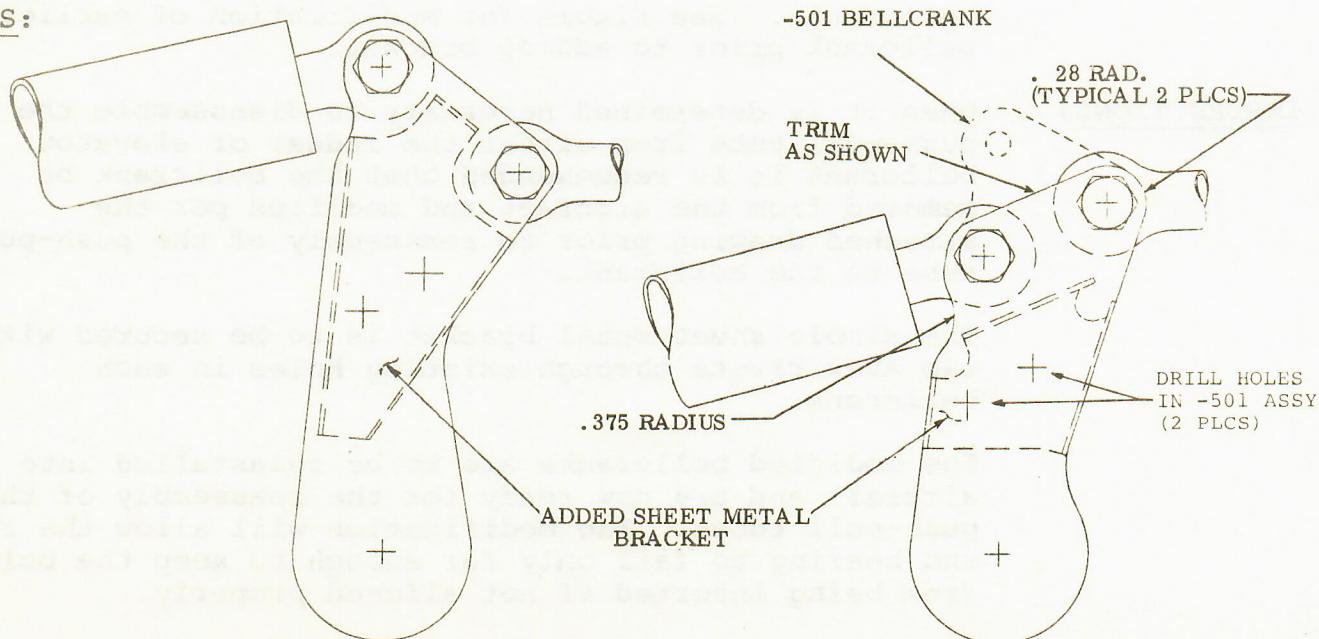
FIGURES/
TABLES:

The possibility exists that the rod end bearings on the end of the rudder and elevator push-pull tubes can be attached to the subject bellcranks, P/N 913031-() (Elevator), and P/N 913030-() (Rudder), and not be assembled properly. The rod end bearing can fall below the bolt holes in the bellcrank and the bolt inserted and torqued. The rod end bearing could be clamped between the bellcrank side plates and allow the elevator or rudder normal movement as long as no extreme air loads are encountered.

It is recommended that the bellcranks be updated to the 913030-503 and 913031-503 configurations at such time as there is reason to disassemble any of the control tube rod end bearings from the bellcranks. See Figure for modification of earlier bellcrank prior to adding bracket.

When it is determined necessary to disassemble the push-pull tube from either the rudder or elevator bellcrank it is recommended that the bellcrank be removed from the aircraft and modified per the attached drawing prior to reassembly of the push-pull tube to the bellcrank.

The simple sheet metal bracket is to be secured with two Avex rivets through existing holes in each bellcrank.
