SUBJECT: M20J RAM AIR REMOVAL - RETROFIT

MODEL/S/N
AFFECTED: M20J, S/N 24-0001 THRU 24-3153

TIME OF
COMPLIANCE: AT OWNERS DISCRETION

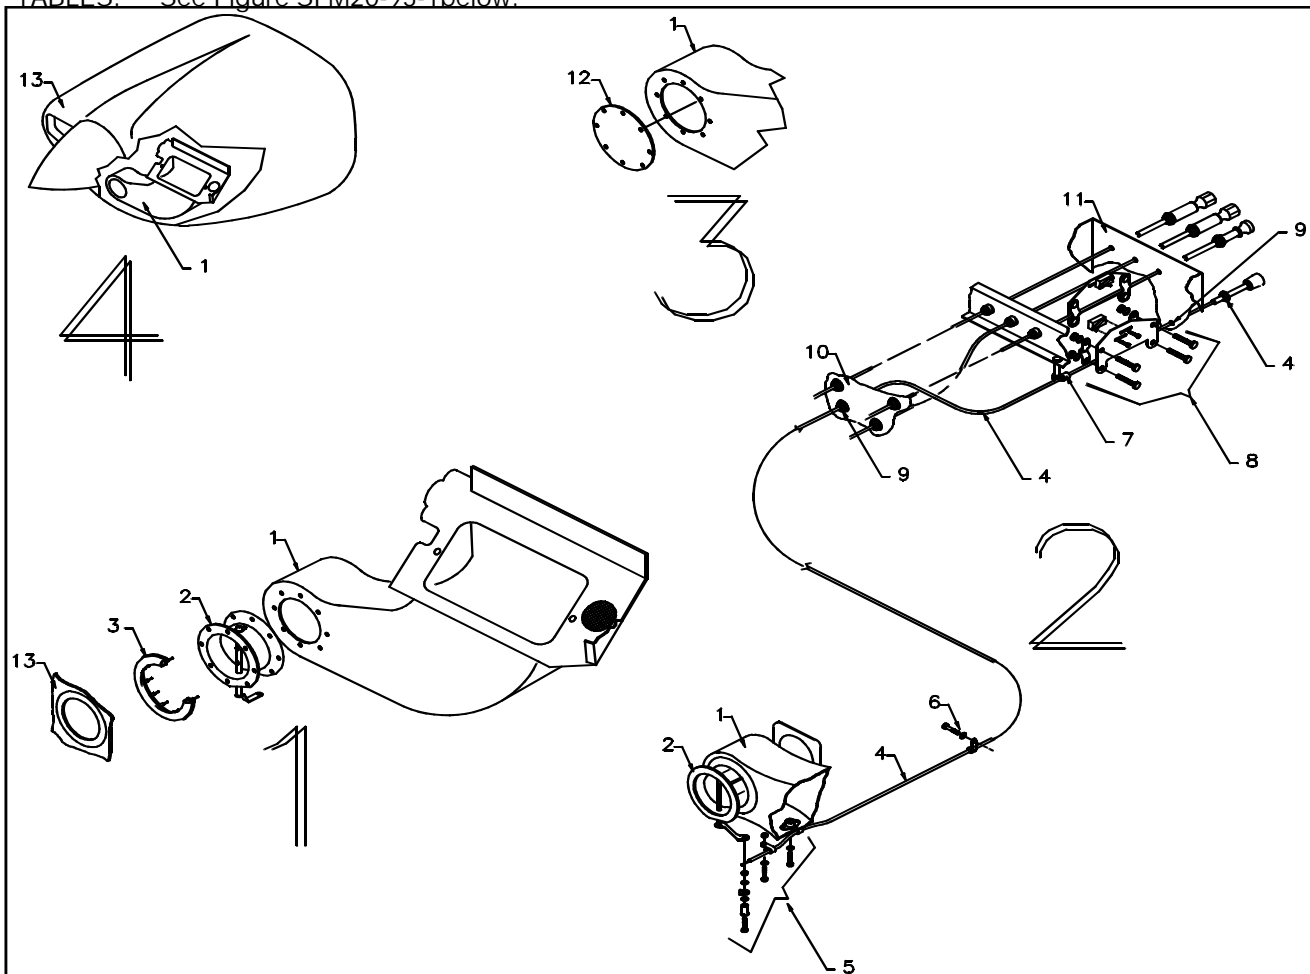
FIGURE SI-M20-93-1

INTRODUCTION: The development of the M20J induction system and cowling created a near optimum design that has shown limited benefit from a ram air induction system. The components of the ram air are a source of maintenance over the life of the aircraft and therefore this retrofit is offered to those owners who may wish to remove the ram air system from the above serial numbered aircraft.

1. Remove upper and lower cowling (13) per M20J Service and Maintenance Manual, No. 121, Section 71-11-00. Refer to Figure SI 93-1 during the accomplishment of the following instructions.

2. Refer to Section 1 of Figure SI 93-1. Locate the air induction assembly (1); then locate the ram air housing assembly, (2) (P/N 600360-501). Remove ram air control cable assembly from lower butterfly arm of ram air housing assembly.

3. Remove rivets from flange of ram air housing and air induction assembly (1) (12 each rivets). The rubber seal (3) for contact/sealing between ram air housing and lower cowling will come off with the housing.

4. Refer to Section 2 of Figure SI 93-1. Remove ram air control cable assembly (4) from lower arm of the ram air housing assembly. Remove ram air control cable assembly (4) from attachment points (5), (6) and (7) along cable.

5. Remove the Ram Air Warning Light Switch components from the control cable assembly, see components at point (8).

Be certain to remove the Ram Air Switch components (8), not the Landing Gear Warning switch components attached to throttle cable assembly.

8. Remove RAM AIR decal from console face in cockpit.
9. Plug hole in bottom of air induction assembly, at point (5), with existing AN3-3A bolt and washer.
10. Plug holes in console (11) and firewall (10). Firewall hole should be plugged with bolt, nut and washers (large OD) included in kit. PRO SEAL 700 or equivalent sealant should be used to seal this firewall fitting. Console hole (11) can be plugged with any style plug, owners discretion. A Heyco 2633 plug is included in kit.
11. Refer to Section 3 of Figure SI 93-1. Install cover, (12) (P/N 600355-003) to Air Induction Assembly (1) with MS20470AD3 rivets. Seal this cover assembly, after installation on to air induction assembly, with RTV-White Silicone sealant (not included in kit). Be certain all possible air passages are thoroughly sealed.

12. Refer to Section 4 of Figure SI 93-1. The lower cowling Ram Air Inlet hole must be sealed over. AC43-13 approved standard practice procedures, fiberglass repair methods, should be used to accomplish this action. Complete this procedure and paint cowling.
