SUBJECT: NORWICH AERO PRODUCTS, INC. Oil Temperature Probes, Inspection for improper assembly.

MODELS/S/N AFFECTED: Mooney M20J (MSE) S/N 24-3293, 24-3298, 24-3299, 24-3300

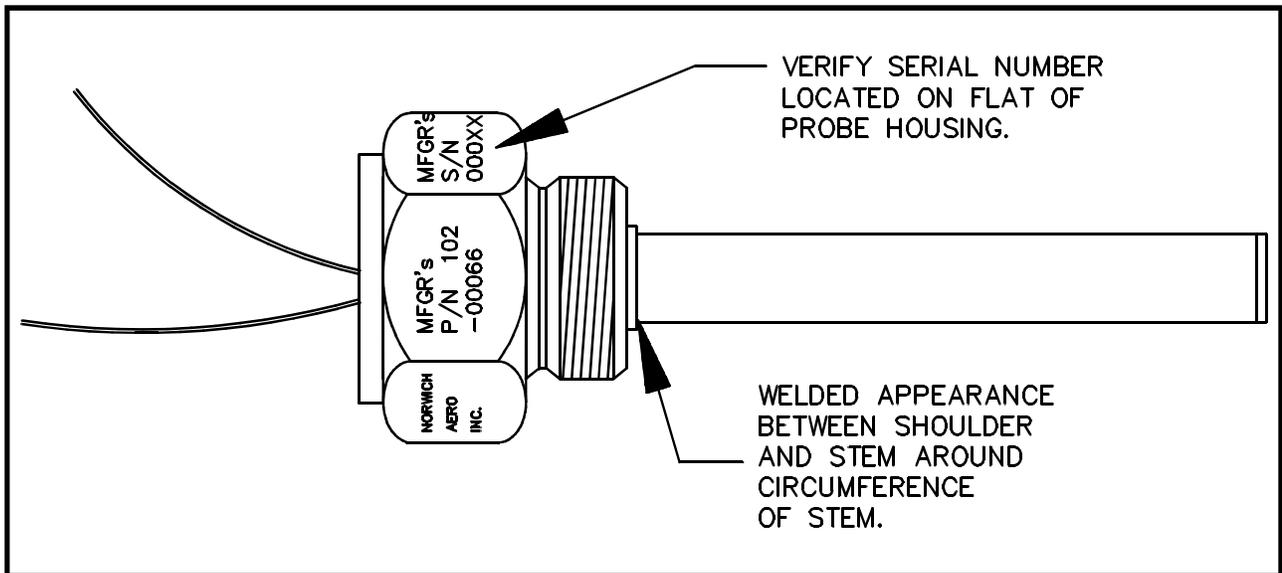
FIGURE SI M20-99-1 OIL TEMPERATURE PROBE (NORWICH AERO)

3. Remove terminal lead connections. Remove probe from accessory case carefully.
4. Inspect probe at threaded shoulder for visible signs of incomplete weld around circumference of threaded shoulder. This weld (fusing) will show up as a light "weld" type operation. If junction between the stem portion and the threaded shoulder is smooth and a visible separation is seen, the unit is **improperly assembled**.

5. Return for Warranty Credit any improperly assembled unit (even if no leaks have occurred) and install a replacement, Mooney P/N, 800263-799.
6. Check all connections, electrical and mechanical, and re-install lower and upper cowling per S & M manual, Section 71-11-00.
