SUBJECT: M20V ALTERNATOR WIRING, MOUNTING AND SECURITY
[Chapter 24 - ELECTRICAL POWER]

MODELS/ SN
AFFECTED: Mooney M20V - 33-0001 THRU 33-0018

TIME OF
COMPLIANCE: **Before Next Flight**

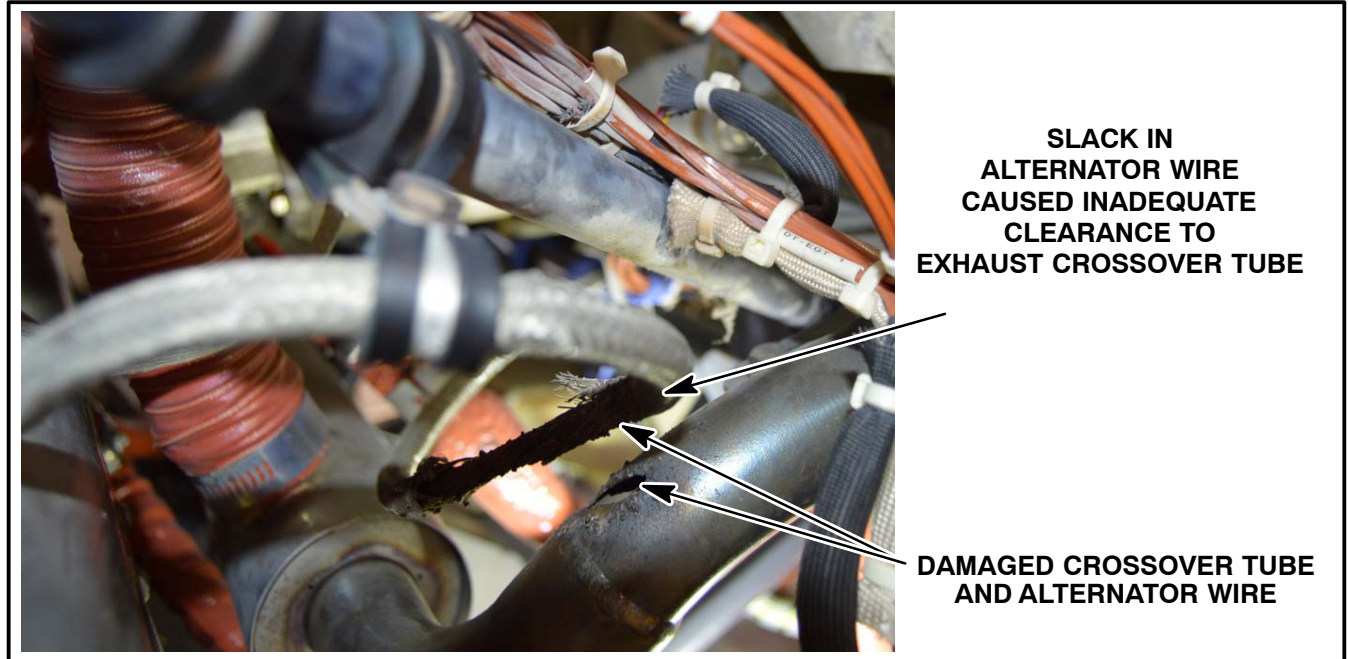
Figure SB M20-340-1 - EXISTING ALTERNATOR CABLE ROUTING

INTRODUCTION: There was a report in the field, of an M20V Acclaim Ultra with an alternator cable damaged on the RH exhaust crossover tube. Mooney Engineering has determined the cable was incorrectly positioned. This allowed the wire to contact the RH exhaust crossover tube causing a short circuit to the alternator. This resulted in damage to the cable and crossover tube. This requires mandatory compliance by owners. **The attached compliance card needs to be filled out and returned to Mooney International Corporation upon completion of this Service Bulletin M20-340C.**

- 1.1. Turn master switch - OFF.
- 1.2. Remove top and bottom cowling, refer to Mooney Service and Maintenance Manual.
- 1.3. Locate alternator cable (refer to Figure SBM20-340-1). Inspect cable for any signs of damage; chafing, cracks in shielding, burnt spots, etc., if cable is damaged, contact MOONEY TECHNICAL SUPPORT support@mooney.com for a replacement cable.

- 1.4. Locate RH exhaust crossover tube. Inspect for damage; holes, cracks, etc., if damaged contact MOONEY TECHNICAL SUPPORT support@mooney.com for a replacement crossover tube, refer to Figure SBM20-340-1.
