SUBJECT: Mooney Aircraft With Smooth Skin Elevators and Balance Weight Inspection
[Chapter 27 - FLIGHT CONTROLS]

MODELS/ SN AFFECTED: All Mooney Models with smooth skin (non-beaded) elevators

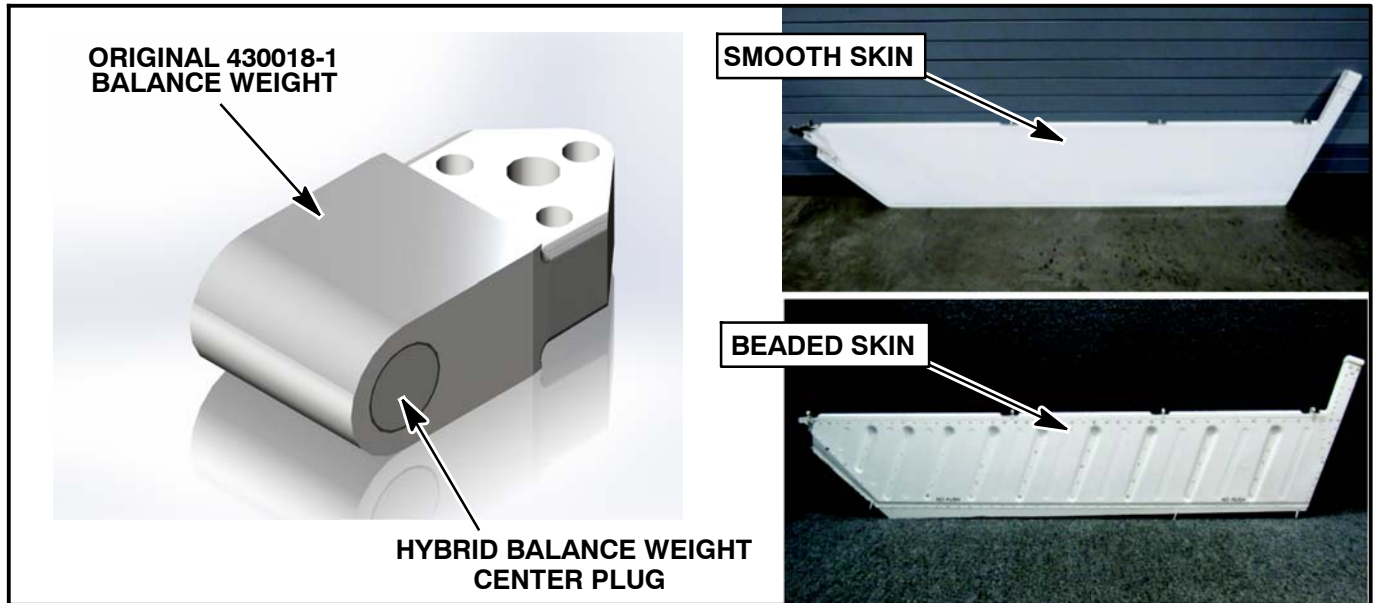
Figure SBM20-345-1 - SMOOTH SKIN ELEVATOR AND BALANCE WEIGHT IDENTIFICATION

- 1.1. If cracks occur, they will most likely be the outer material surrounding center plug, refer to **Figure SBM20-345-1 and SBM20-345-2.**
- 1.2. Inspect all areas of the elevator balance weight for any abnormalities, refer to **Figure SBM20-345-2.** If required, remove paint from the area to be inspected.

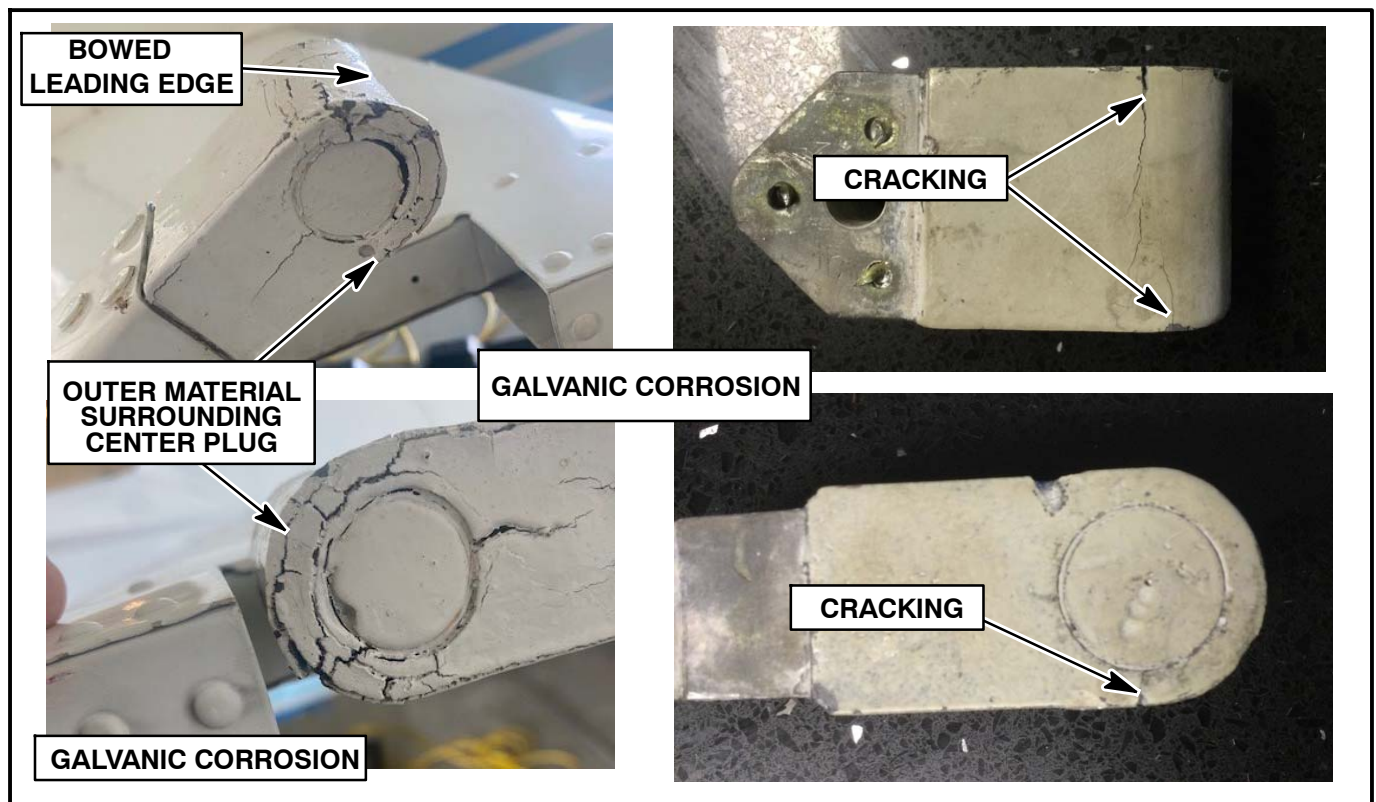
Figure SBM20-345-2 - ABNORMALITIES - SEVERE GALVANIC CORROSION AND CRACKING OF THE ORIGINAL 430018-1 BALANCE WEIGHT

- 1.3. If the balance weight is found to be "abnormal" - DO NOT FLY - Please contact Mooney Technical Support at email technicalsupport@mooney.com for further instructions.

If elevator balance weights are the original 430018-1 style, DO NOT FLY, the balance weights will need to be replaced with new weights developed by Mooney in a later revision of this Service Bulletin.
