MOONEY AIRCRAFT, INC.

Service Letter 20-68

Kit - Repair, P/N 4010 on Tail Truss (P/N 4009)

M-20 And M-20A Serial Numbers 1002-1447

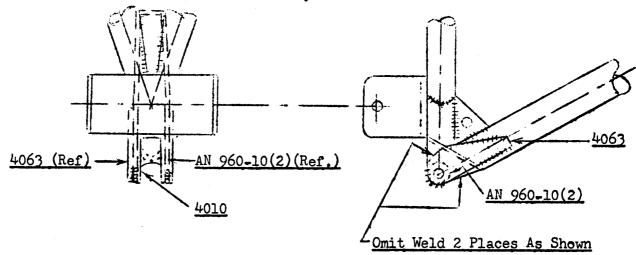
INSTRUCTIONS: To repair a crack in the trim attachment fitting (P/N 4010) on the tail truss (P/N 4009), the following procedure must be followed.

- 1.) Drill a #40 hole at the end of the crack, making certain that the crack does not extend past the hole.
- 2.) Vee the crack out, using a small, thin file. Remove all traces of the crack.
- 3.) Weld up the vee using an oxy-acetylene torch. File off any excess weld that may interfere with P/N 7108 trim link or P/N 4063 finger straps.
- 4.) Clean the fitting in the area of the new weld and inspect carefully.
- 5.) Bolt the 4063 finger straps in place on each side of the trim attachment fitting (P/N 4010) using a 7/16 wide spacer between the ears of P/N 4010 and one AN 960-10 washer as a spacer between strap and fitting on each side. The AN 960-10 washers are not to be removed. Weld as shown in Fig. 1. Remove 7/16 spacer, clean, inspect, and paint.
