**Engine Cooling Baffles**

M20E 101 thru 471

S.L. Kit 20-122

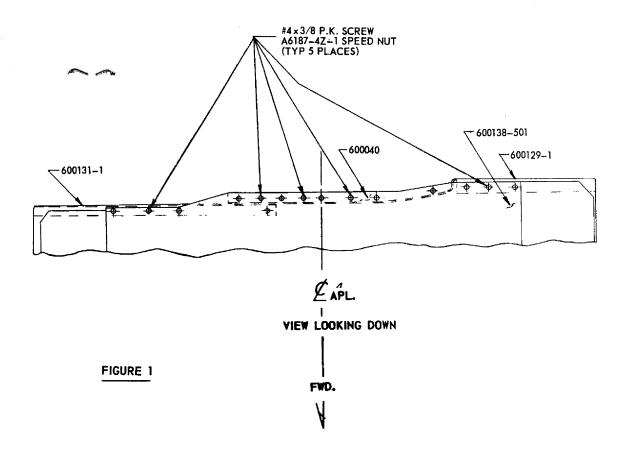
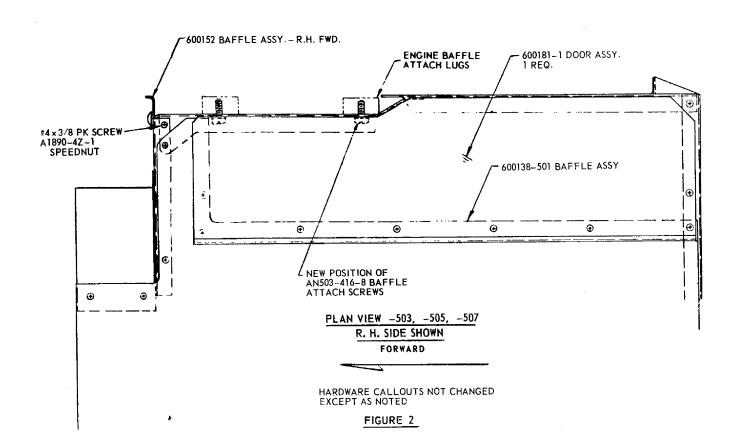
Examine the engine cooling baffles for cracks around the rocker box cover attaching points and at all corners and along all bends. If the baffles are cracked, remove and replace them with 600138-501 Baffle Assy-Engine Top, 600151 Baffle Assy-Left Fwd., 600152 Baffle Assy-Right Fwd., 600136-501 Door Assy-Left Side, and 600181-1 Door Assy-Spark Plug Access (Right Side).

- 1. Remove Top and side cowls.
- 2. Remove top baffle assembly.
- 3. Remove right and left forward baffle assemblies.
- 4. Install 600151 left forward baffle with original hardware in the same manner as the original baffle.
- 5. Install 600152 right forward baffle assembly on the inboard side of the baffle attaching lugs with original hardware installed on the inside of the baffle, see Figure 2.
- 6. Install top baffle assembly 600138-501 and back drill 600129-1, 600040, and 600131-1 baffle assemblies to match, install A6187-4Z-1 speed nut and no. 4x 3/8 PK screws (typ. 5 places) in addition to original screws. See Figure 1 for location of new fasteners.
- 7. Install new spark plug door Assemblies, 600136-501, left side and 600181-1 right side.
- 8. Reinstall top and side cowls.
