MBEK: M20-173

Oil Pressure Line Replacement and Rerouting

M20E S/N 69000l thru 37, 39 thru 43, 45, 47, and 690050 M20F S/N 69000l thru 48, 50, 52 thru 57, 60, 61 and 690063

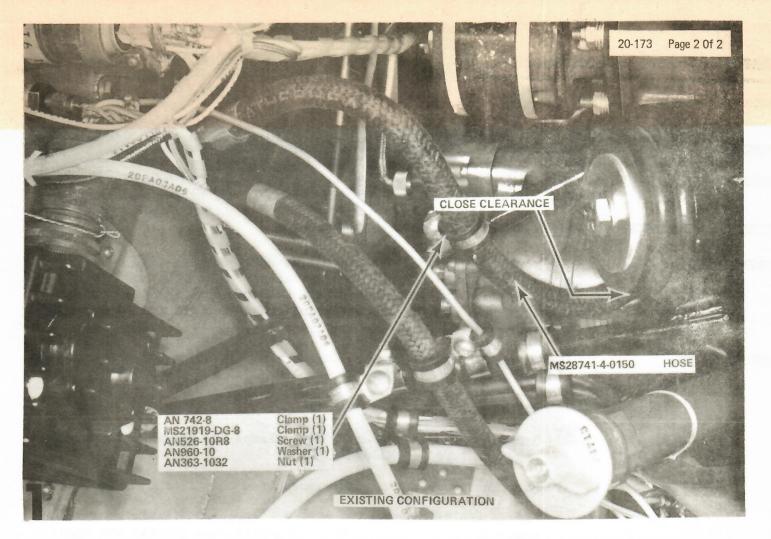
The routing of the oil pressure line P/N MS28741-4-0150 on above models may create a condition that allows the engine mount to contact the oil line. To preclude this possibility, a longer oil pressure line must be installed and routed per the following instructions.

(Refer to Figures 1 and 2 on page 2/2 for location and orientation of all parts)

- 1) Remove the top cowl.
- 2) Remove AN742-8 and MS21919 DG-8 clamps and hardware from oil pressure hose P/N MS28741-4-0150.
- 3) Disconnect the oil pressure hose from the fitting at the engine.
- 4) Remove the fitting at the engine. Apply a suitable thread compound to the fitting and re-install same so that the hose end of fitting points down and 10° forward.
- 5) Disconnect oil pressure hose from firewall fitting and remove hose P/N MS28741-4-0150.
- 6) Install oil pressure hose P/N MS28741-4-0190 routed as shown on Figure 2 on page 2/2 and attach to the tubular engine mount with MS21919 DG-8 clamps (2).
- 7) Run engine at 1200/1500 RPM for approximately 10 minutes or until oil temperature reaches 180/200°F and check for leaks.
- 8) Re-install cowling.
- 9) Fill out and mail enclosed Service Bulletin Compliance Card.
