SERVICE INSTRUCTION M20-117

SUBJECT: TO ADVISE OWNERS OF CORRECT ORIENTATION MOUNTING THE NOSE GEAR "RETRACTING LINK" WHEN SERVICE AND MAINTENANCE IS PERFORMED ON ALL MOONEY AIRCRAFT.

MODELS/ SN AFFECTED: All M20 thru M20TN Series Aircraft

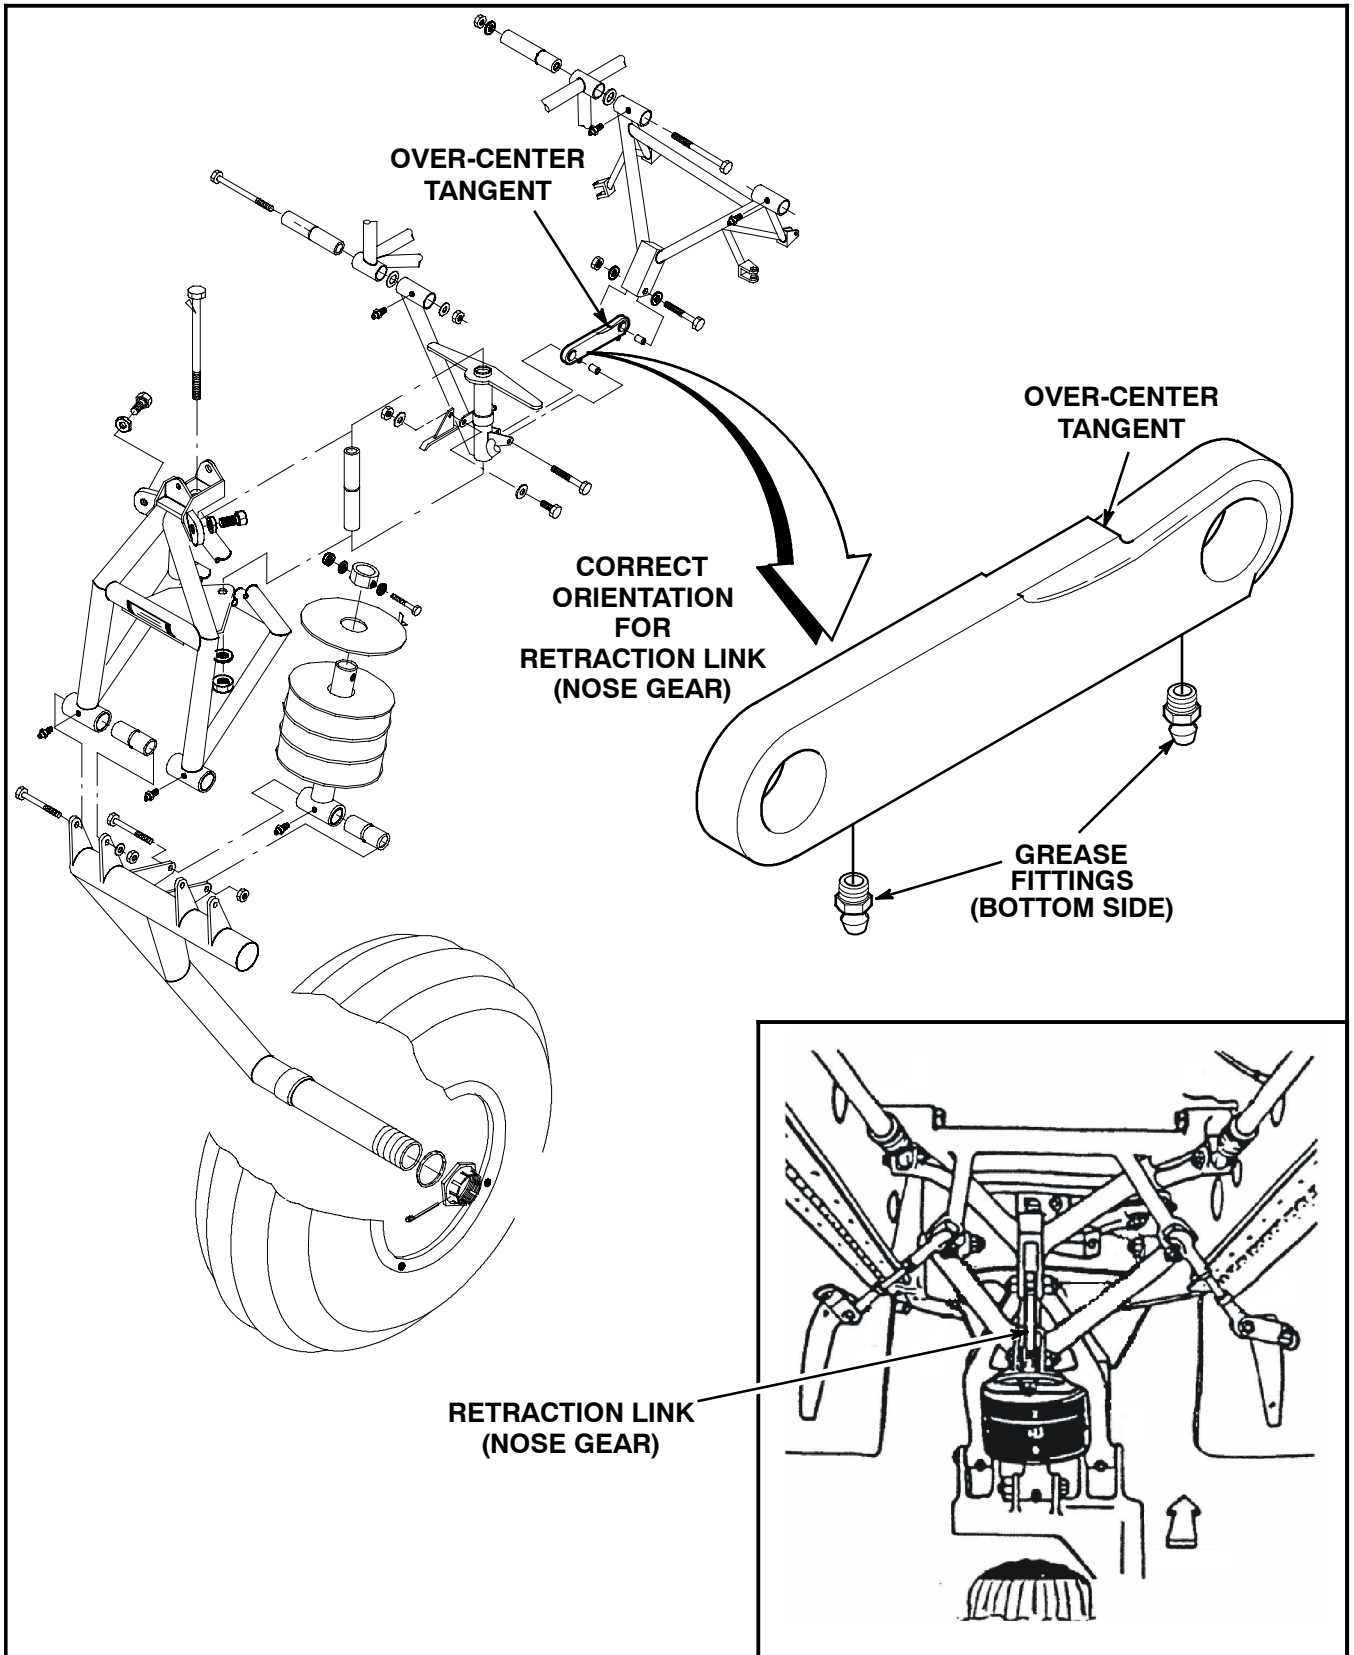
INTRODUCTION: There has been a reported instance in the field, that the nose gear "Retracting Link" was incorrectly installed (upside down). This incorrect installation caused the nose gear to collapse upon landing.

FIGURE 1 - ORIENTATION OF NOSE GEAR RETRACTION LINK

INSTRUCTIONS: This information is to clearly identify the correct orientation when installing the nose gear "Retracting Link" and orientation of the "over-center" tangent as shown in Figure 1.

Refer to the applicable Mooney Service Manual for nose gear rigging instructions.
