SERVICE INSTRUCTION M20-18

SUBJECT: Inspection of Carburetor Air Box
MODEL AFFECTED: M20, Serials 1002 through 1200
MANUFACTURER RECOMMENDATION: On or before next 100 hour inspection

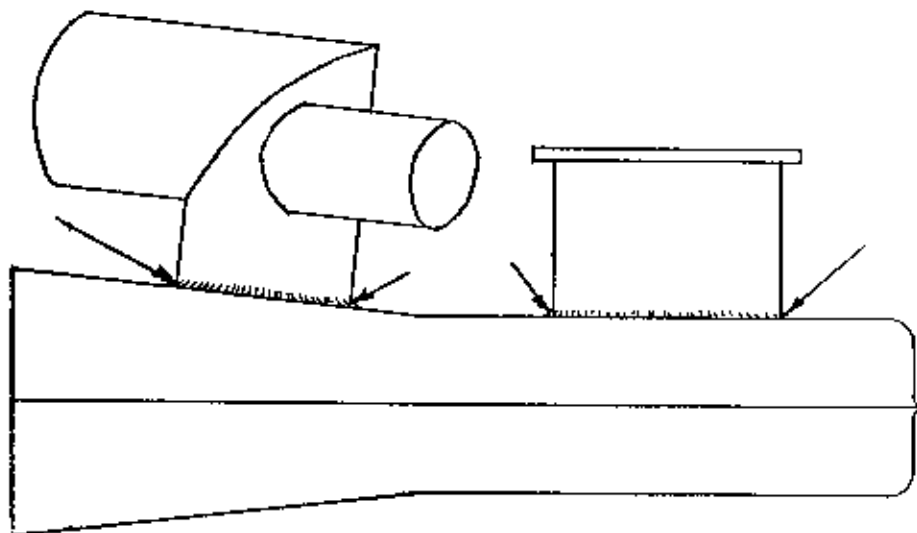
1. Remove side cowls.
2. Remove carburetor air box from aircraft.
3. Thoroughly inspect the air box for cracks. Particular attention should be paid to the vane attachment welds and areas shown in the attached sketch.
4. If any evidence of cracks is found, the carburetor air box assembly (Part No. 6178) should be replaced.
5. Replace carburetor air box.
6. Replace the side cowls.

CHECK FOR CRACKS AT POINTS INDICATED

Some design improvements made for later model aircraft have been incorporated into the carburetor air box offered in this service letter. The basic improvement is the use of stronger material which should substantially increase the service life of the air box. We recommend that the present air box be replaced if this inspection shows it necessary.
