SERVICE BULLETIN

NUMBER: M20-213

SUBJECT: POSSIBLE EMERGENCY LOCATOR TRANSMITTER (ALERT 50) ANTENNA GROUNDING

MODELS AFFECTED: M20C, S/N 20-1186 thru 20-1258; M20F, S/N 22-1306 thru 22-1438; M20J,S/N 24-0001 thru 24-0454

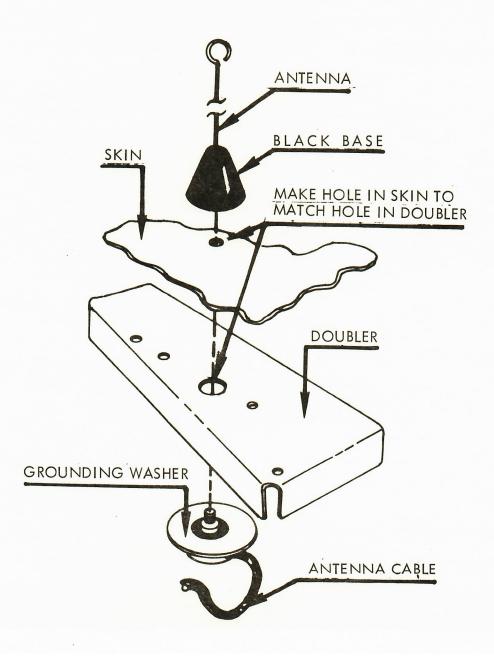
INSTRUCTIONS: Remove the ELT antenna by turning the black base counter-clockwise. Remove the antenna cable (stud) by pushing downward. Enlarge the hole in the skin to coincide with the matching hole in the doubler (approx. ½ inch). Apply zinc chromate to the raw edges of metal, being careful to remove any excess from the bottom of the doubler being contacted by the grounding washer of the antenna cable and attach the antenna by screwing the black base until secure. After installation seal underside with RTV-102 or equivalent to prevent water leaks.

INTRODUCTION: It has been discovered that the ELT antenna mounting hole in the aircraft skin may be too small to allow proper insulation of the center stud. This could prevent the proper operation of the ELT signal in case of an accident. Therefore,
