## SERVICE BULLETIN

NUMBER: M20-221

OIL PRESSURE TRANSDUCER INSTALLATION MODIFICATION

M20J 24-0084, 24-0378 thru 24-0906, 24-0908 thru 24-0925, 24-0927 thru 24-0942, 24-0946

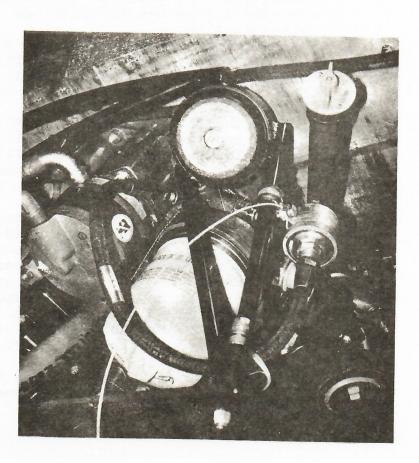
There has been a report of possible interference between the oil pressure transducer housing and the upper right hand engine mount. The interference may cause failure of the transducer installation and result in loss of engine oil pressure.

Route the transducer and hose under the upper right hand engine mount tubes and secure to upper outboard tube with the two clamps and hardware; the smaller clamp around the engine mount tube and the larger clamp around the transducer body as shown in Figure 1.

Connect the flex hose, P/N S94B90145, to this adapter and the other end, 1/8 inch pipe thread, to the transducer; use Tite Seal on all pipe threads. Position hose and fitting to obtain a clearance of .20 in. between hose socket and vacuum pump housing.

Connect the ground wire, wire no. 21DH04C20, under the bolt head holding the clamps together and to the landing light ground

Secure hose to engine mount with TY-RAP, MS3367-1, ensuring clearance between adjacent components.
